ROOF ASBESTOS SURVEY

**Conejo Truck Inspection Building
07-VEN-101 PM R9.1
Ventura County, California**

**GEOCON PROJECT NO. S9475-06-08
TASK ORDER NO. 08
PPNO. 07 0000 0542 (EA 07-278901)
CALTRANS CONTRACT NO. 07A2729**

APRIL 2011

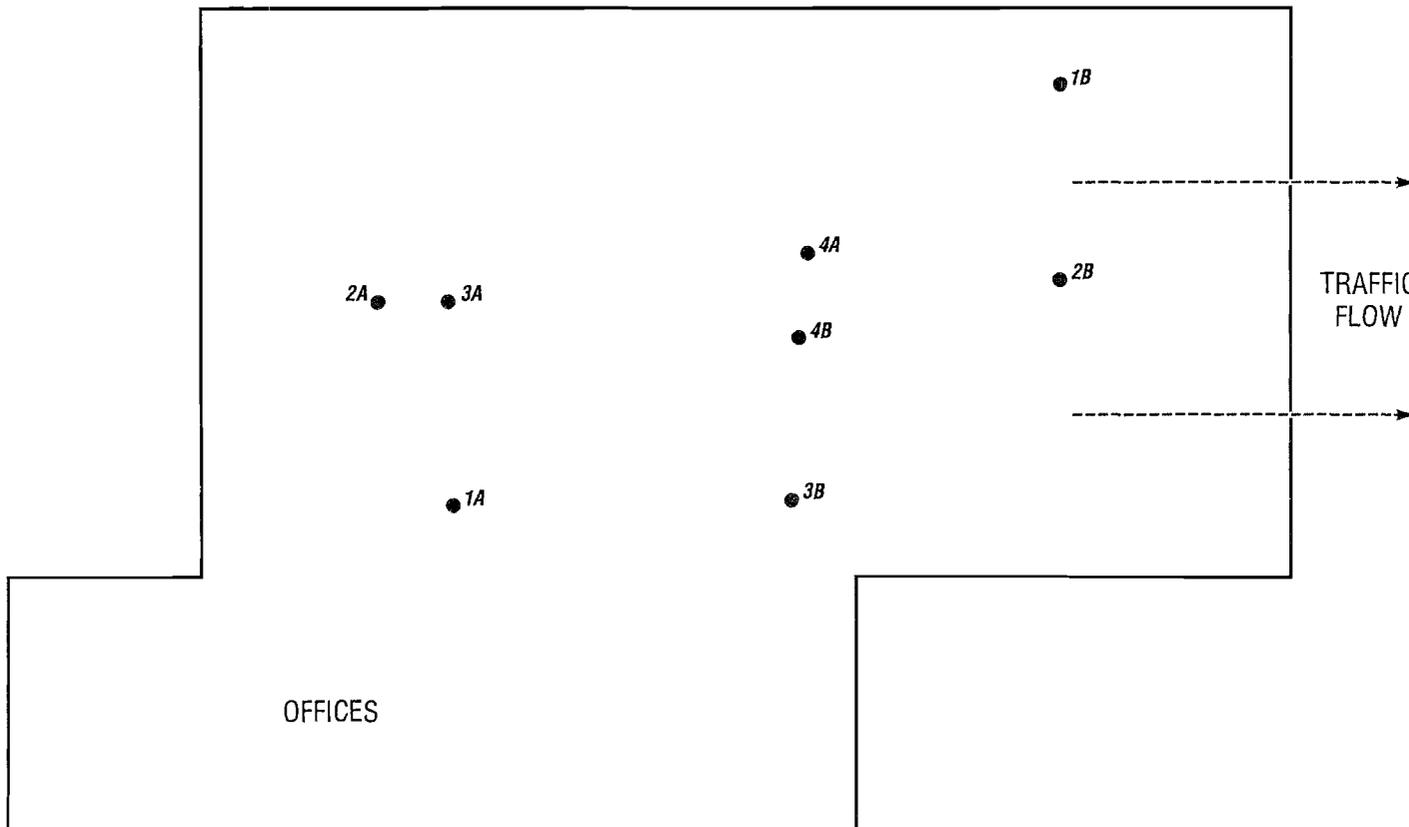
Figure 2

SITE PLAN

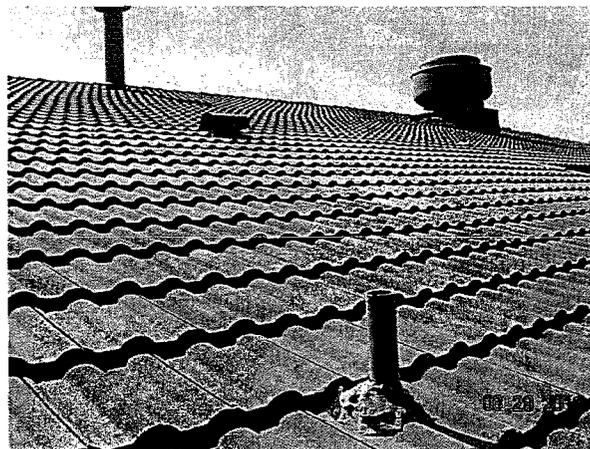
Chrysotile asbestos at a concentration of 5% was detected in a sample representing approximately 25 square feet of nonfriable asphalt roofing mastic observed at penetrations, flashing, and at various locations on the roof where leakage was apparently occurring. Some of the mastic is beneath the tiles.

Photo 3 – Mastic used on roofing penetrations

The SCAQMD requires that ACM identified during our survey be removed and disposed of prior to activities that would disturb the material. Asbestos-containing roofing mastic (a NESHAP Category I nonfriable/nonhazardous material) may be disposed of as nonhazardous asbestos waste. However, the disturbance of the material is still covered by the Cal/OSHA asbestos standard contained in Title 8, CCR Section 1529. We recommend that a licensed roofing contractor registered with Cal/OSHA for asbestos-related work perform activities that would disturb the roofing mastic. The roofing contractor is responsible for determining which work methods will be used. The work methods must meet the requirements of the Cal/OSHA asbestos standard. Contractors are responsible for informing the landfill of the contractor's intent to dispose of asbestos waste. Some landfills may require additional waste characterization. Contractors are responsible for segregating and characterizing waste streams prior to disposal.
