Effect Of Broom Texture On Motorcycle Rideability

## EFFECT OF BROOM TEXTURE ON MOTORCYCLE RIDEABILITY

INTERIM REPORT

**CA-HY-MR3126-8-72-32**

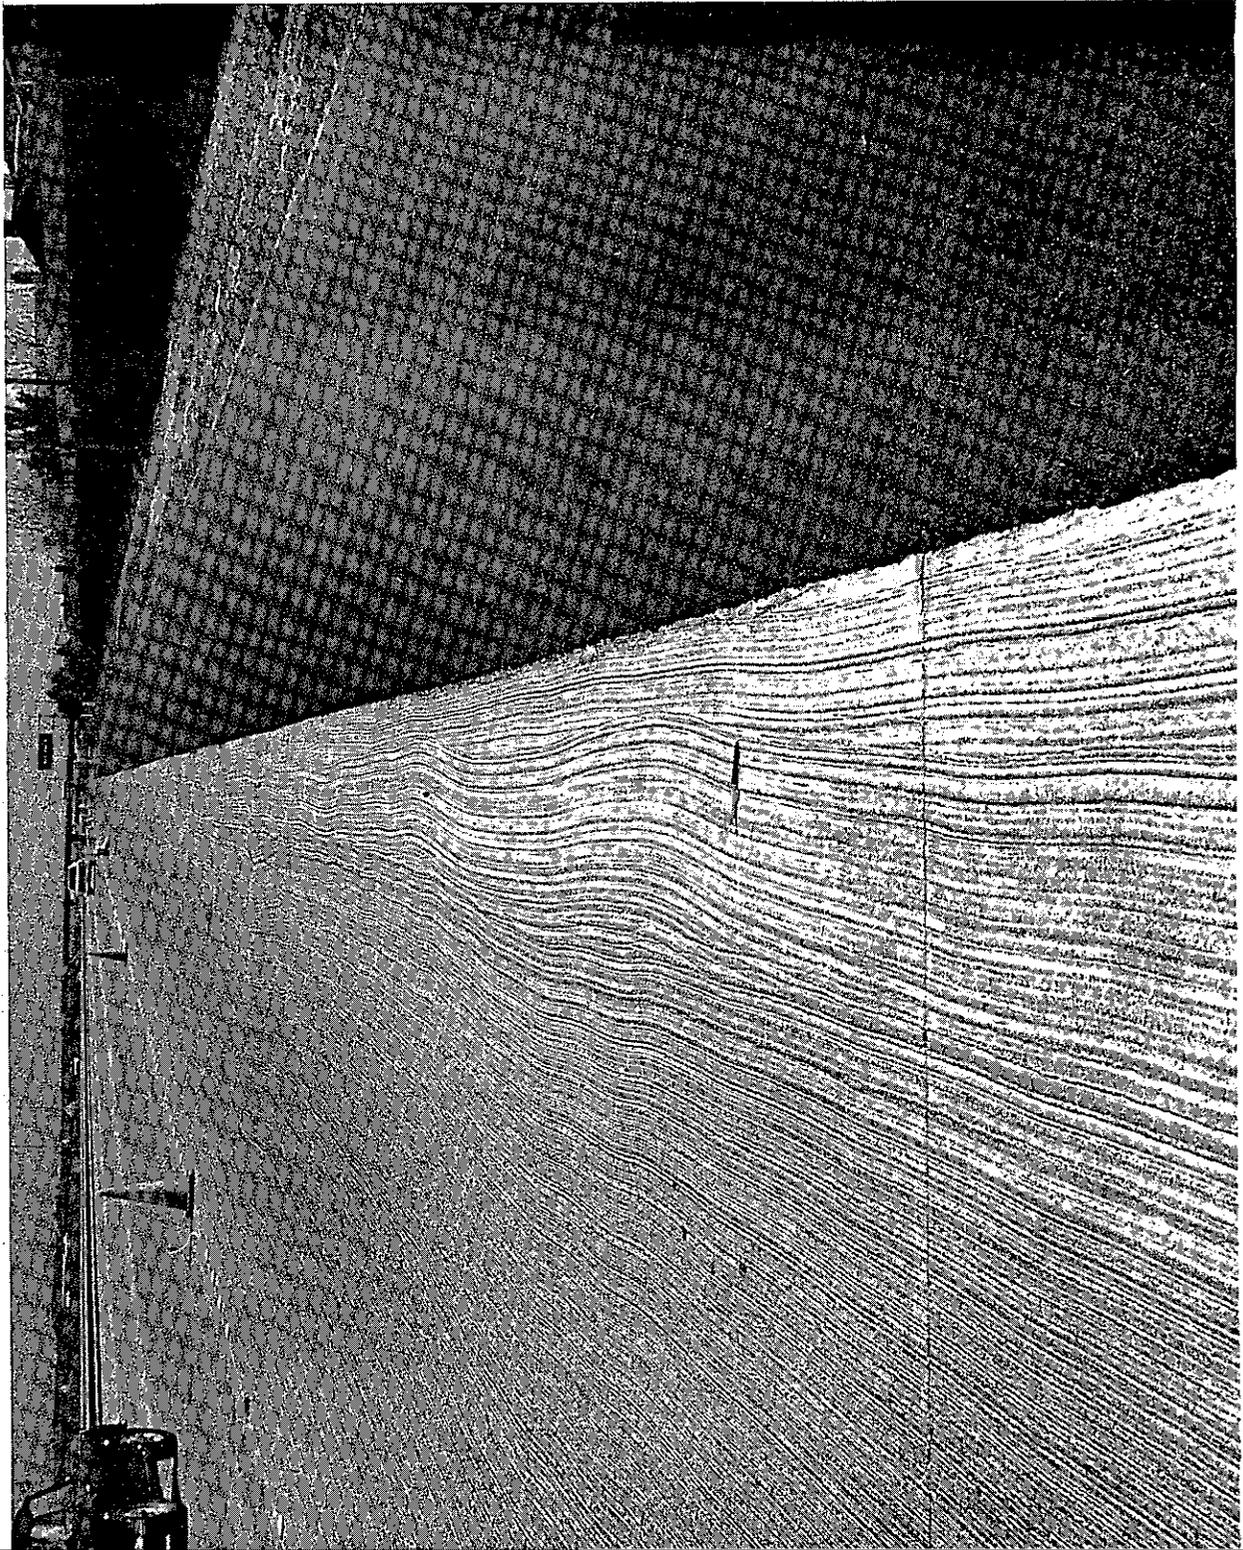
vicinity of Occidental Avenue O.C., the No. 4 (right hand) Eastbound lane was selected for concerted evaluation. This particular area had a heavy broom texture with deep wavy striations (see Figures 1 and 2) and represented a section of the more severe texture. In addition, a cursory evaluation was made of the portion of freeway from Watt Avenue to Stockton Boulevard in the outer lane, both directions.

Figure 1. Typical condition of surface texture

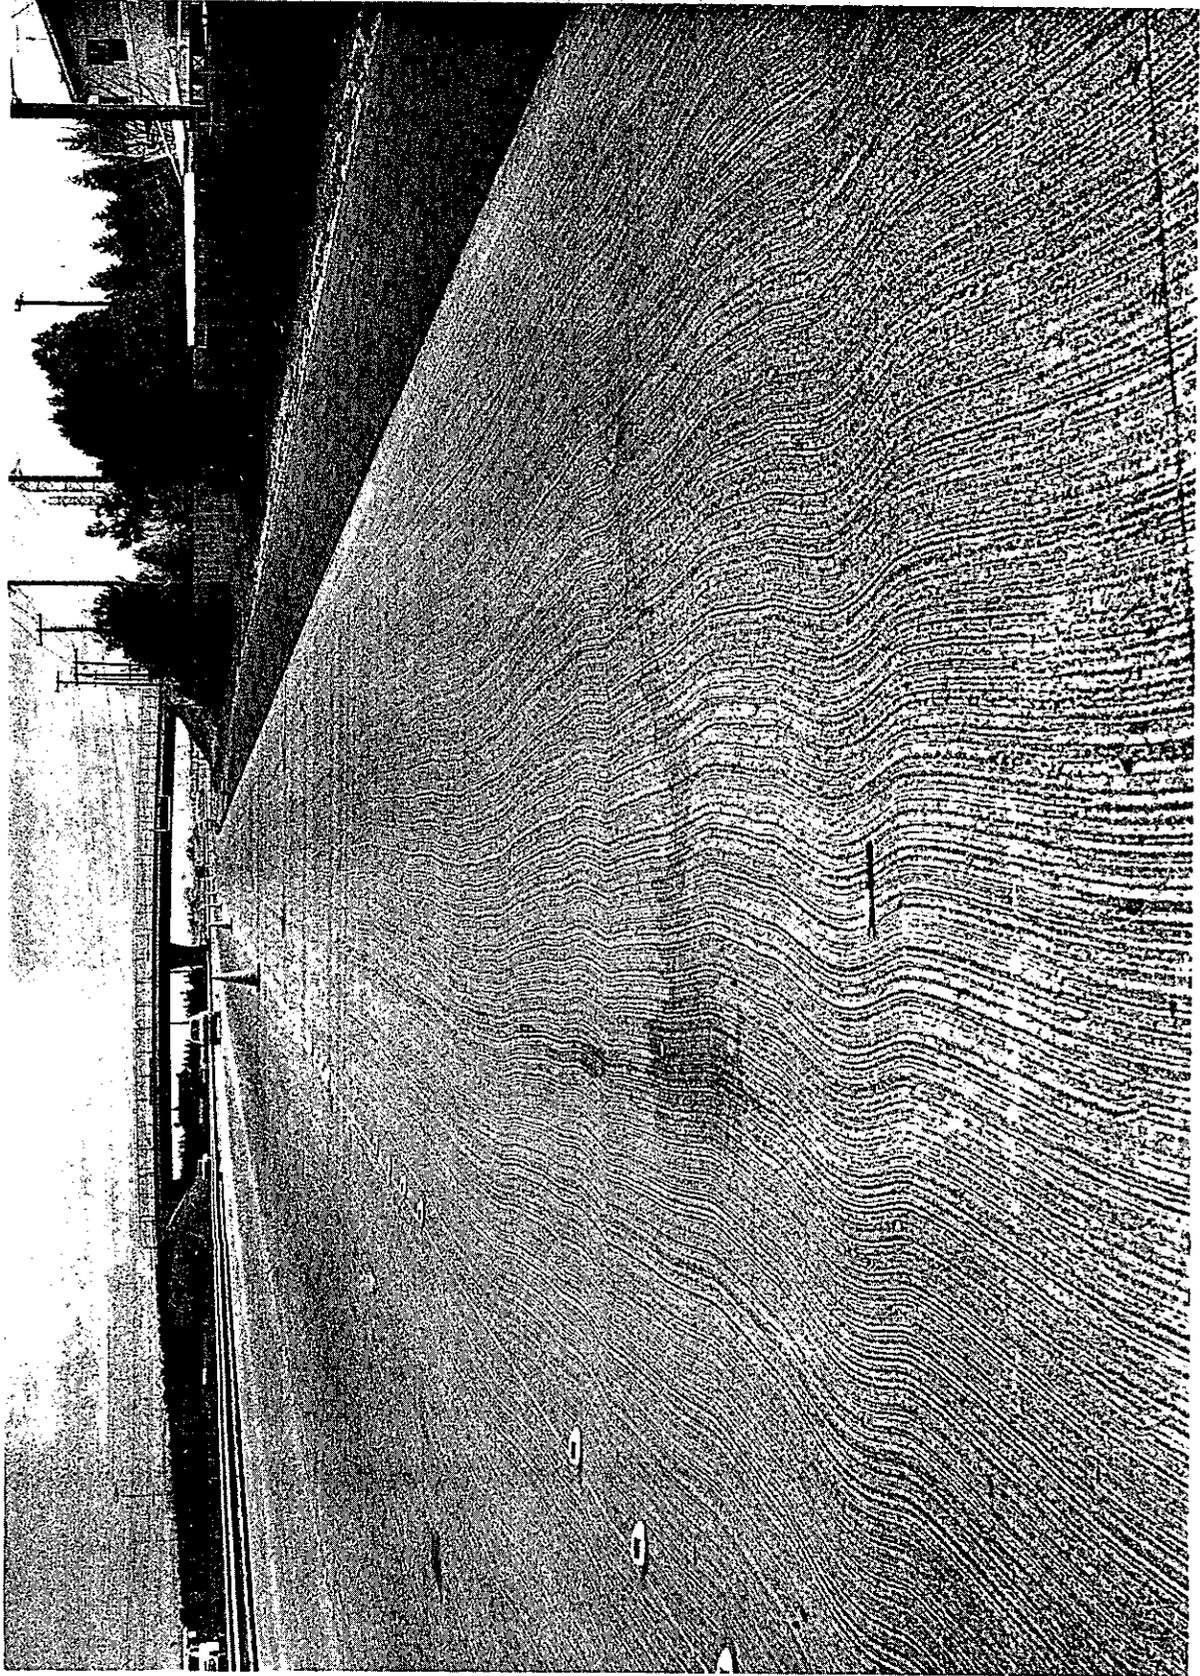
Figure 2. Typical condition of surface texture

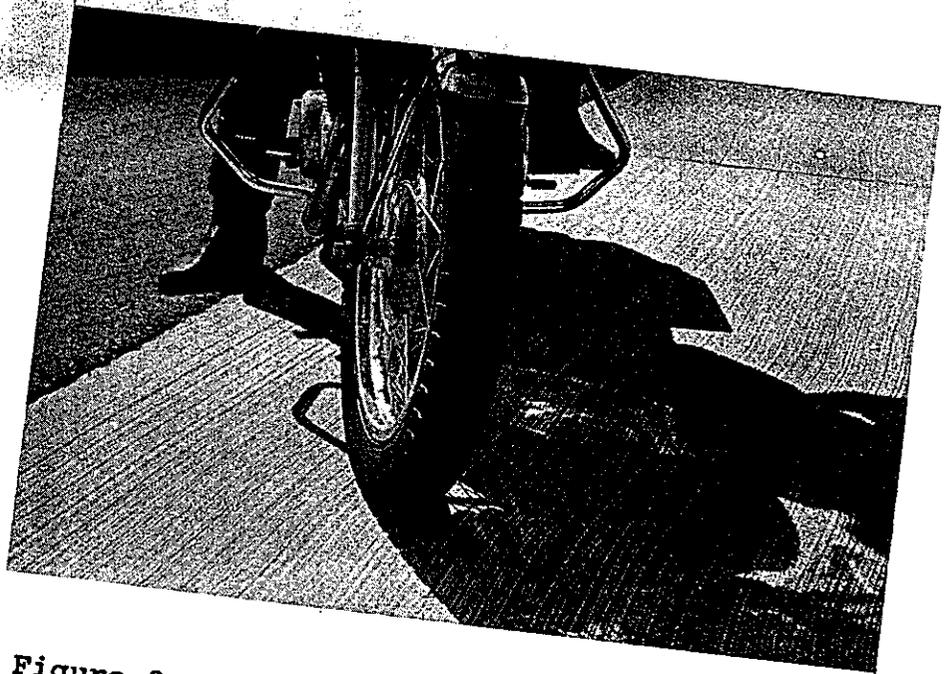
There was some slight oscillation with the semi-knobby tires on the 500 cc bike, and a moderate amount with the 250 cc bike. Although this oscillation was more apparent using the 250 cc bike, it presented no problems in controlling the machine at the test speeds.

Figure 9. 500 cc Bike with Semi-knobby Tires

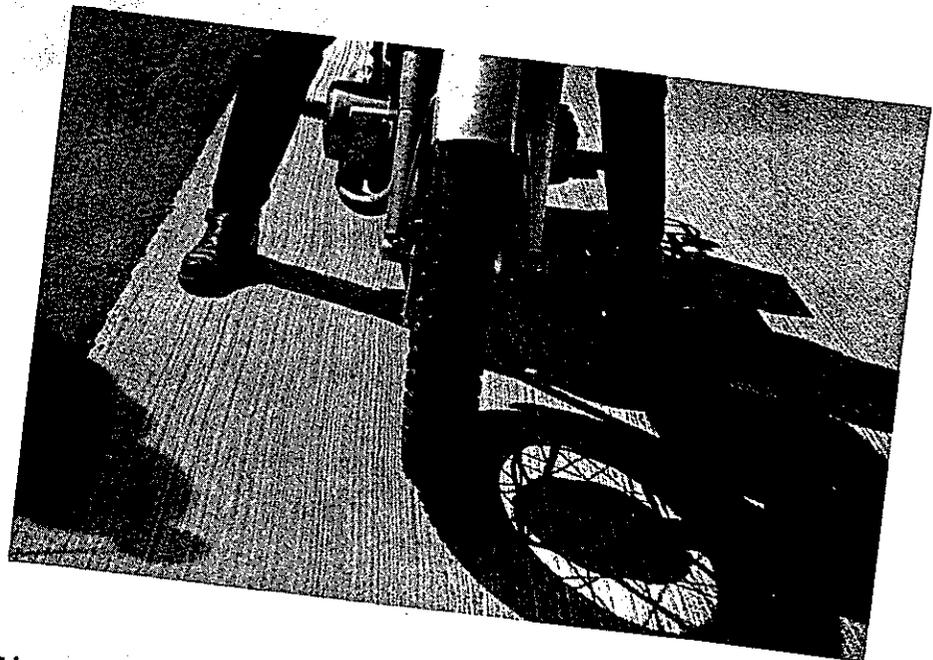
Figure 10. 250 cc Bike with Semi-knobby Tires
