Faulting Of Portland Cement Concrete Pavements

January 1972

FAULTING OF PORTLAND CEMENT CONCRETE PAVEMENTS

Presented at the 51st Annual Meeting  
of the Highway Research Board  
January 1972

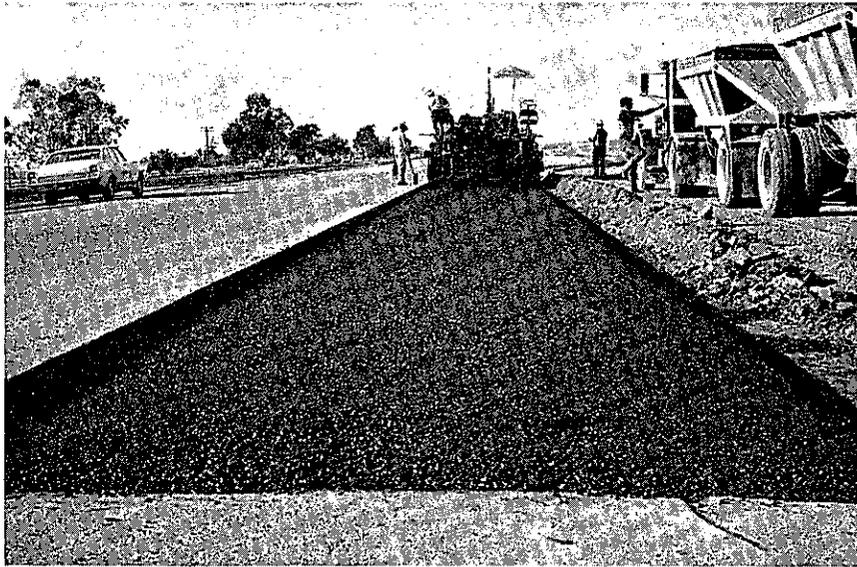
The aggregate base of the shoulder was replaced with permeable AC (very open graded) in a 1000-ft. section. (See Figure 1.)
3. US 99, South of Sacramento - Two 2000-ft. sections
  - A. A seal consisting of a fiberglass reinforced plastic strip - 2 ft. wide, placed along the edge of the slab and over the widened CTB in the shoulder. Aggregate base and AC then placed as usual. (See Figure 2.)
  - B. Aggregate base replaced with permeable AC. (See Figure 3.)
4. I-205, South of Sacramento - 2000-ft.

Fig. 1 Permeable asphalt concrete shoulder being placed on I-5

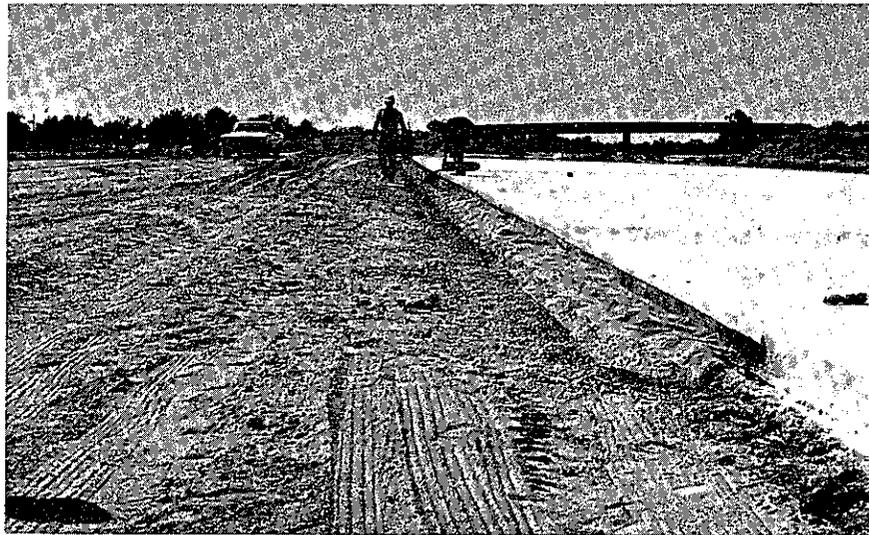
Fig. 2 Fiberglass reinforced plastic placement, US 99

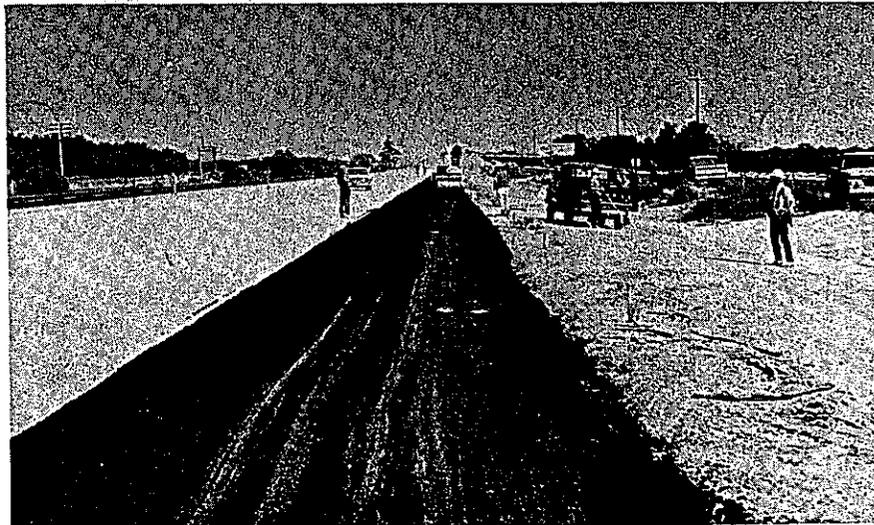
With less than 10% of the aggregate passing the No. 4 sieve and using 2% asphalt, there was some difficulty in compacting the permeable AC. After some experience, it was found that cooler mix temperatures and lighter rollers (6-8 tons) provided better results. On the shoulder replacement test section, wheel rolling in the confined area was felt to be sufficient. A steel wheeled roller was used on the dense graded surface course. The cost of the permeable AC under the experimental conditions was 20% to 40% more than the dense graded mix.

Fig. 3 Rolling of Permeable asphalt concrete,  
US 99

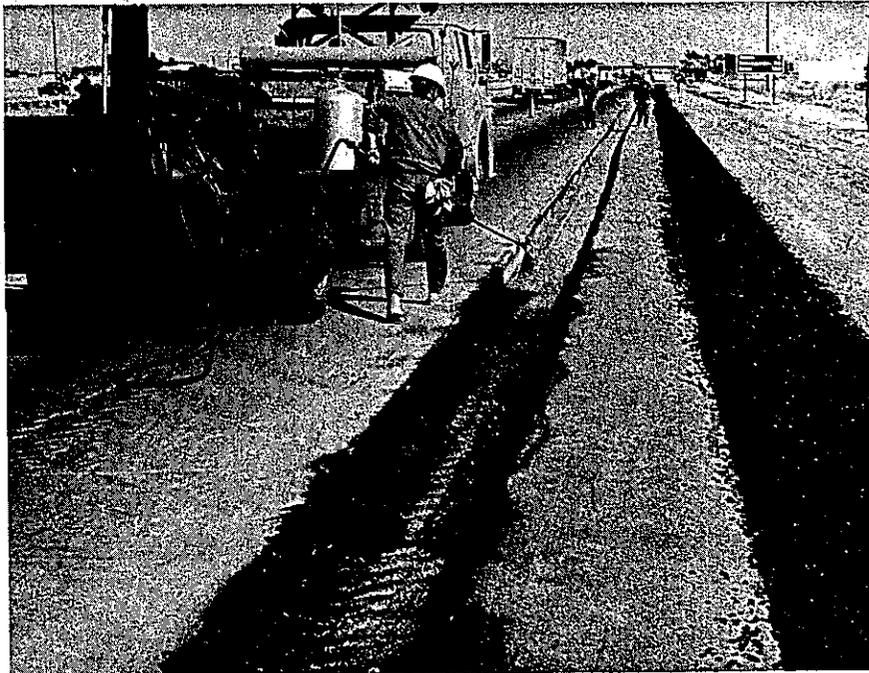
This was a partial shoulder replacement of a pavement that had been in service about 8 years and had moderate faulting. A 2-ft. wide section of the outer shoulder adjacent to the slab was removed down to the bottom of the slab. Loose material was broomed away, a tack coat of asphalt emulsion applied, then 0.5-ft. permeable AC and 0.25-ft. dense graded AC to complete the shoulder. A 2000-ft. section was replaced in both the eastbound and westbound lanes. The basic objective of this work was to eliminate erodable shoulder material from the areas adjacent to the slab to see if faulting could be arrested. In addition to providing erosion resistance, the permeable AC is expected to provide better drainage which may also help reduce faulting tendencies. Performance of the test sections will be compared to that of adjacent untreated areas. (Reconstruction features are shown in Figure 4.)

Fig. 4 Partial shoulder replacement - I-80

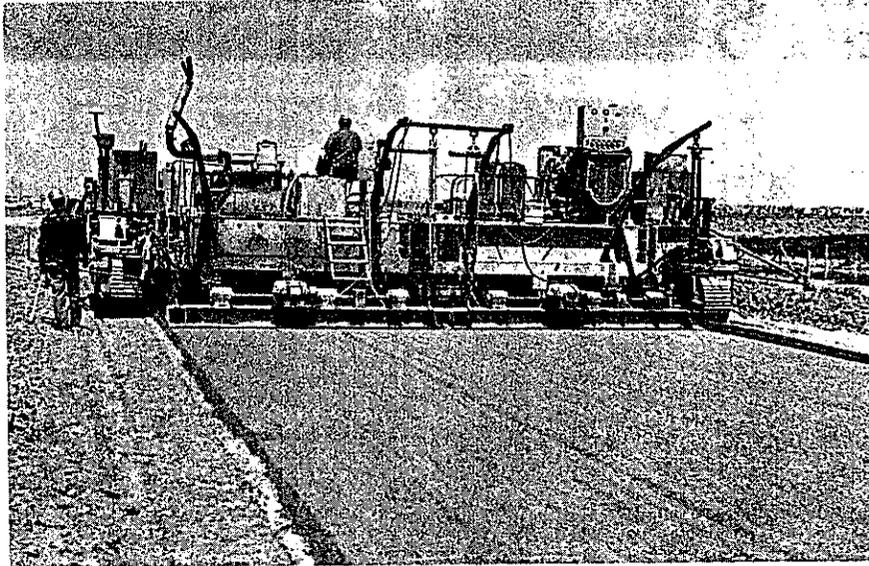
Recently it has been noted that a few contractors are changing their CTB placing methods. They have gone to central mixing, whether required or not, and to placing with a slipform paver. Instead of a wet mix and internal vibration, they use the regular dry mix and a vibrating screed behind the paver, followed by rollers. This results in a much harder appearing surface and trimming is seldom if ever necessary. Unfortunately, there is no test method available for measuring abrasion resistance of CTB in place. If the trend to this type of construction continues, our objection to CTB due to trimming may be overcome (see Figure 7).

Fig. 7      Placing cement treated base with slipform paver
