Evaluation Of A Shoreline Erosion Control Project

December 1973

Transportation Laboratory
California Division of Highways
Sacramento, California 95819

Interim 1971 thru 1973

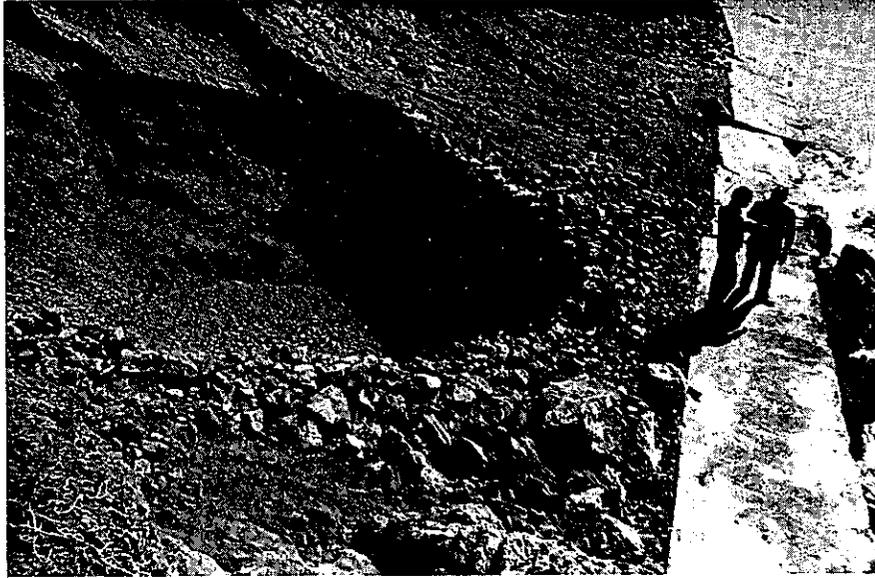
Because of the irregularity of the coastline and the presence of offshore rocks, currents along the shore are weak and tend to be local. The absence of strong long duration currents precludes the movement of large amounts of sand. In the vicinity of the seawall, however, strong local currents have been observed moving sand both north and south. These sand losses resulted in undercutting the sea wall and extensive damage. Plate 3 shows this damage. Note that all sand is scoured away from the foundation. Plate 4 shows a collapse of seawall backfill material as a result of scour. The wall under severe wave attack is shown by Plate 5.

Plate 4 - Loss of Seawall Backfill Material

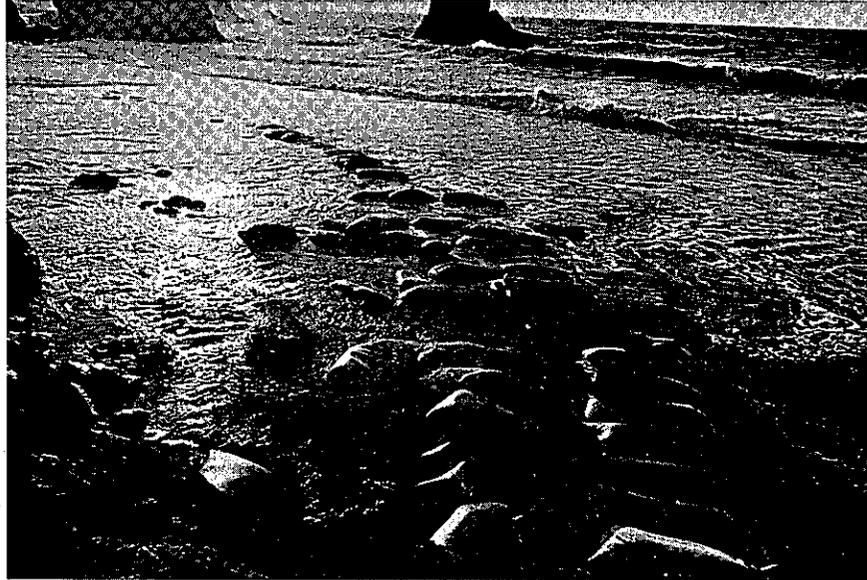
Plate 12 is a view of the sill looking toward the south taken five months after the sill was completed. Several of the bags can be seen to have been displaced. It can also be seen that the south end of the sill is lower in elevation than the north end. The groin is not visible because it is even lower. It is believed that the absence of sand behind the bags permitted the wave action to displace them. Observations during low tides indicate that waves break over the sill and the water in running

back to the sea must run south across the groin. The velocity of this runoff is great enough to carry away the sand so that the bags never had any support. Control of the elevation of the top of the sill and groin would eliminate this problem and permit the entrapment of sand.

In spite of this problem, it is estimated that only about 10% of the bags on the sill have been displaced. The displacements are nearly all in the direction of the beach, and in a few cases, have not resulted in a total loss of effectiveness. Although the sand bag structure has not been observed in an exposed condition since November of 1972, it has been seen through the water. It appears to be basically still intact after 15 months. Except for the bags at the extreme surf line, they are all covered by a solid and apparently permanent growth of marine algae. Bags in the surf line are expected to fail as a result of severe abrasion. This failure will probably occur between 3 and 5 years depending on the severity of the exposure.

Plate 12 - Sill - Five Months After Completion
