Investigation of the Crashworthiness of Barrier Mounted Hardware: Barrier Mounted Sign and Signpost

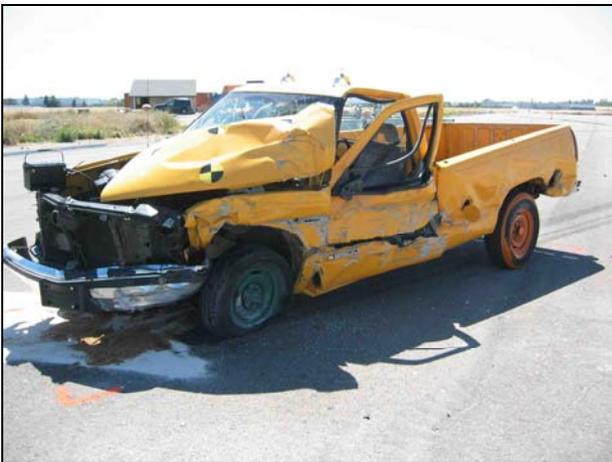
Figure 3 – Vehicle After Test

There was significant damage to the driver's side front quarter of the vehicle. The hood was pushed back and penetrated the windshield 250mm (9.8in), measured from the center of the windshield to the resting place of the hood. The driver's side front wheel was pushed backward 340mm (13.4in) from its initial location. There was a jagged slash down the entire driver's side of the truck caused by the two bolts that hold the signpost assembly to the barrier. The front grill of the truck broke off and traveled over the barrier into the opposing traffic side of the barrier. The top of the driver's side door deformed outward from the vehicle's frame. Inspection of the occupant compartment revealed that the dashboard

was pushed back 202mm (8.0in). The driver side had a peak loss of 98mm (4.0in) measured between the bottom of the dashboard and the floorboard.

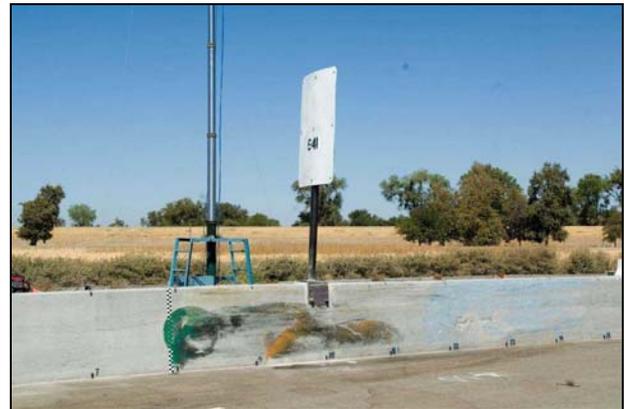
Figure 4 – Impact Area After Test

Vehicle Trajectory. For Structural Adequacy, the barrier successfully redirected the vehicle with only minor cosmetic damage. Also, the signpost remained on the barrier and would require only minor maintenance. For Occupant Risk, Test SS641 failed due to the windshield being penetrated, hazardous debris, and high occupant compartment deformation. The vehicle's exit angle and rate of return into traffic were within the guidelines given for Vehicle Trajectory. Since this test failed, it is recommended that Caltrans consider not using this method of mounting signs on median barriers and develop safer ways to display signage.
