GEOTECHNICAL DESIGN REPORT

07-LA-105-PM R3.5

Abutment 5 Approach Slab Repair,
Imperial Highway Overcrossing
Br. No. 53-2655

Subject: Geotechnical Recommendations for Abutment 5 Approach Slab Repair at Imperial Highway Overcrossing (OC) over State Route 105 (SR-105)

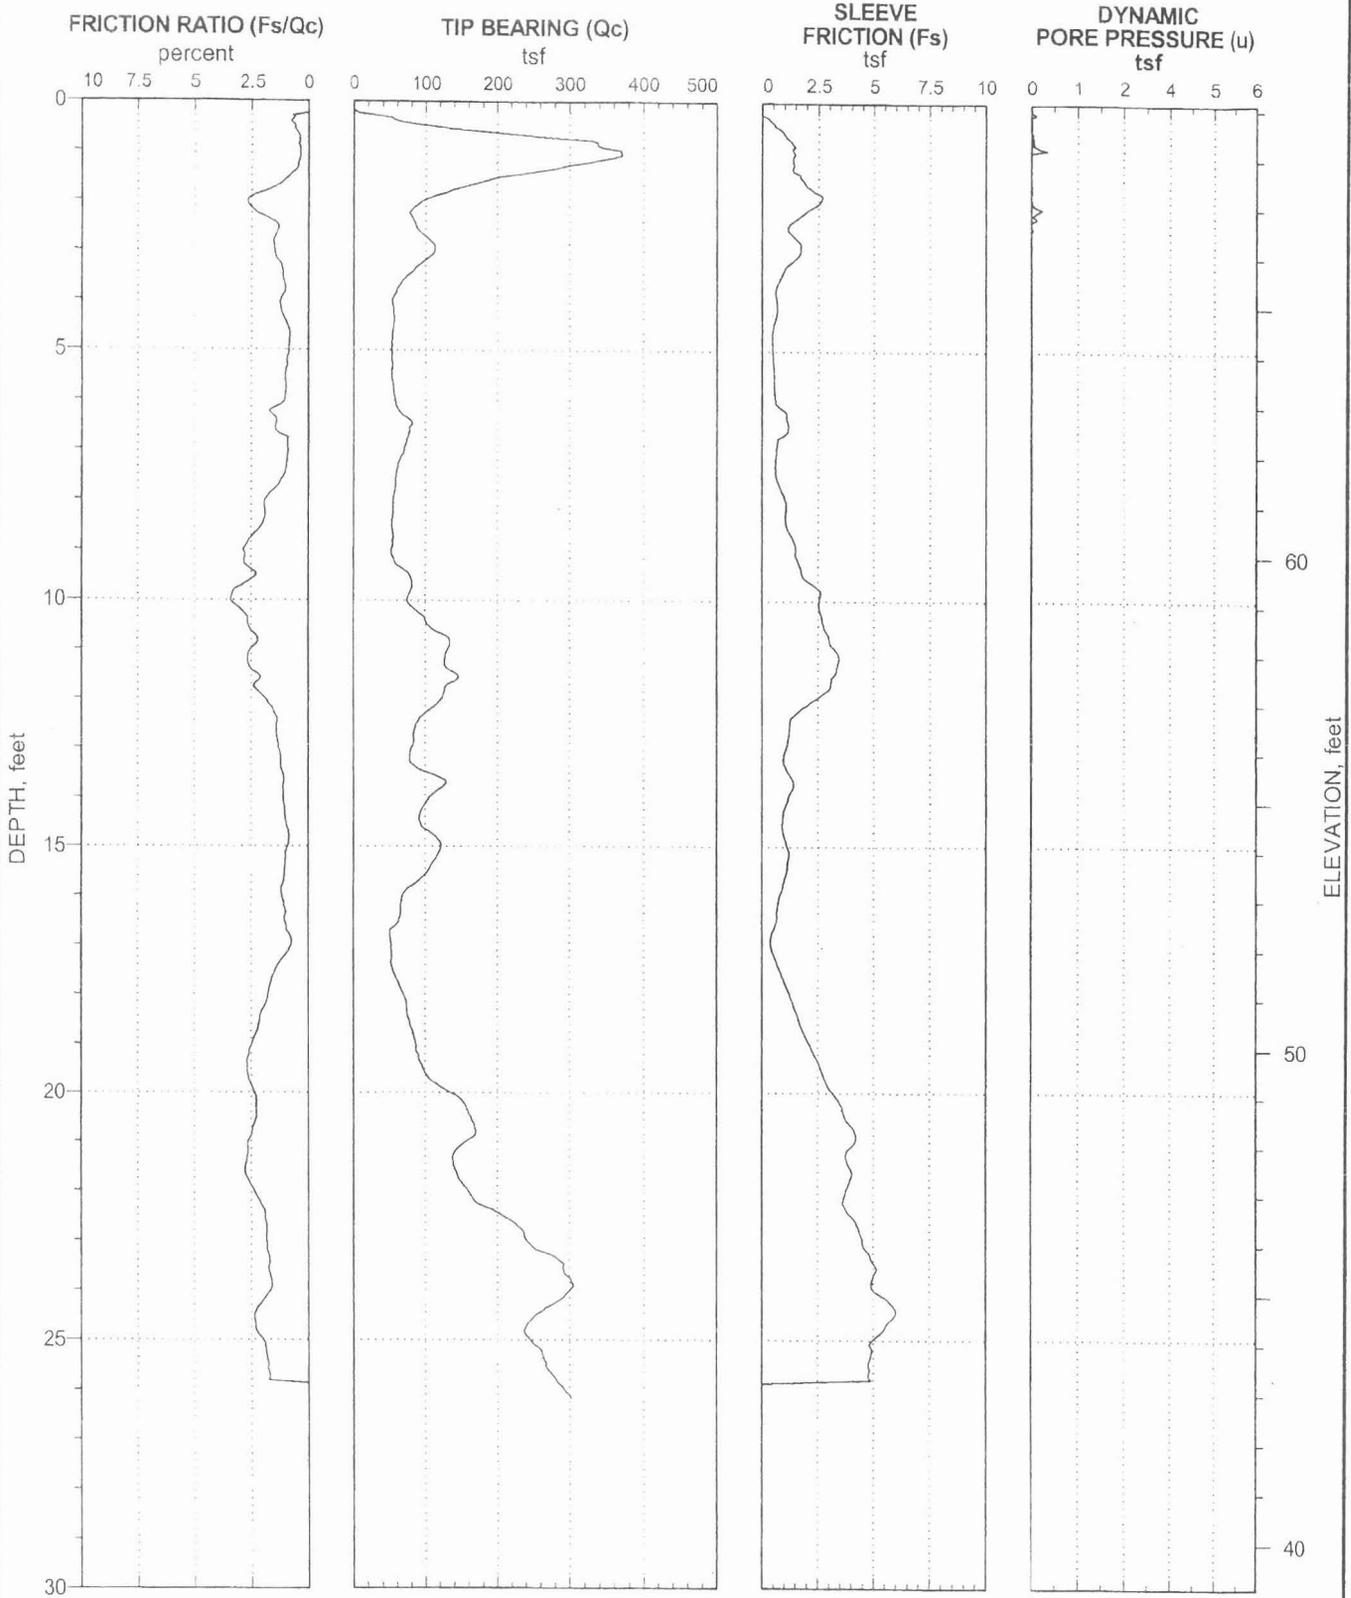
REPORT TITLE BORING RECORD				HOLE ID CPT-07-102	
DIST. 07	COUNTY LA	ROUTE 105	POSTMILE 3.4/3.4	EA 07-4S7601	
PROJECT OR BRIDGE NAME Imperial Highway Overcrossing (OC) @ Interstate 105					
BRIDGE NUMBER 53-2657		PREPARED BY PP		DATE 2-20-08	SHEET 1 of 1

CALTRANS CPT RECORD 052007 07-4S760.GPJ CT SACTO 053107.GDT 2/29/08

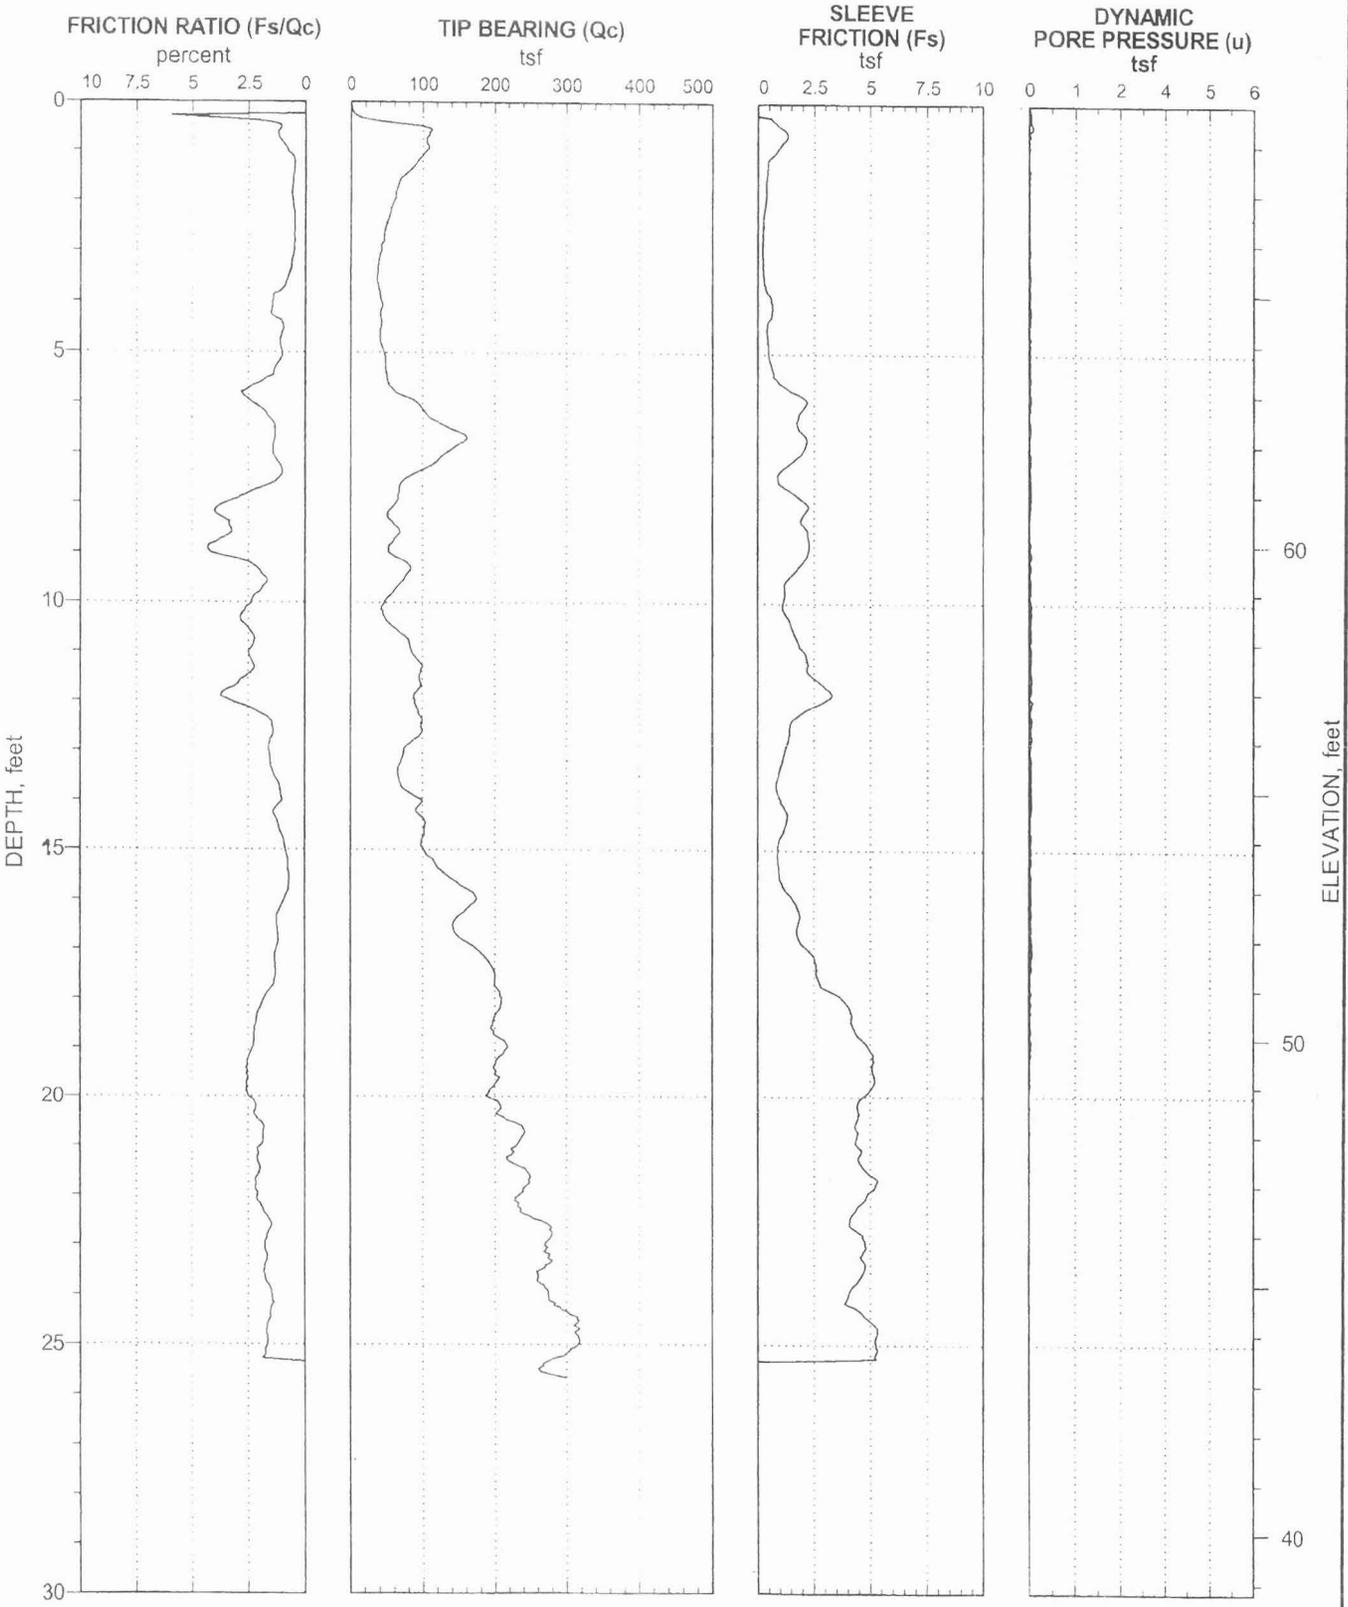
REPORT TITLE BORING RECORD				HOLE ID CPT-07-103
DIST. 07	COUNTY LA	ROUTE 105	POSTMILE 3.4/3.4	EA 07-4S7601
PROJECT OR BRIDGE NAME Imperial Highway Overcrossing (OC) @ Interstate 105				
BRIDGE NUMBER 53-2657	PREPARED BY PP	DATE 2-20-08	SHEET 1 of 1

CALTRANS CPT RECORD 052007 07-4S760.GPJ CT SACTO 053107 GDT 2/29/08

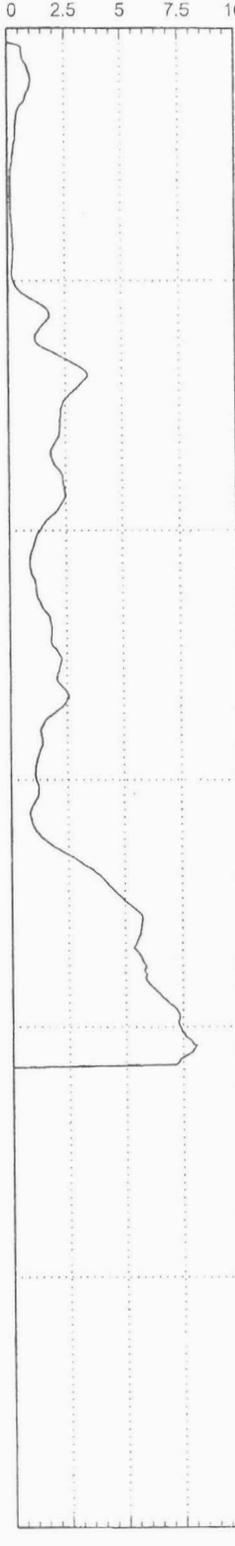
FRICITION RATIO (Fs/Qc)

TIP BEARING (Qc)

SLEEVE FRICTION (Fs)

DYNAMIC PORE PRESSURE (u)

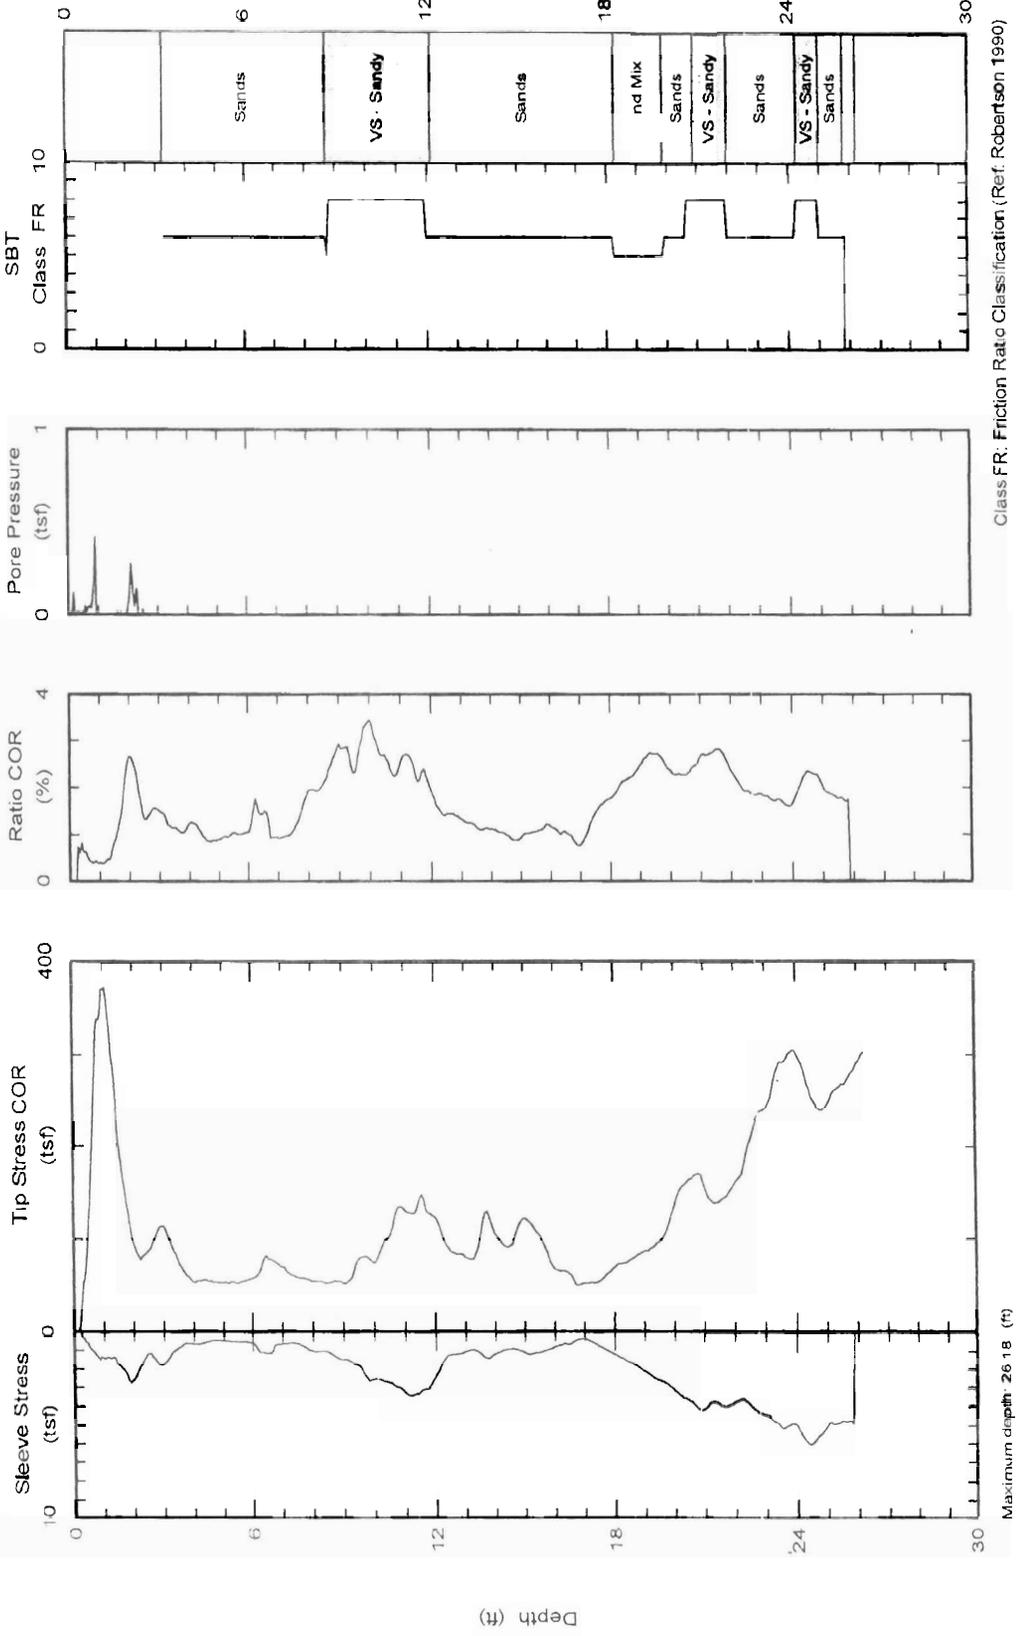
Date: 27/Nov/2007
Test ID: 127701-2
Project: 07-4s7600

Class FR: Friction Ratio Classification (Ref: Robertson 1990)

The continuous soil profile data obtained from the three CPT soundings were further processed and evaluated to obtain the relative densities of the near surface soils. Based on OGDS1's evaluation, about 1½ to 2½ ft of well-compacted (Relative densities, D_r , above 65%) gravelly sandy soil layer was observed immediately below the PCC slab on all three CPT soundings. A poorly compacted (Relative densities, D_r , about 35% to 50%) 5 to 6 ft sandy soil layer underlies the well-compacted layer. Existing soil compaction is less than the required 95% relative compaction for Structure Backfill shown in the Caltrans Standard Specifications (2006).

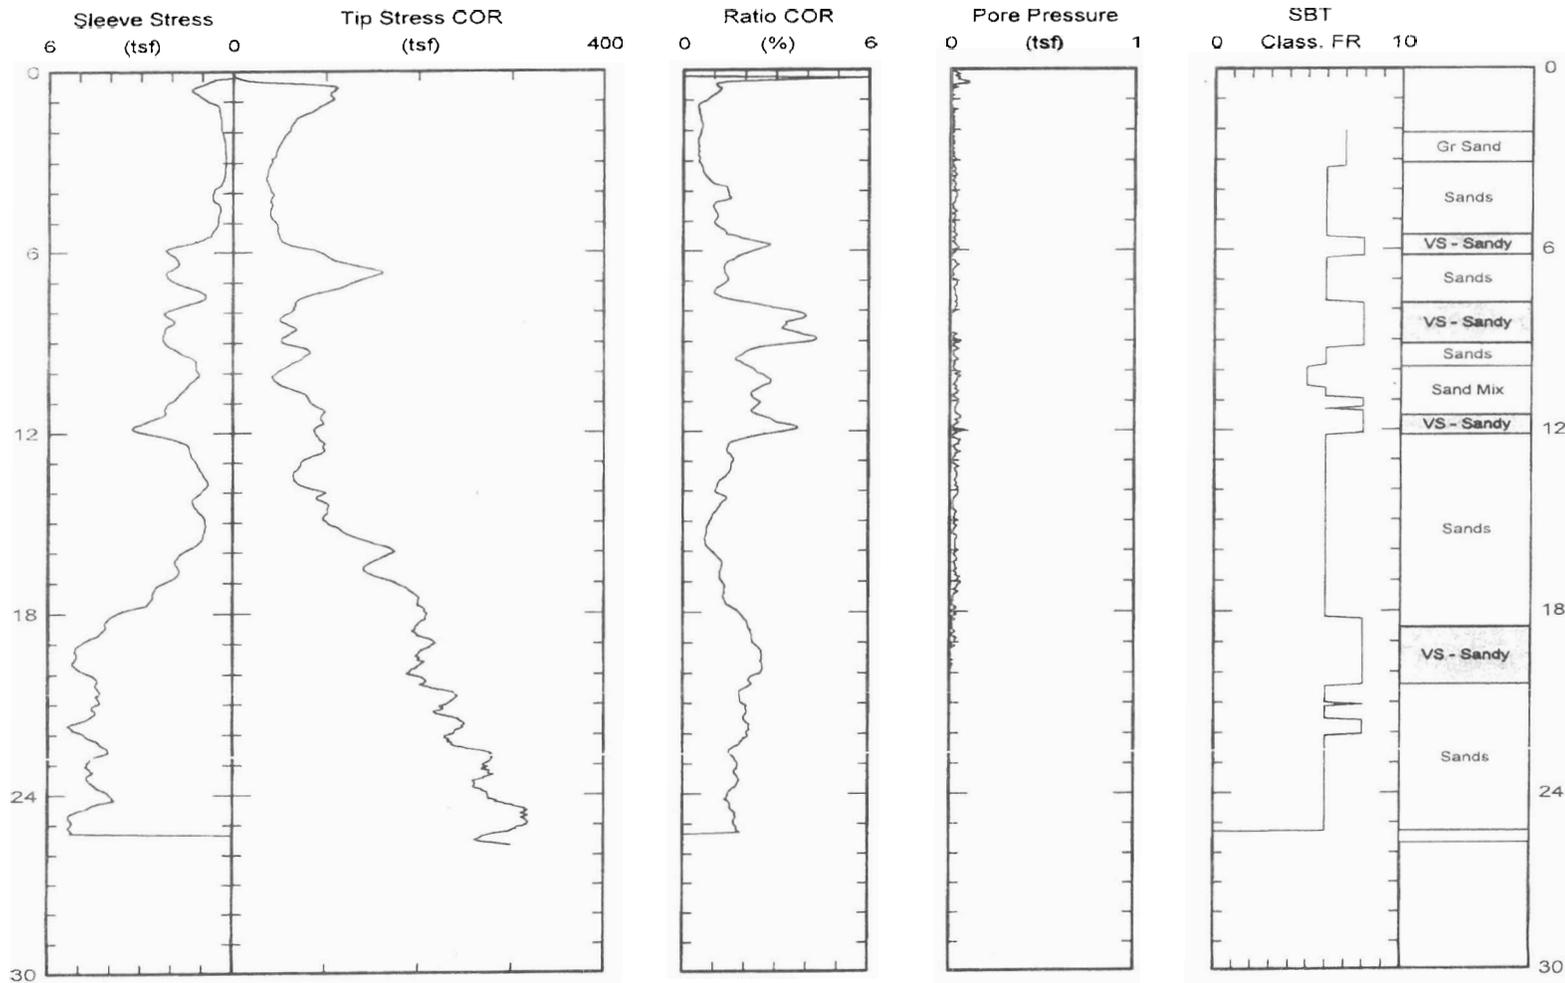
Date: 28/Nov/2007
 Test ID: 127702-3
 Project: 07-4s7600

Maximum depth: 25.67 (ft)

Class FR: Friction Ratio Classification (Ref. Robertson 1990)

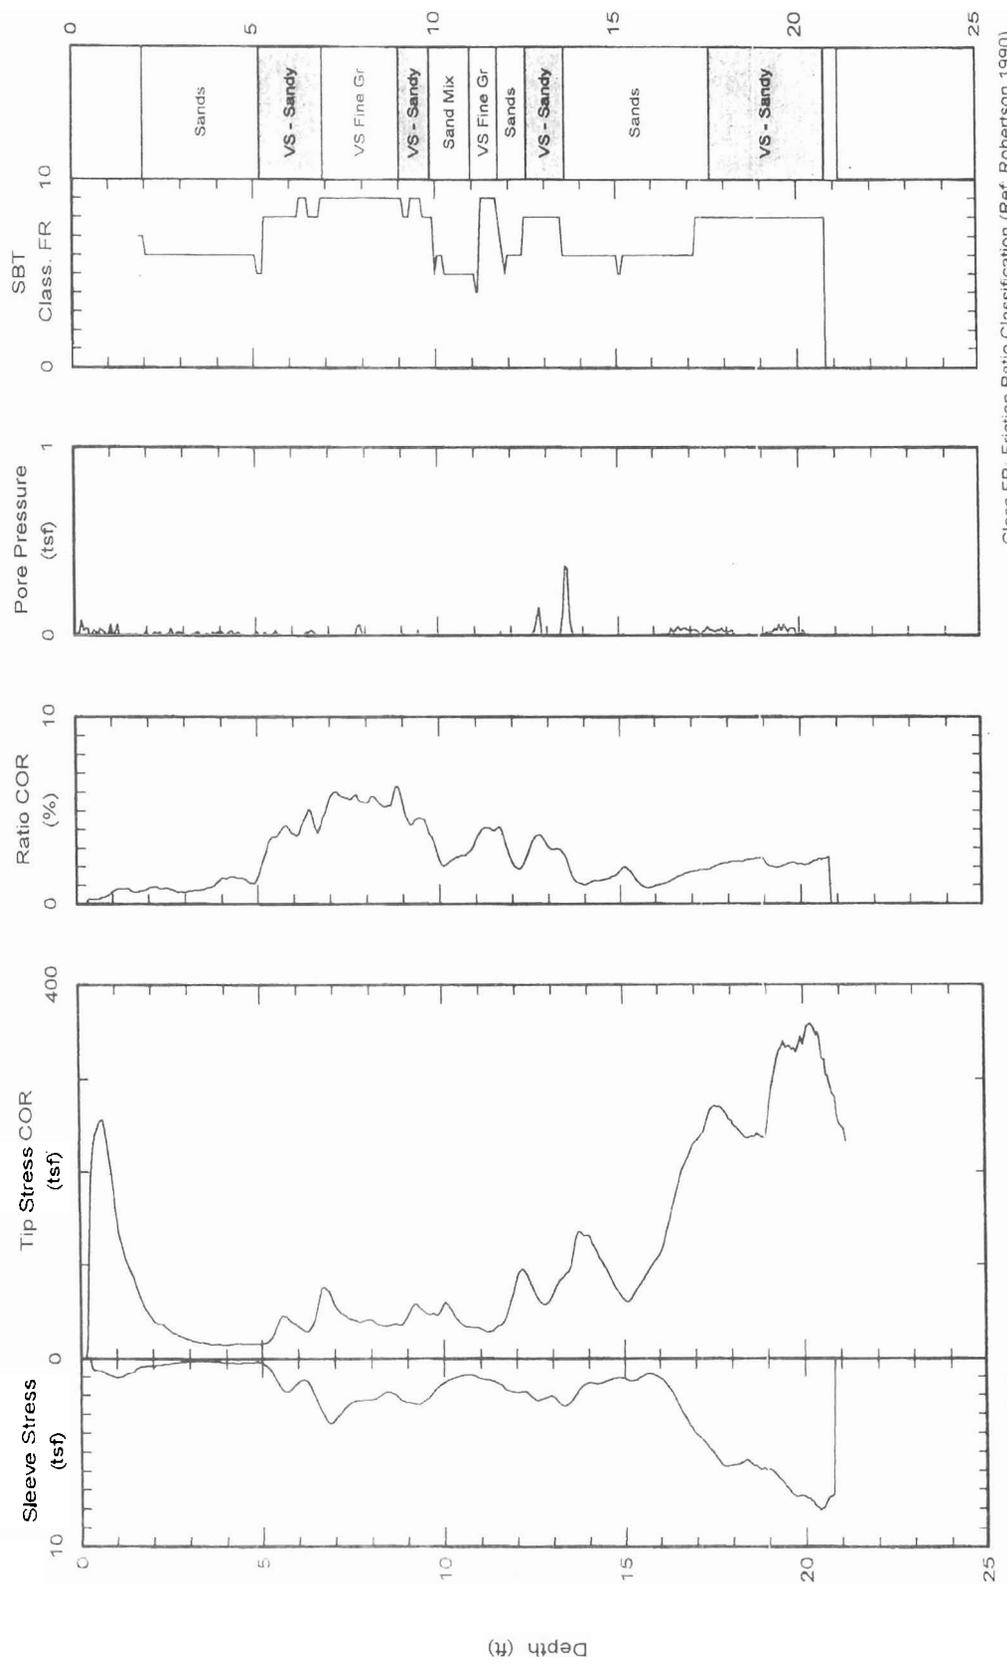
Division of Engineer Service Geotechnical Service 5900 Folsom Blvd. Sac., CA 95819 www.dot.ca.gov	Lat: 0 Lon: 0 Elevation: 0 Customer: Pratheep Piratheepan Job Site: 07-LA-105-3.36	Date: 28/Nov/2007 Test ID: 128701-4 Project: 07-4s7600
---	--	--

Class FR: Friction Ratio Classification (Ref. Robertson 1990)

Maximum depth: 21.14 (ft)

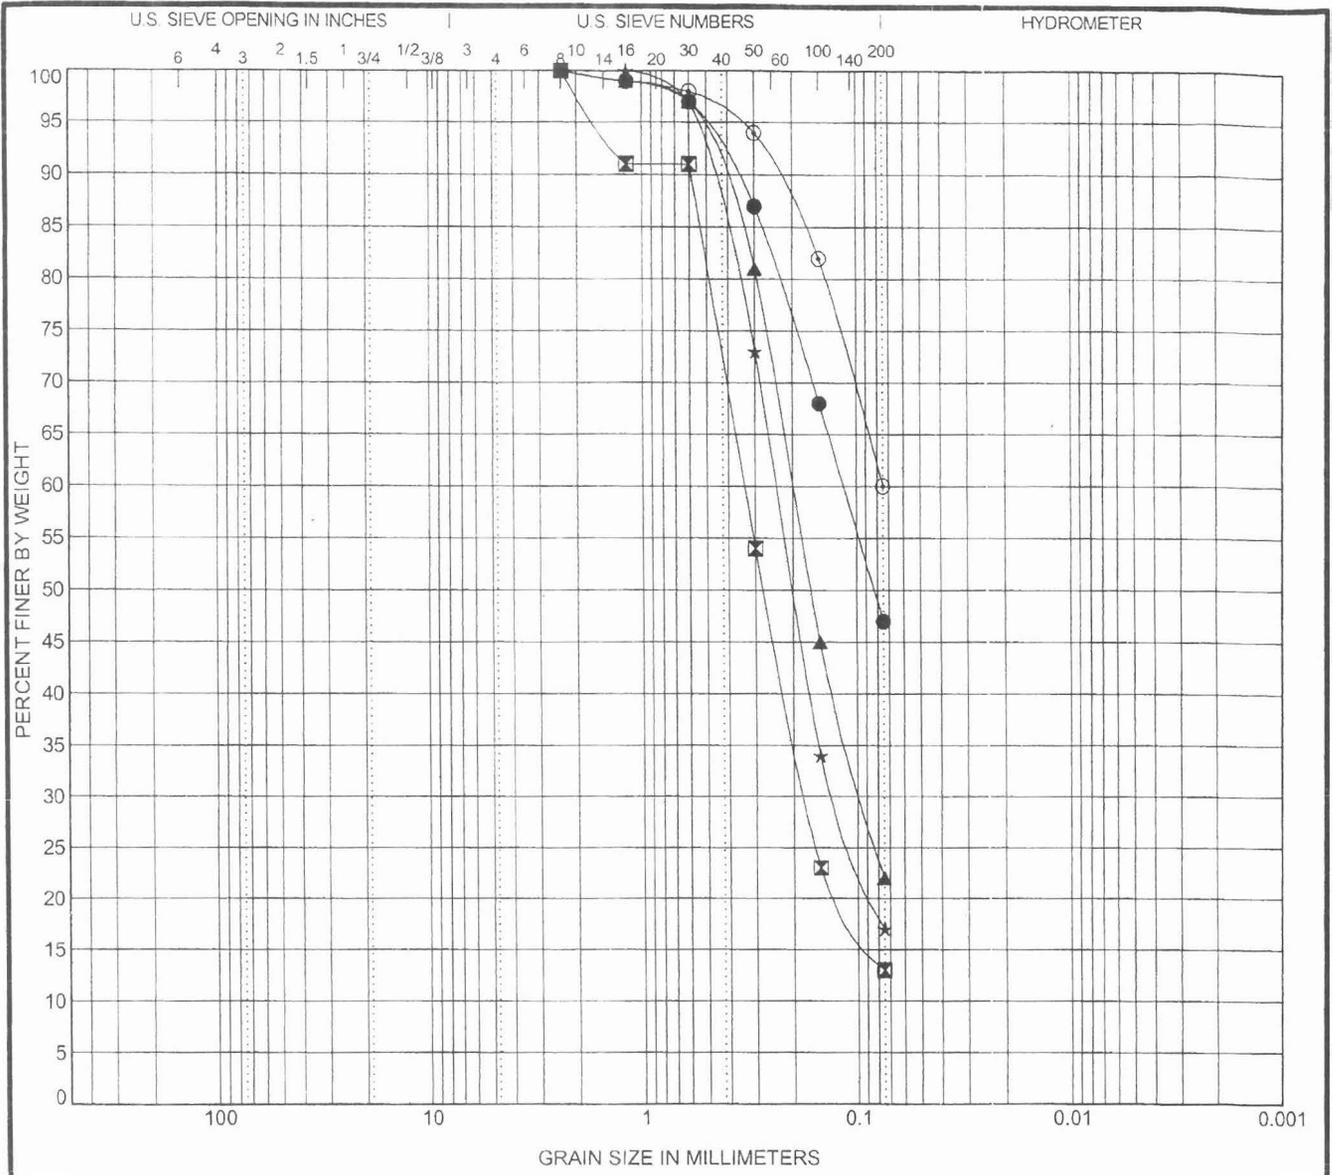
COBBLES	GRAVEL		SAND			SILT OR CLAY
	coarse	fine	coarse	medium	fine

Specimen Identification	Classification	LL	PL	PI	Cc	Cu
● R-07-101 12.0	CLAYEY SAND	24	14	10		
⊠ R-07-101 16.0	Well-grade SAND with SILT	NP	NP	NP		
▲ R-07-101 21.0	SILTY SAND	NP	NP	NP		
★ R-07-101 26.0	SILTY SAND	NP	NP	NP		
⊙ R-07-101 31.0	SANDY SILT	NP	NP	NP

test results are presented in Table No. 1 through No. 3 below. The results of sieve analysis and consolidation tests are attached to this report.

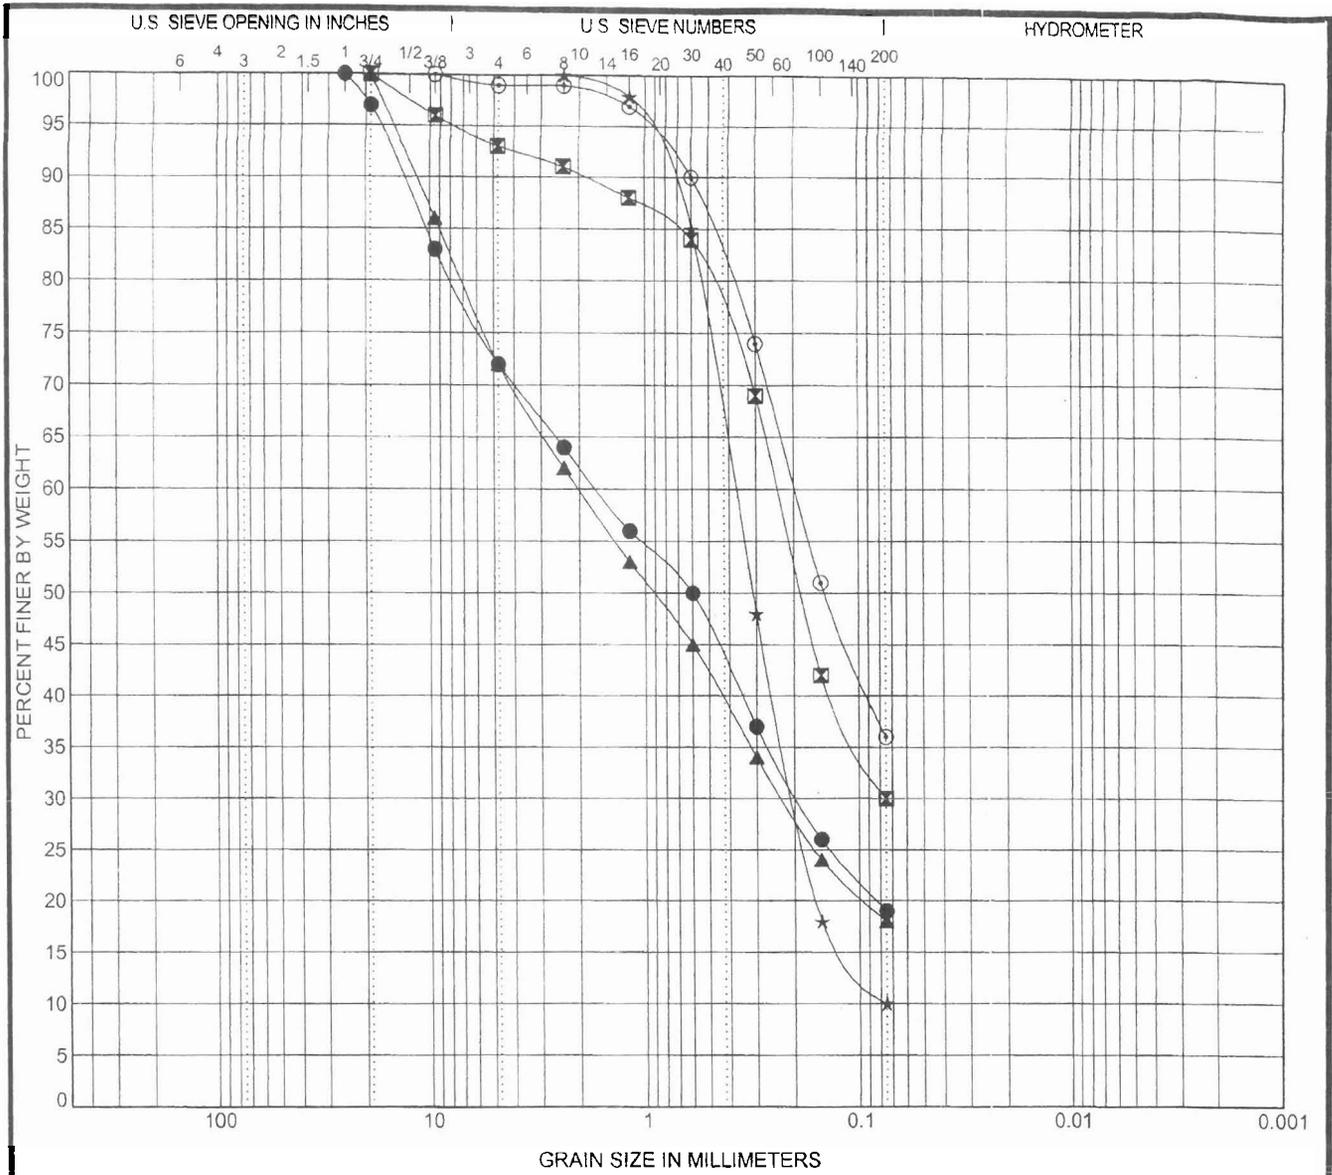
COBBLES	GRAVEL		SAND			SILT OR CLAY
	coarse	fine	coarse	medium	fine

Specimen Identification	Classification	LL	PL	PI	Cc	Cu
● R-07-101 2.8	SILTY SAND with GRAVEL	NP	NP	NP		
⊠ R-07-101 3.2	SILTY SAND	NP	NP	NP		
▲ R-07-101 3.5	SILTY SAND with GRAVEL	NP	NP	NP		
★ R-07-101 11.3	Poorly Graded SAND with SILT (SP-SM)	NP	NP	NP	1.39	5.01
⊙ R-07-101 11.7	SILTY SAND	NP	NP	NP

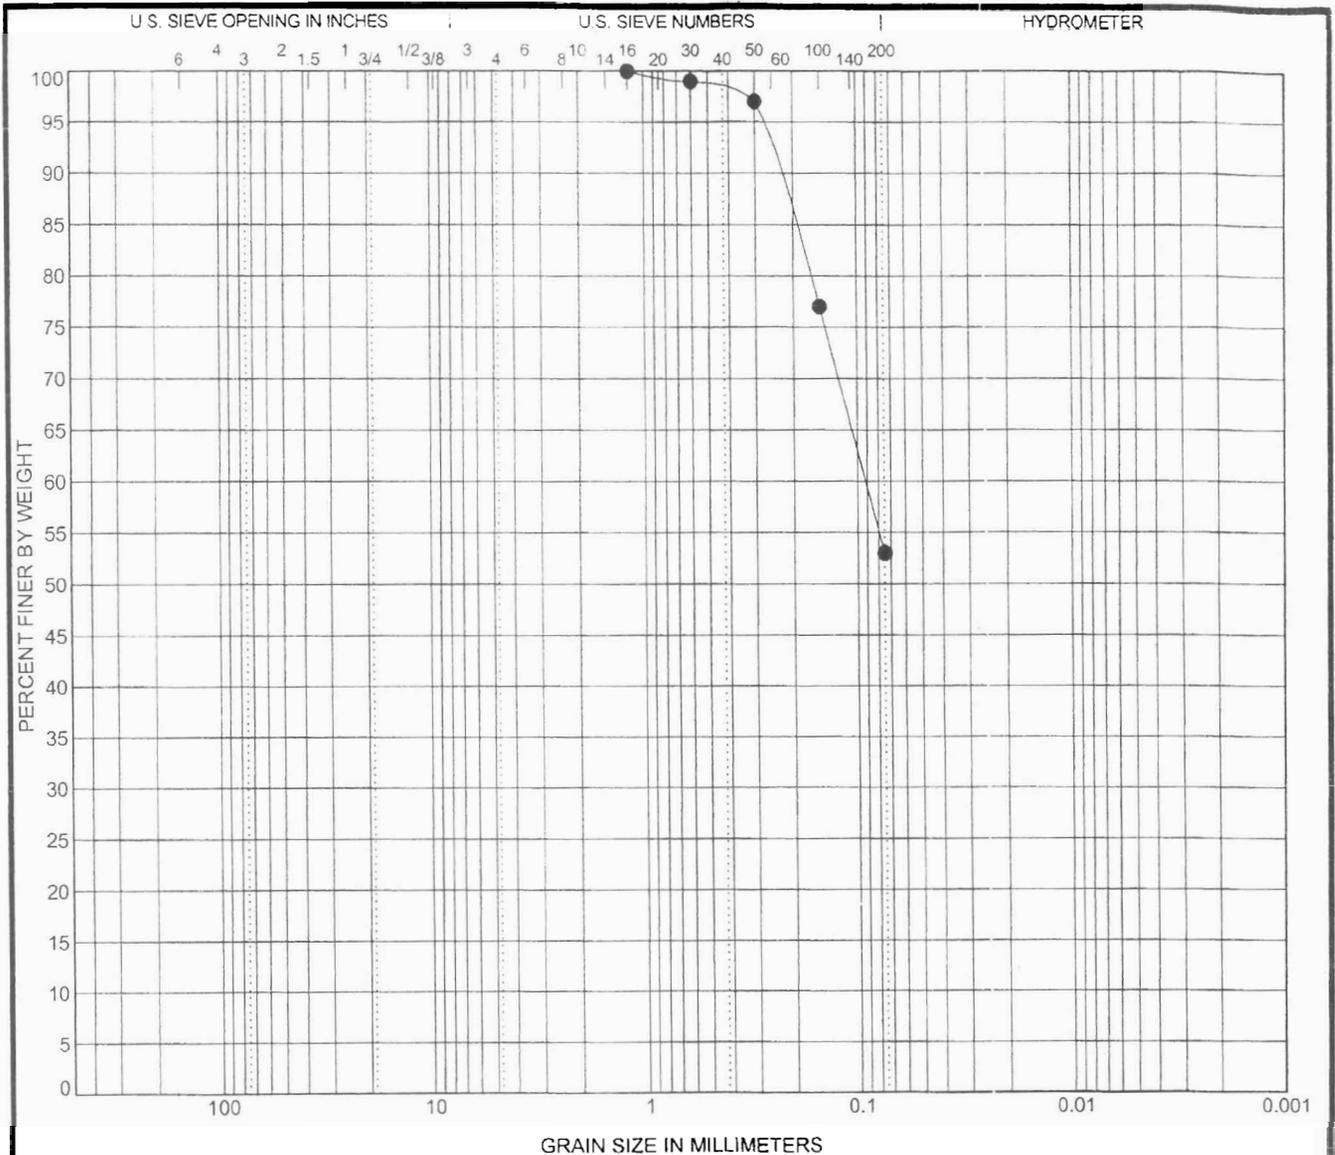
COBBLES	GRAVEL		SAND			SILT OR CLAY
	coarse	fine	coarse	medium	fine

Specimen Identification	Classification	LL	PL	PI	Cc	Cu
R-07-101 36.0	SANDY SILT	NP	NP	NP

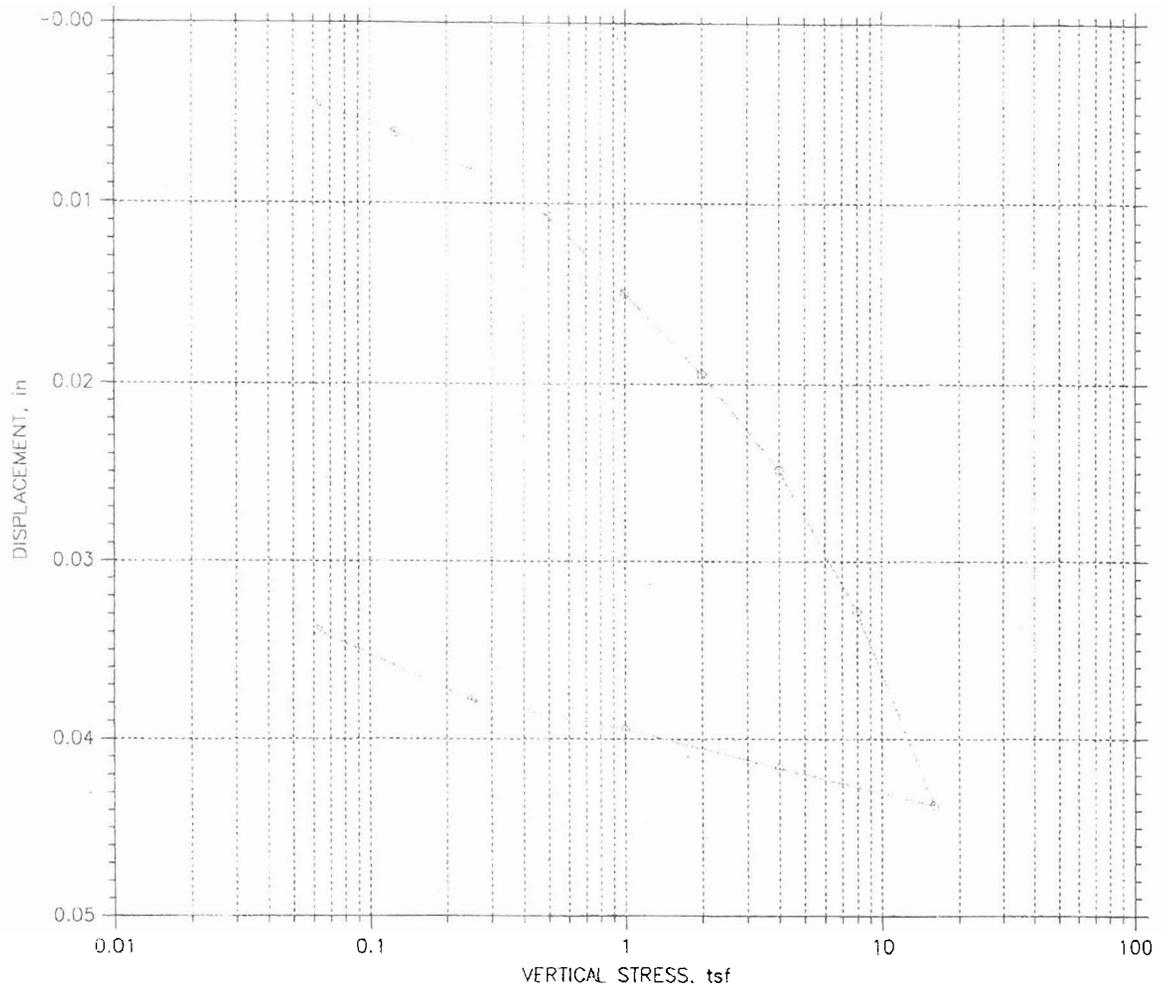
CONSOLIDATION TEST DATA SUMMARY REPORT

Before Test	After Test
Overburden Pressure: 8.854e-312 tsf		Water Content, %		21.18	18.66
Preconsolidation Pressure: 3.612e-311 tsf		Dry Unit Weight, pcf		102.2	107.1
Compression Index: 2.75859e-313		Saturation, %			
Diameter: 1.94 in		Height: 0.75 in		Void Ratio	0.66
LL: 0	PL: 0	PI: 0	GS: 2.72		0.59

Project: Sett Appr Slab @Imp Hwy@Location: 07-LA-105-3.36		Project No.: 07-4S7601
Boring No.: R-07-01		Tested By: KS
Sample No.: 5-1		Checked By: GL# 08-007
Test No.: 07075-G1		Test Date: 12/26/07
Sample Type: 2" BRASS		Depth: 12.0-12.3'
Description: WET, DENSE, BROWN MEDIUM SAND		Elevation: Br# 55-2655
Remarks:
