A Report on Installation of an Experimental Joint Section in  
PCC Pavement

March 1958

D.L. Spellman

State of California  
Department of Public Works  
Division of Highways  
Materials and Research Department  
3435 Serra Way

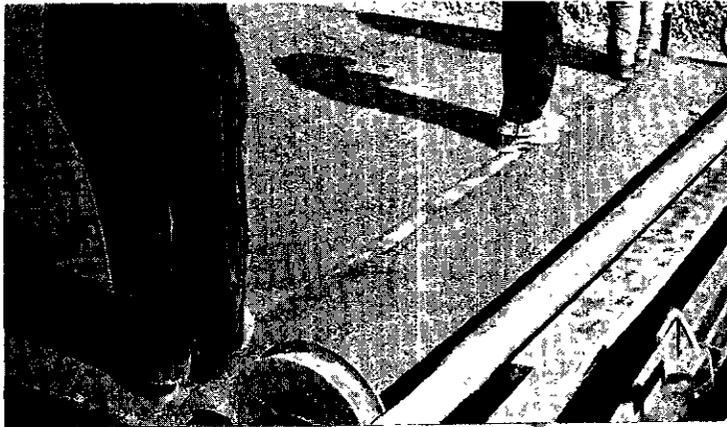
Picture 1

Forming trench for  
"Mortar Substitu-  
tion" joint.

These joints were made by removing a portion of the fresh concrete in the form of a trench and back-filling with a 1:2 mortar made with concrete sand and cement. The mortar was mixed in a small drum-type mixer at the site. The joints were then marked for sawing. The first few trenches were made by shoveling out fresh concrete in the line of the proposed joints. This proved difficult as the fresh concrete "slumped" inward as each shovelful was removed. Later the trench was formed by placing a 2" x 4" board, flat side down, on the concrete and displacing a portion of the mix by two or three men working the board down with their weight, scooping up the excess concrete with shovels. The resulting trench was about 4 inches wide and 2 inches deep, the full width of the lane. Much less mortar was required to fill a trench this size and the mortar could be compacted better.

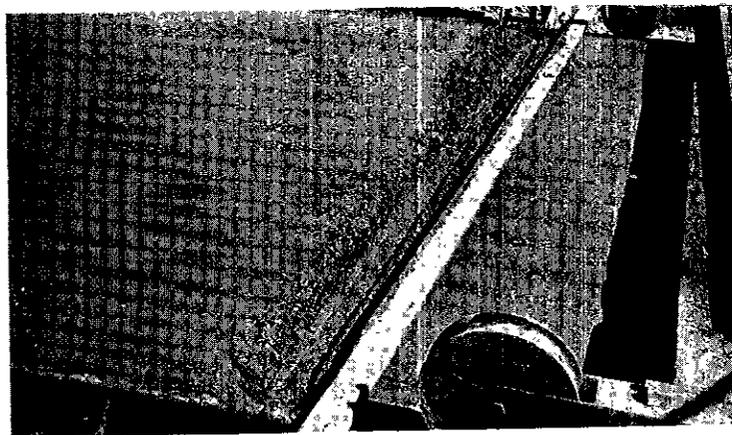
Picture 2

Trench ready for  
mortar.

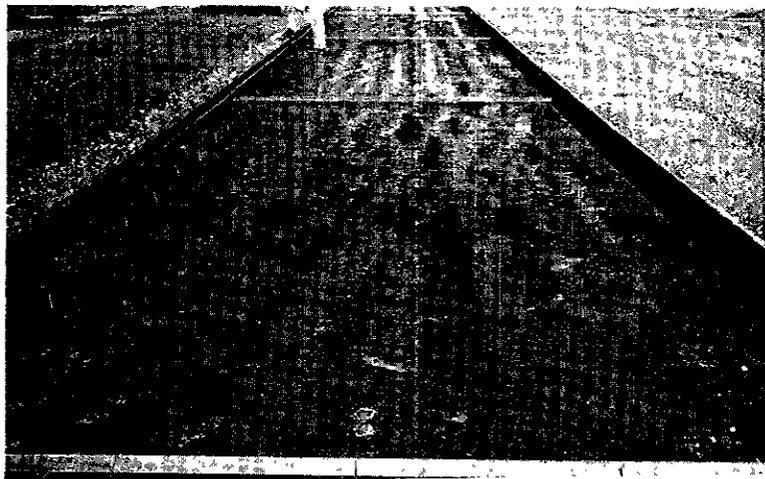
Picture 4

Redwood strips nailed to subgrade in advance of spreader.

In this section, 1x2" wood strips were nailed to the subgrade in advance of the mixer and covered with concrete using shovels. The batch of concrete from the dump bucket was then carefully dumped so as not to dislodge the strip. Operations were then carried on in the usual manner.

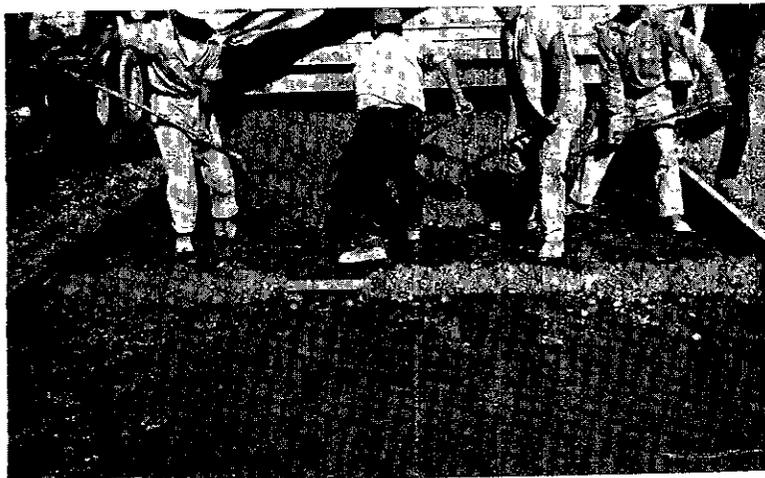
Picture 5

Covering strips with concrete before advance of spreader.

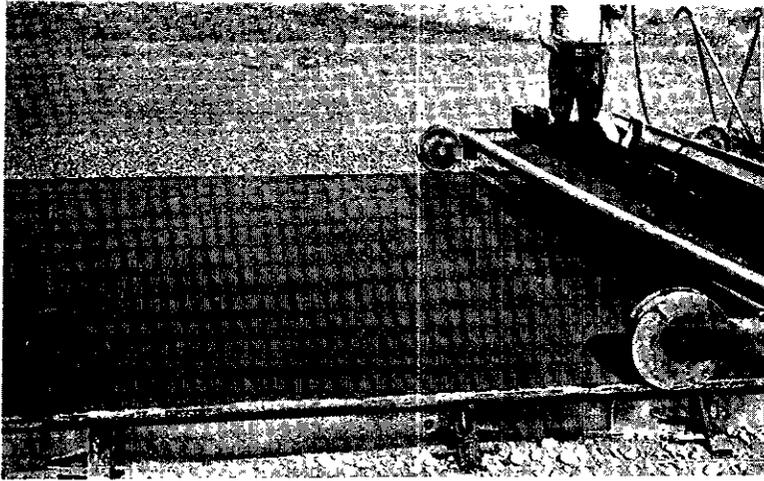
Picture 7

Groove cut in fresh concrete to receive steel strips.

In placing the double steel strips, a groove was first made in the fresh concrete with the T-iron cutter. The strips, freshly coated with the adhesive, were placed in the groove, and the concrete surface hand finished. The mechanical floating and finishing operations were then carried out in the usual manner. Though every effort was made to keep the steel strips within  $3/16$ -inch of the surface, finishing operations caused some of them to sink slightly. The single steel strips were inserted in the same way but were not coated with adhesive.

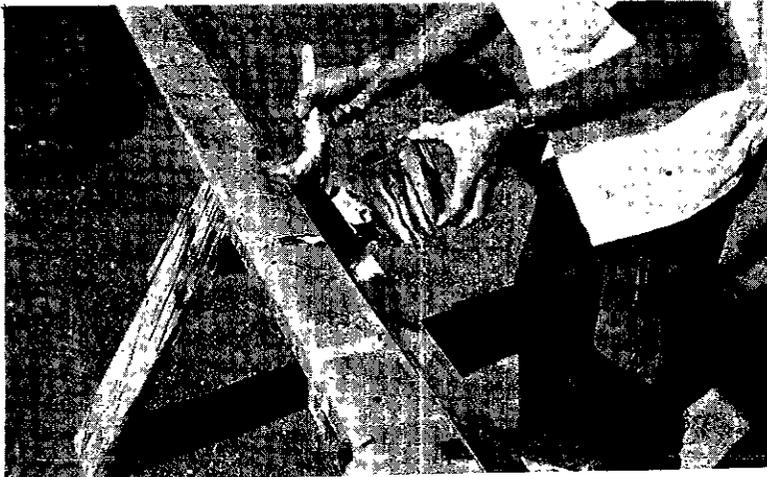
Picture 8

Coating steel strips with adhesive before being inserted in fresh concrete. (Single steel strips not coated.)

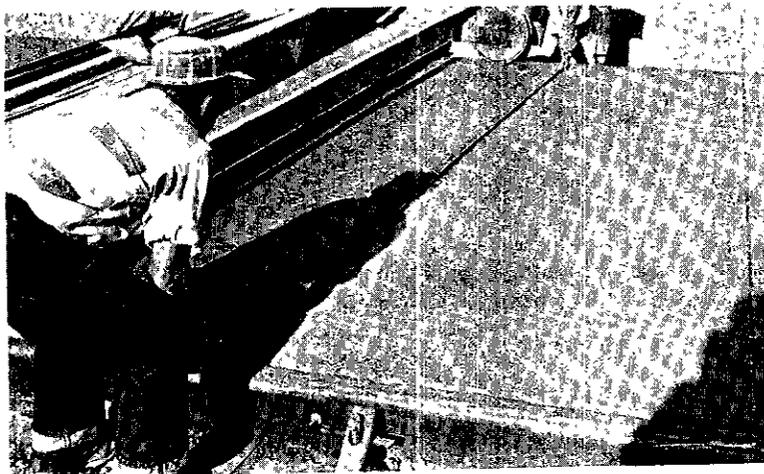
Picture 9

Steel strips being inserted in concrete.
