## REDUCTION OF ACCIDENTS BY PAVEMENT GROOVING

John L. Beaton  
Ernest Zube and John Skog

**RESEARCH REPORT**

**NO. M & R 633126**

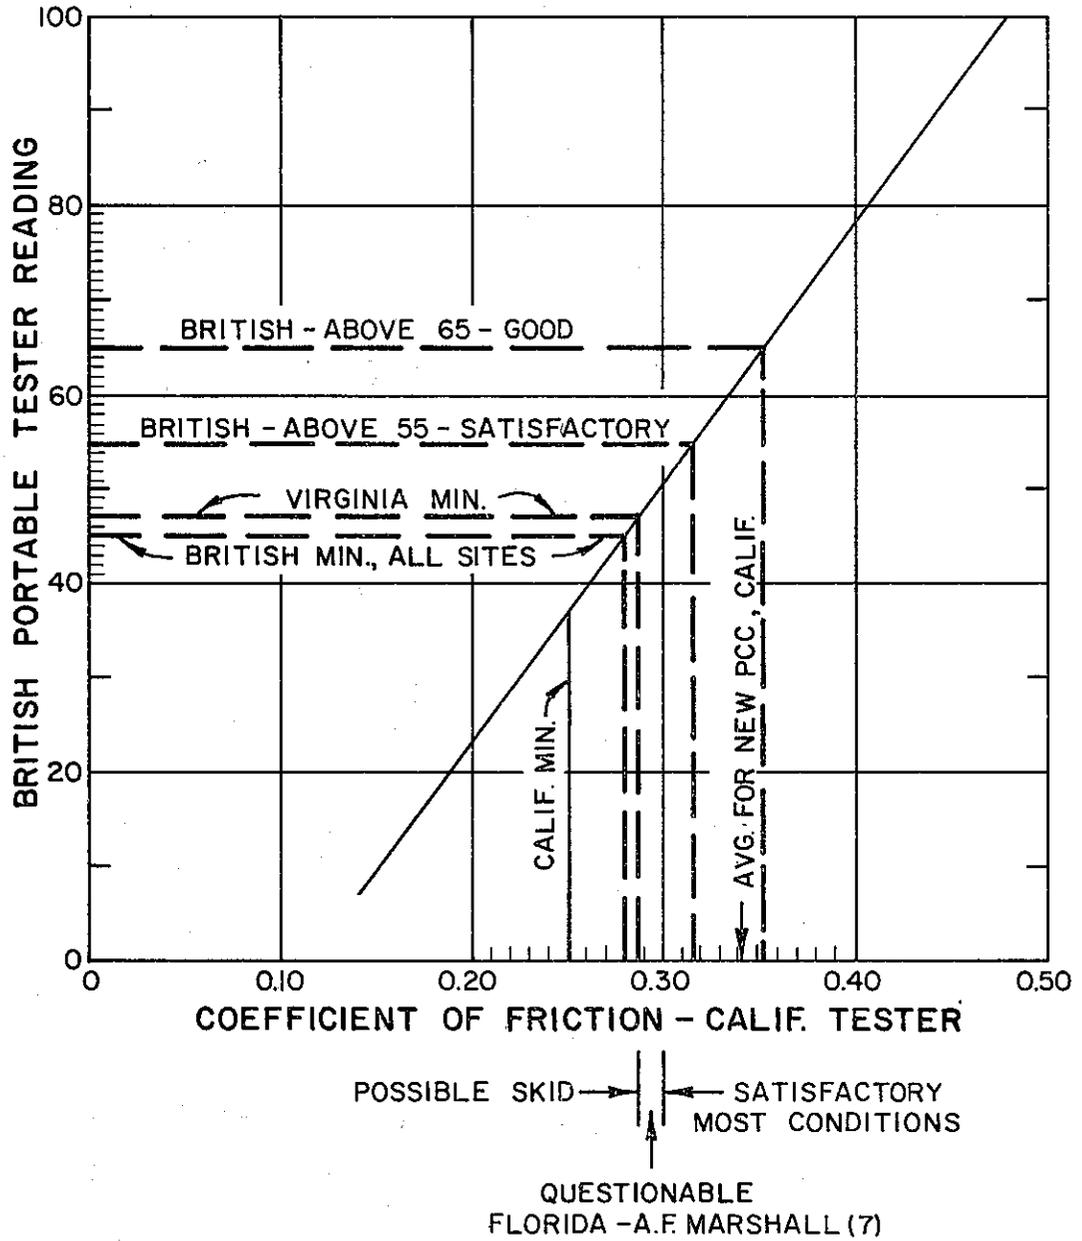
# CORRELATION STUDIES ON MINIMUM FRICTION VALUE FOR REMEDIAL ACTION

On the basis of the correlation, a comparison of the recommended British values with the tentative California minimum figure is shown in Figure 1. Also shown is the Virginia minimum figure which was attained by using the correlation chart of D. C. Mahone<sup>4</sup> which provides an approximate correlation between the British Portable Tester and the Virginia test car at 40 mph.

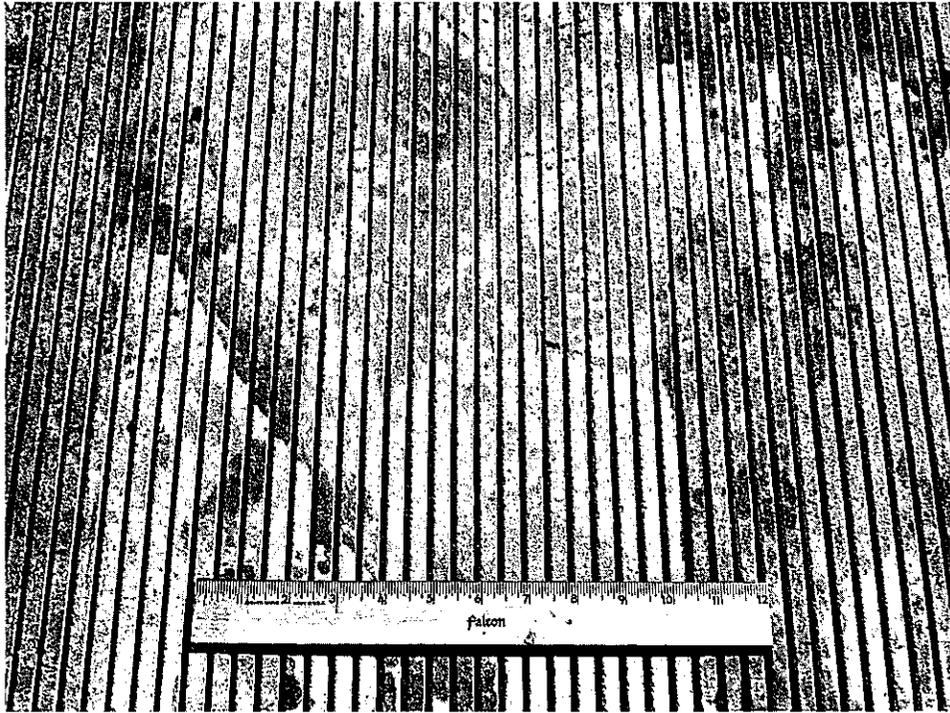
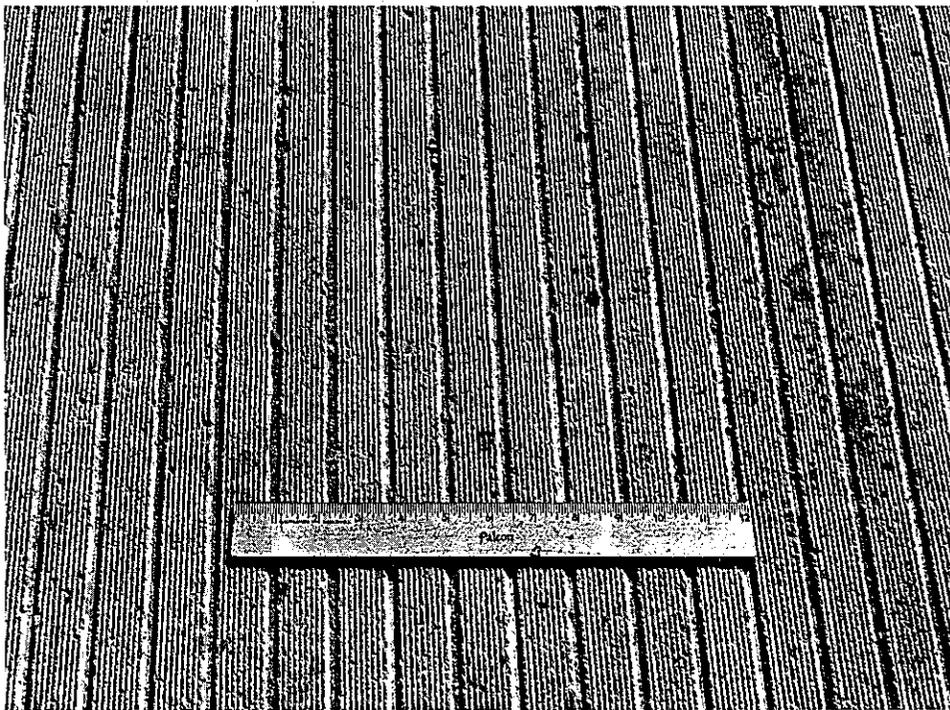
Photographs of Several Patterns Used on Various Projects

Rectangular Grooves

Style 15

Groove patterns vary. The most common type is rectangular in form and may be varied in width and depth and distance between centers of grooves. Other types have rectangular form, but the bottom is partially rounded, and the edges at the pavement surface are also rounded. Others have a large V cut separated by smaller V cuts. Figure 2 shows two types of patterns.

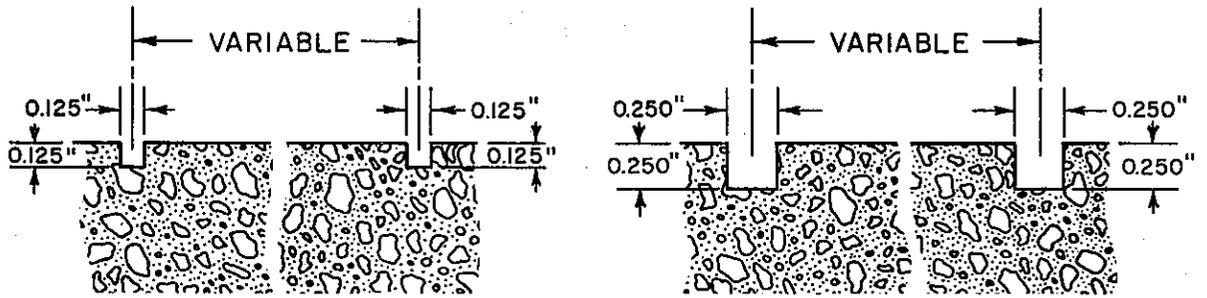
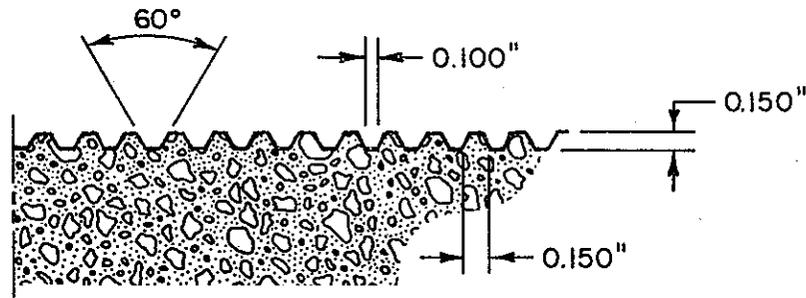
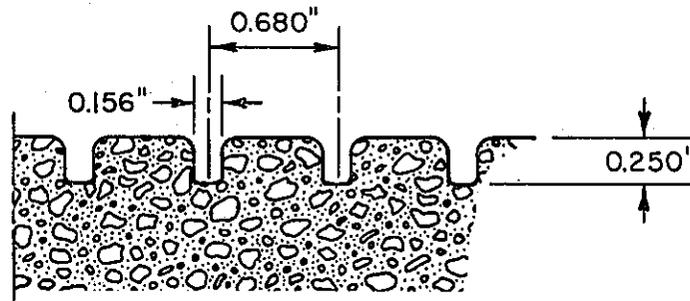
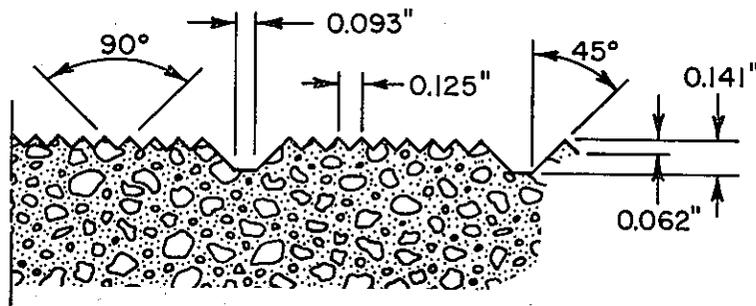
Figure 3

# GROOVING PATTERNS USED ON VARIOUS PROJECTS

RECTANGULAR PATTERNS

STYLE 6-47 GROOVES PER FT.

STYLE 9

STYLE 15

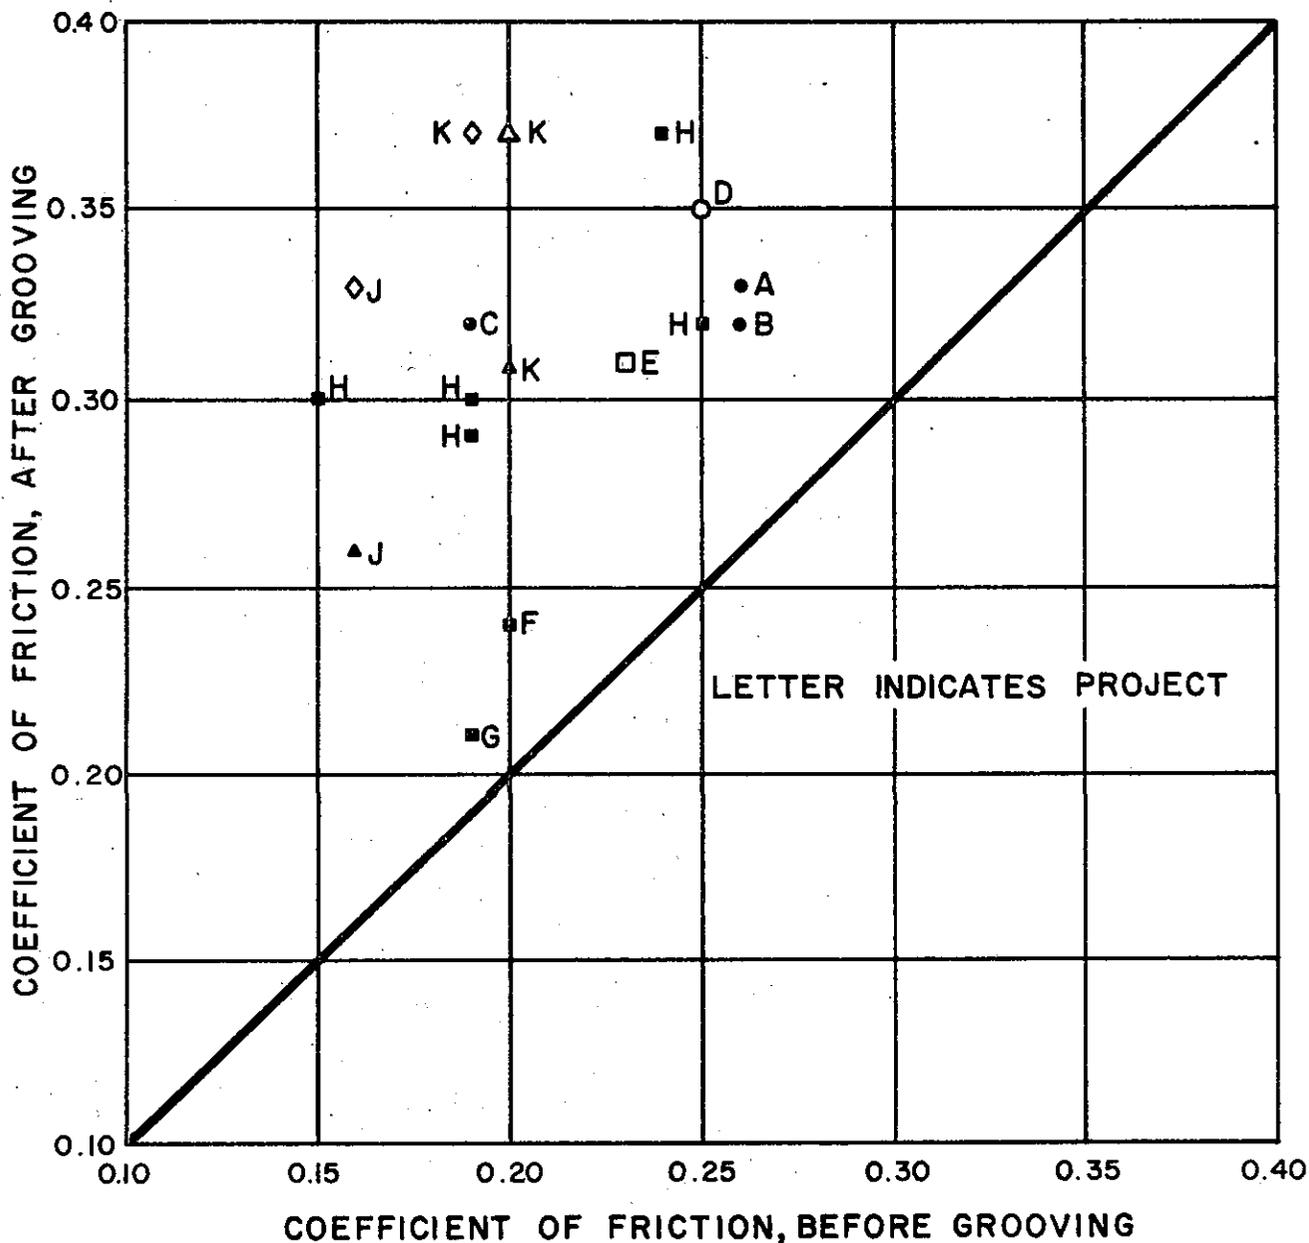
## EFFECT OF GROOVING PATTERN ON AVERAGE COEFFICIENT OF FRICTION VALUE OF PCC PAVEMENTS

- x 1/8" on 1/8" Centers, Rectangular Grooves
- △ Christensen Style 6
- ▲ Christensen Style 9
- ◇ Christensen Style 15

A number of patterns have been used in our serration work to date. This was done in order to determine the increase in the friction factor, wear resistance, and possible vehicle handling problem. In all cases the grooves are all in a longitudinal direction. Figure 3 shows the patterns used on the various projects, and Table A the increase in the friction value after grooving and the change during service life. Figure 4 shows the effect of grooving on the average coefficient of friction value for the various PCC pavement projects.

In all cases the friction value is raised by pavement grooving. However, it appears that the nature of the existing concrete surface and the type of pattern effect the degree of improvement in the friction value. As an example there is a much greater improvement in the friction value for project H than on projects F and G for a  $1/8'' \times 1/8''$  on 1" centers with a rectangular groove. This is also confirmed by the results from projects J and K where two different patterns are compared on two different projects.

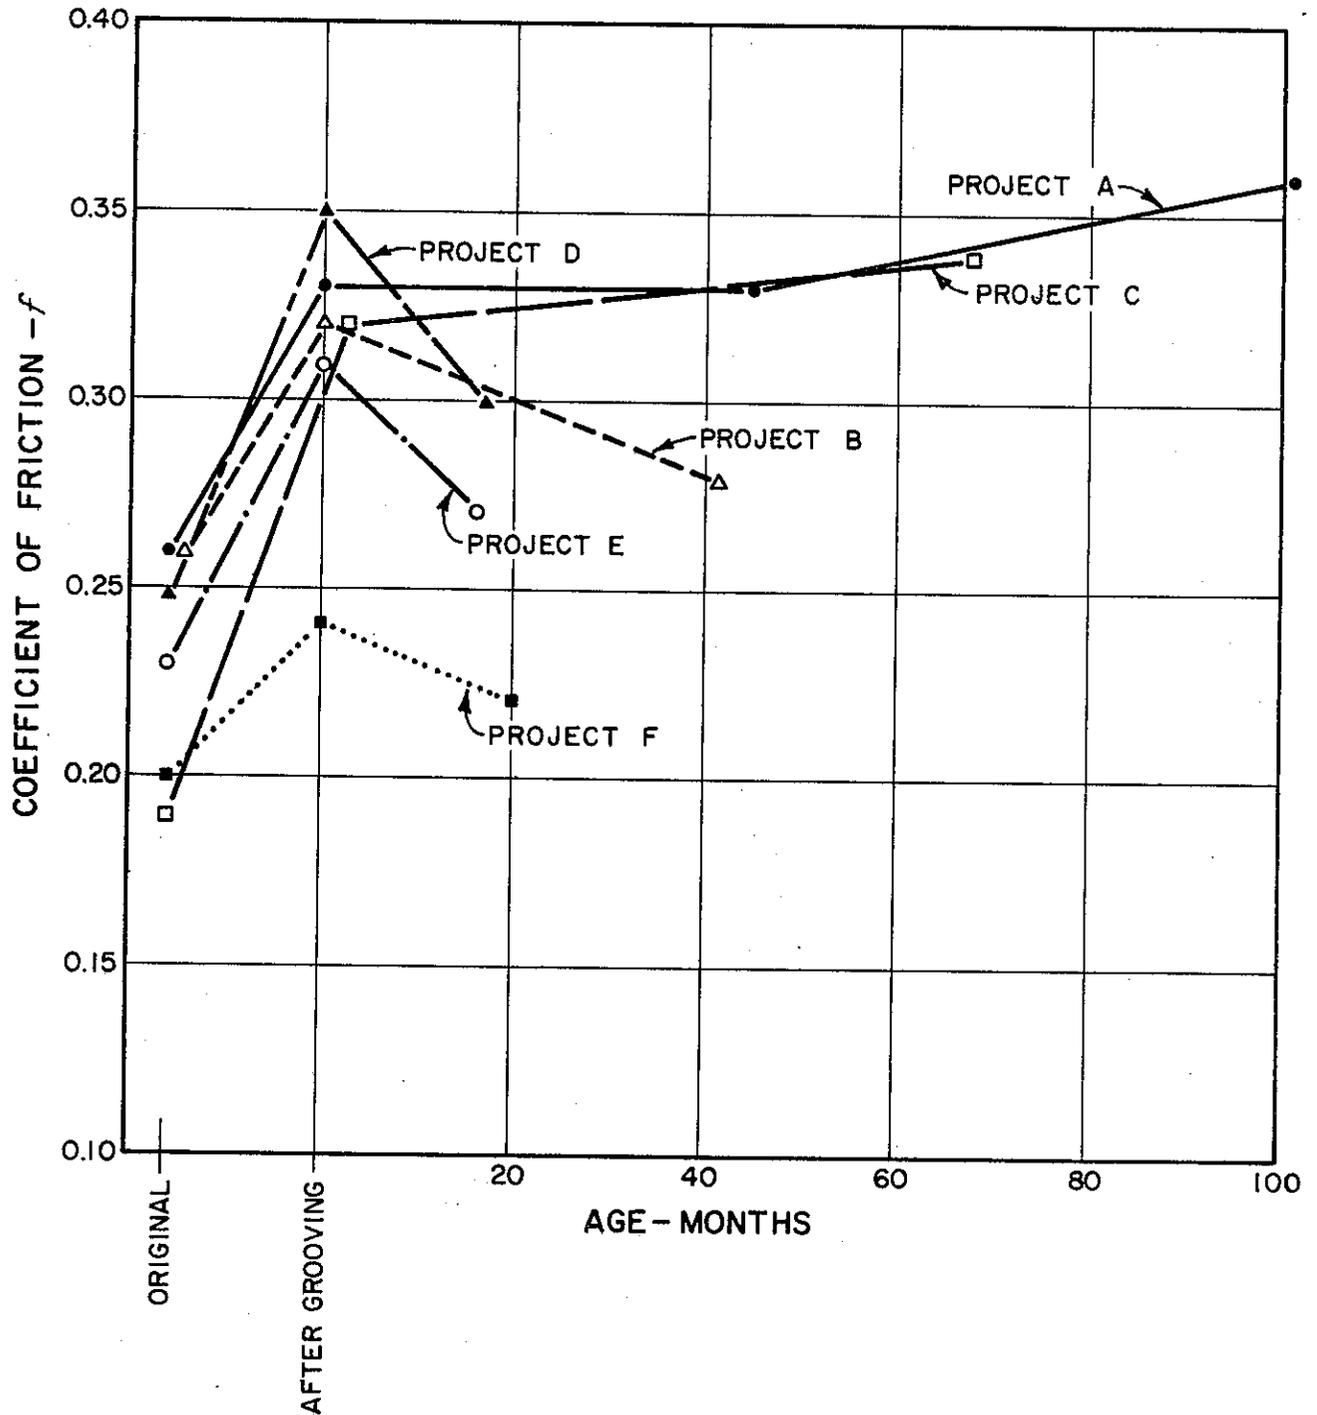
### CHANGE IN FRICTION VALUES FOLLOWING GROOVING OF PCC PAVEMENTS

A very important characteristic of any treatment for raising the existing friction value is its resistance to wear and polish of traffic. Results of variations of friction measurements with time on various grooved projects are shown in Table A and Figure 5. Not sufficient time has elapsed on the majority of the projects to draw any firm conclusions. It appears, however, that the nature of aggregate and mortar strength may influence the resistance to wear and polish of the grooved areas. However, it is interesting to note that projects A and B cover the travel lanes of heavily travelled freeways having a high percentage of trucks. All the projects shown in Figure 5 are in snow free areas. Project H in Table A is in a partial snow region where chains may be required. After the first winter the surface does not appear to be damaged by chain action. This project will be closely watched since project M in Table B has shown considerable

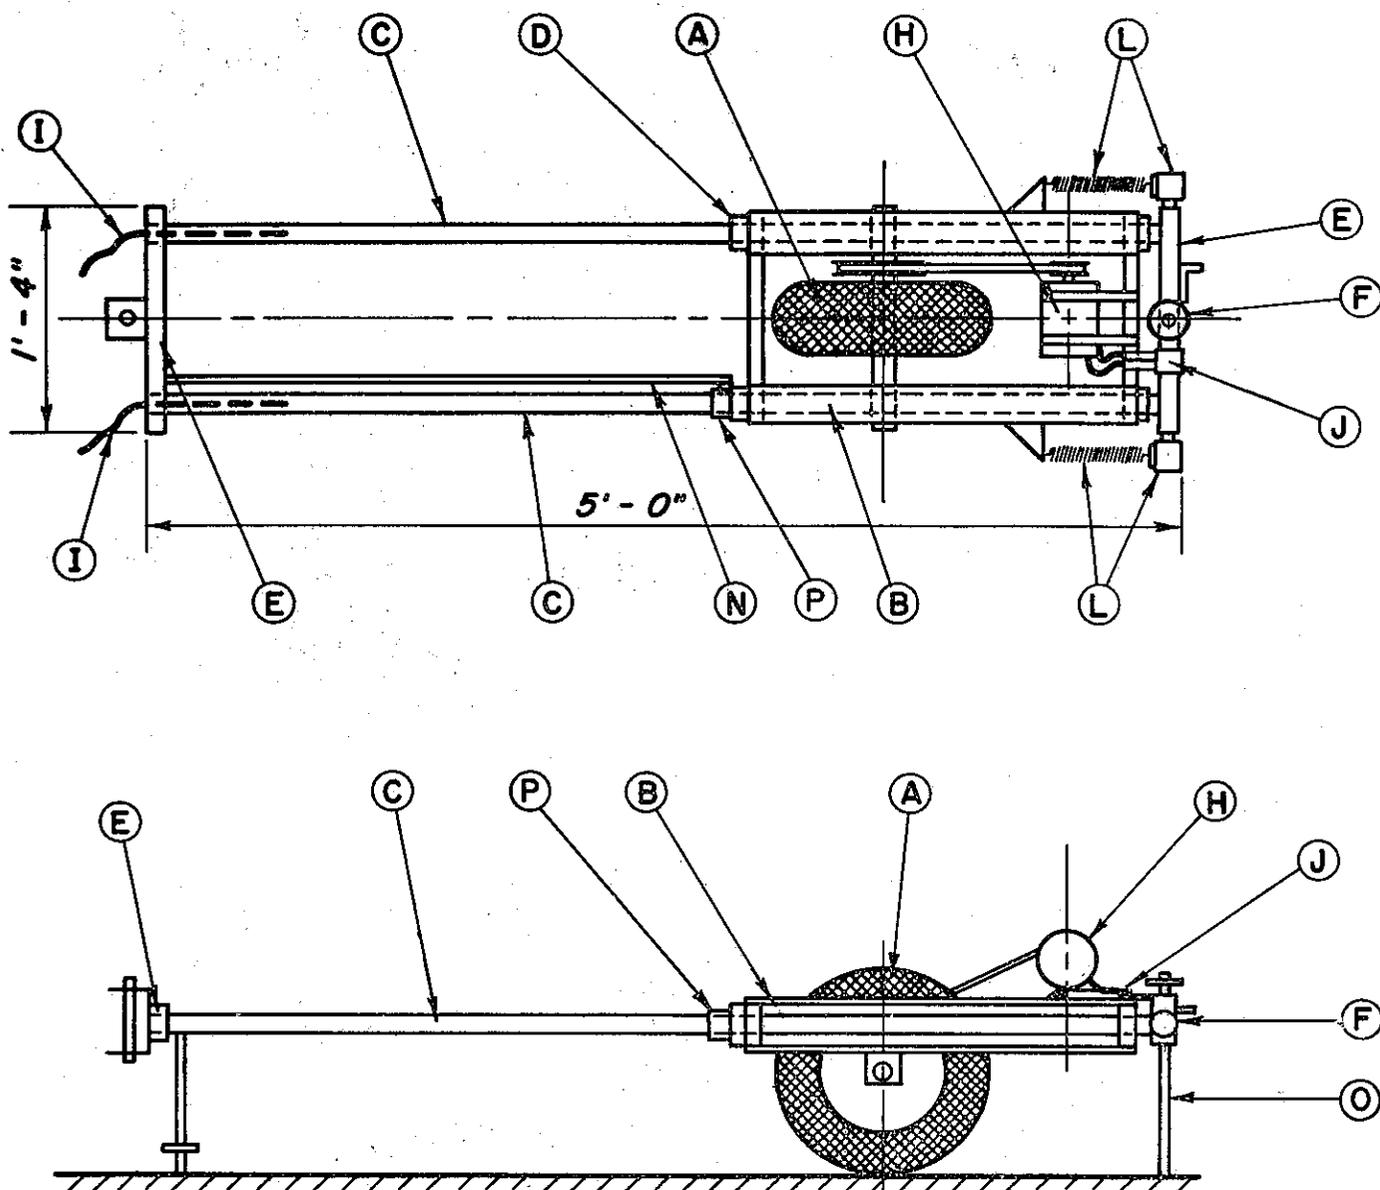
FIGURE I  
DIAGRAM OF SKID TESTER

a. Reference is made to Figures I through III in connection with the following description of the construction of the test unit. A 4.80/4.00 x 8, 2-ply tire with ( $25 \pm 2$  psi) air pressure ( $\Delta$ ), manufactured with a smooth surface, together with rim, axle and driving pulley is mounted on a carriage (B). The tire is brought to desired speed by motor (H). The carriage moves on two parallel guides (C), and the friction is reduced to a low uniform value by allowing three roller bearings fitted at  $120^\circ$  points to bear against the guide rod at each corner of the carriage. The bearing assembly may be noted on Figure III (D). The two guide rods (C) are rigidly connected to the end frame bars (E). The front end of this guide bar frame assembly is firmly fastened to a restraining anchor. The bumper hitch provides for swinging the skid tester to the right or left after positioning the vehicle. The rear end of the frame assembly is raised by a special adjustable device (F), Figure II, so as to hold the tire  $\frac{1}{4}$ -inch off the surface to be tested. This device is so constructed that the tire may be dropped instantaneously to the test surface by tripping the release arm (G), Figure II. Tachometer (K) indicates the speed of the tire.

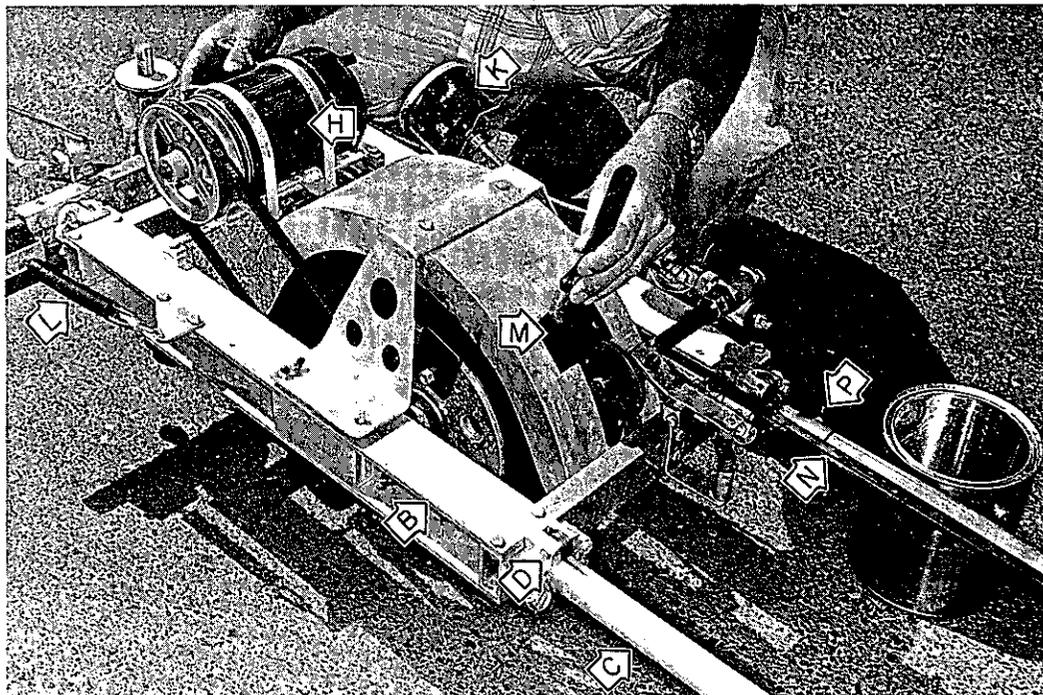
FIGURE III  
CLOSE-UP VIEWS OF SKID TESTER

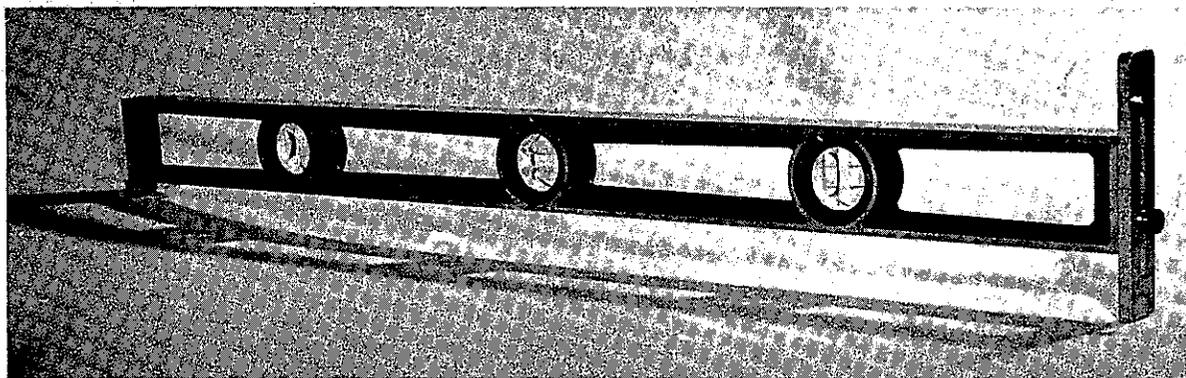
FIGURE IV  
LEVEL FOR DETERMINING GRADE

a. A 28" long standard metal carpenter's level, Fig. IV, is fitted at one end with a movable gauge rod which is calibrated in % of grade.

1. Determine and record grade with special level, see Fig. IV.

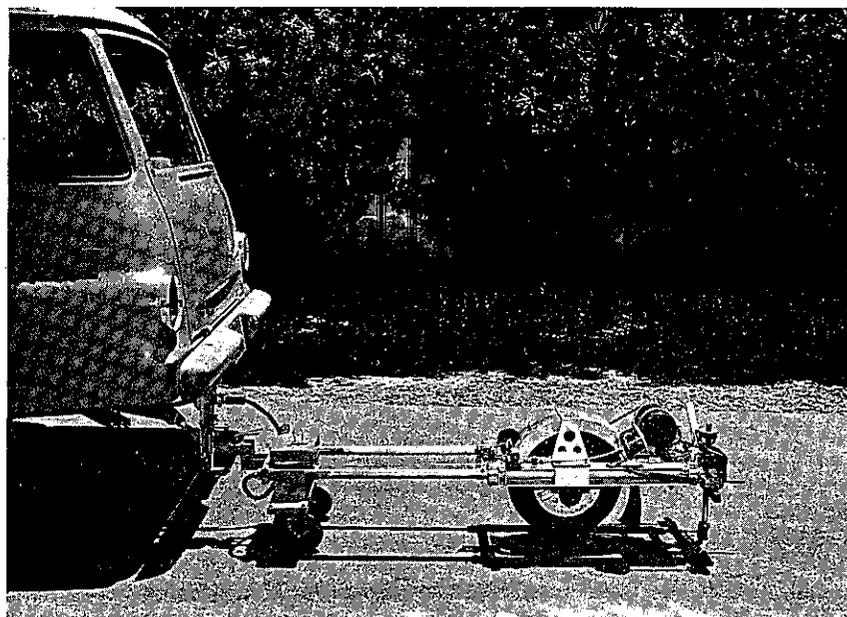
FIGURE V  
APPARATUS IN POSITION FOR TESTING

2. Remove apparatus from vehicle and attach to bumper hitch, Fig. V.

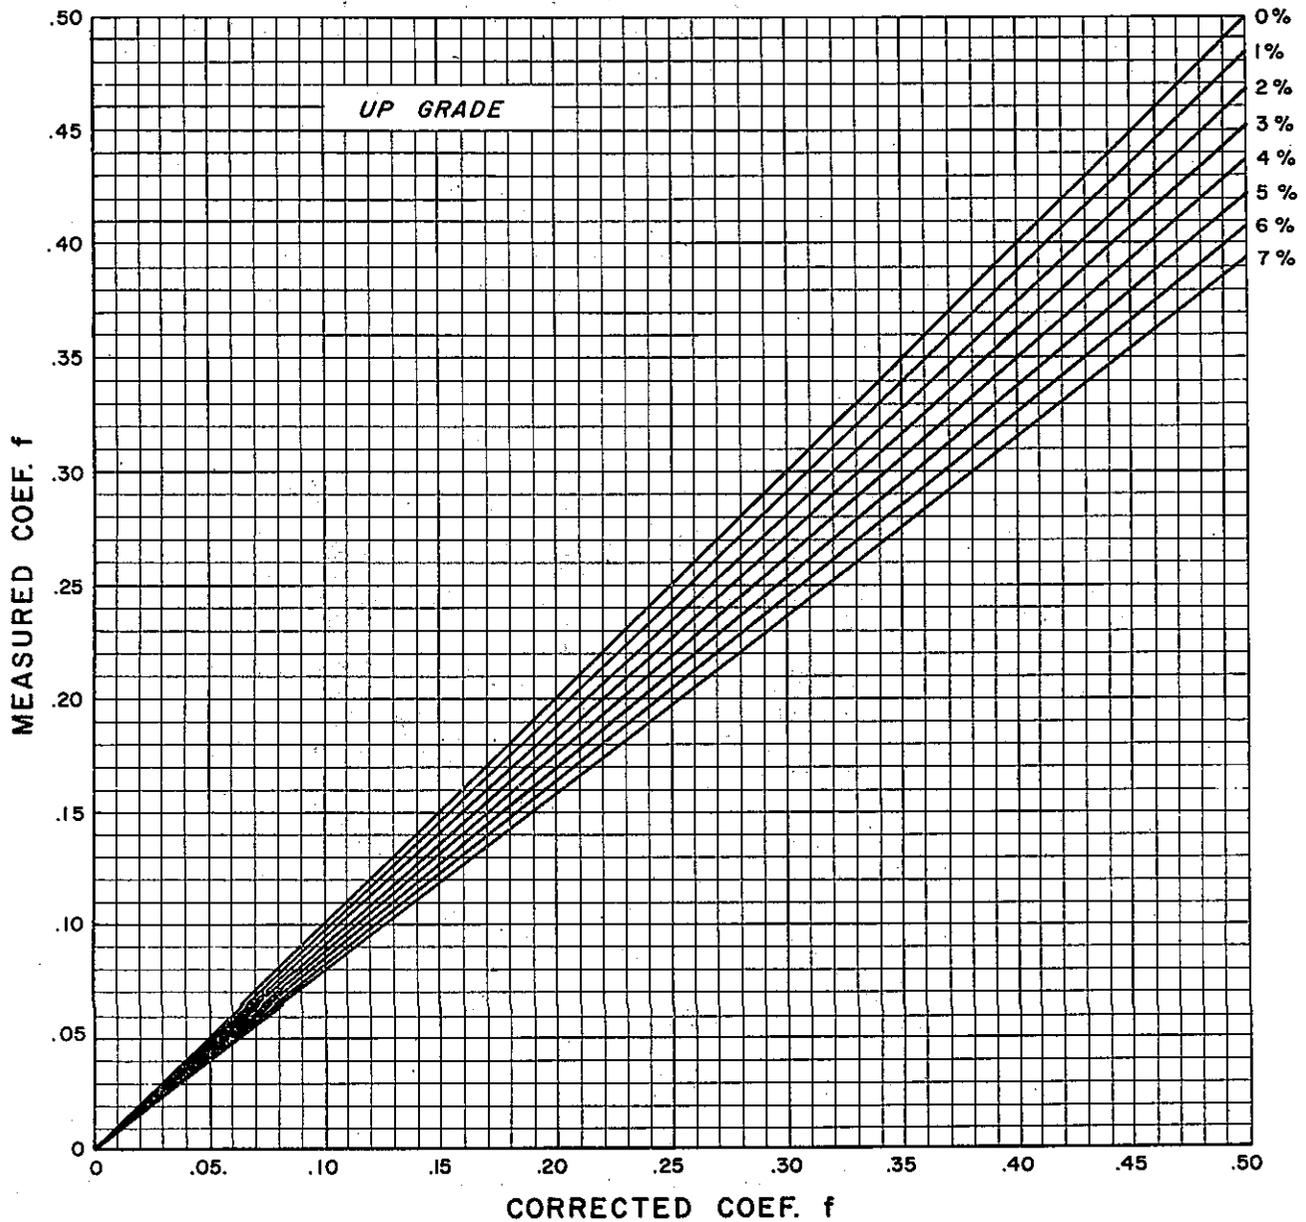
FIGURE VI

### COEFFICIENT OF FRICTION CORRECTION CHART FOR MEASUREMENTS MADE ON GRADES

1. Make grade corrections using charts shown in Figures VI and VII.

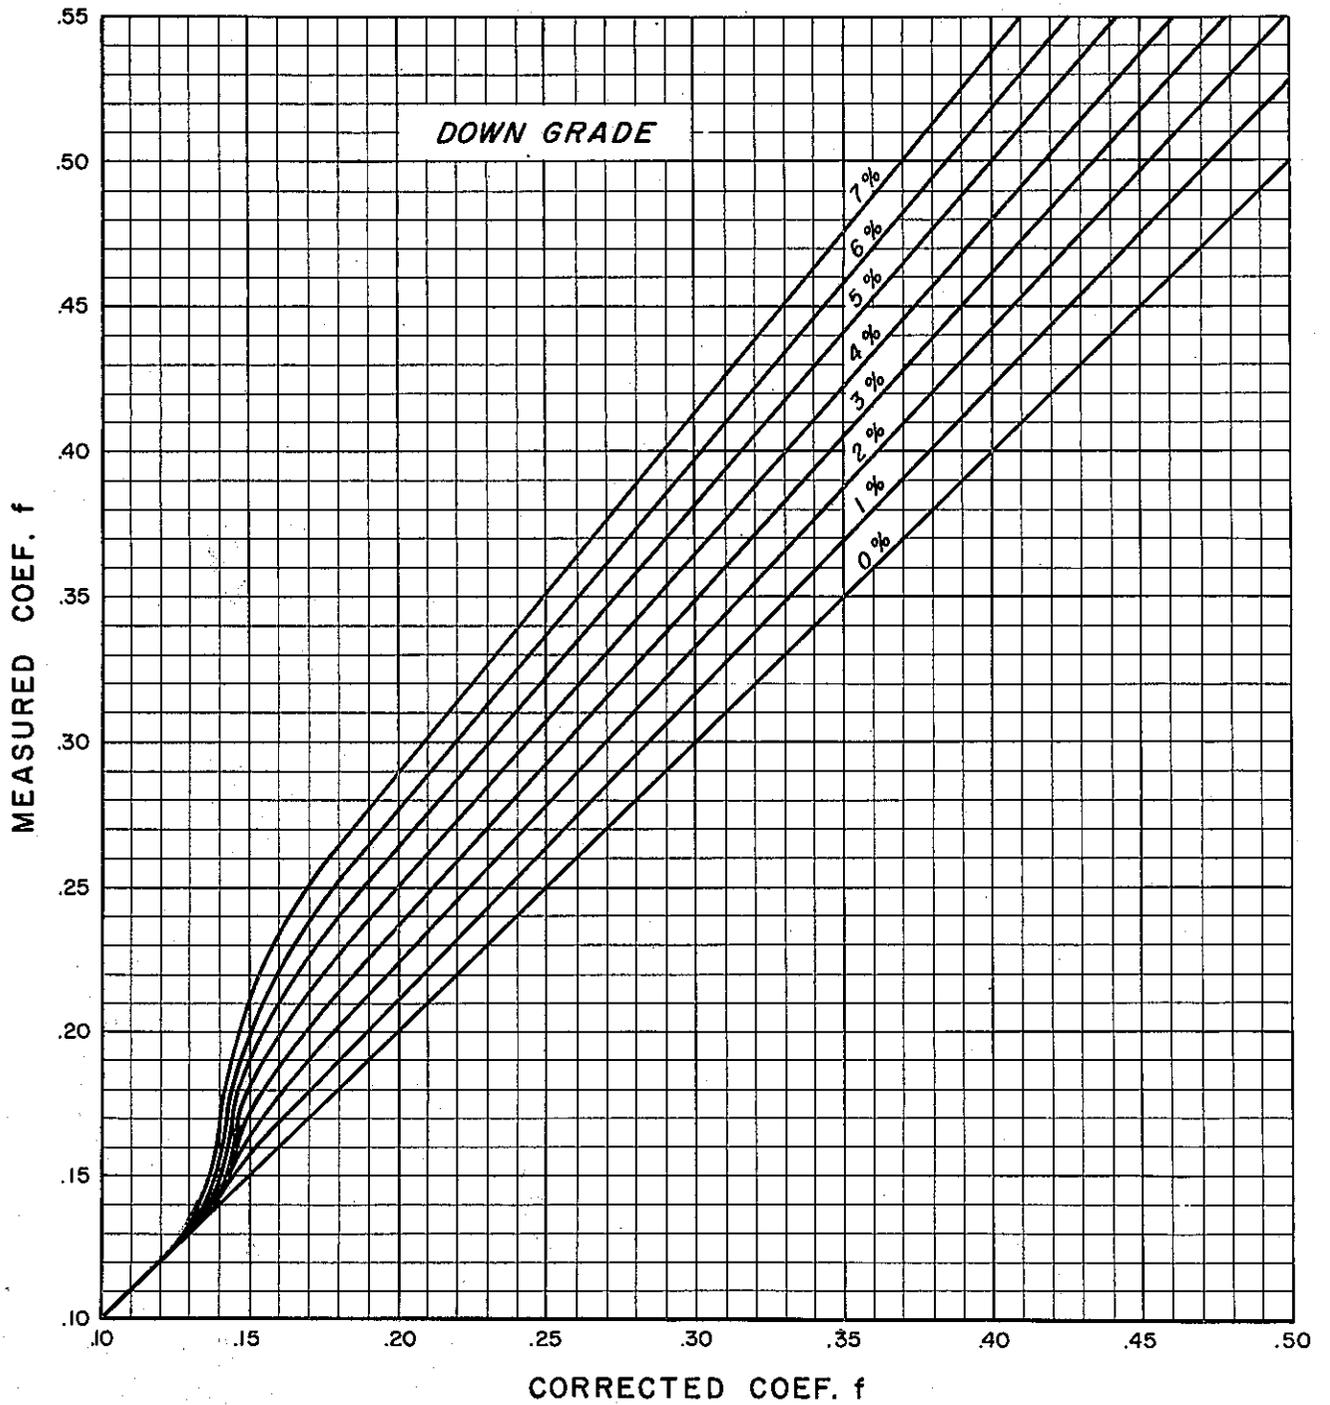
FIGURE VII

COEFFICIENT OF FRICTION CORRECTION CHART  
FOR MEASUREMENTS MADE ON GRADES

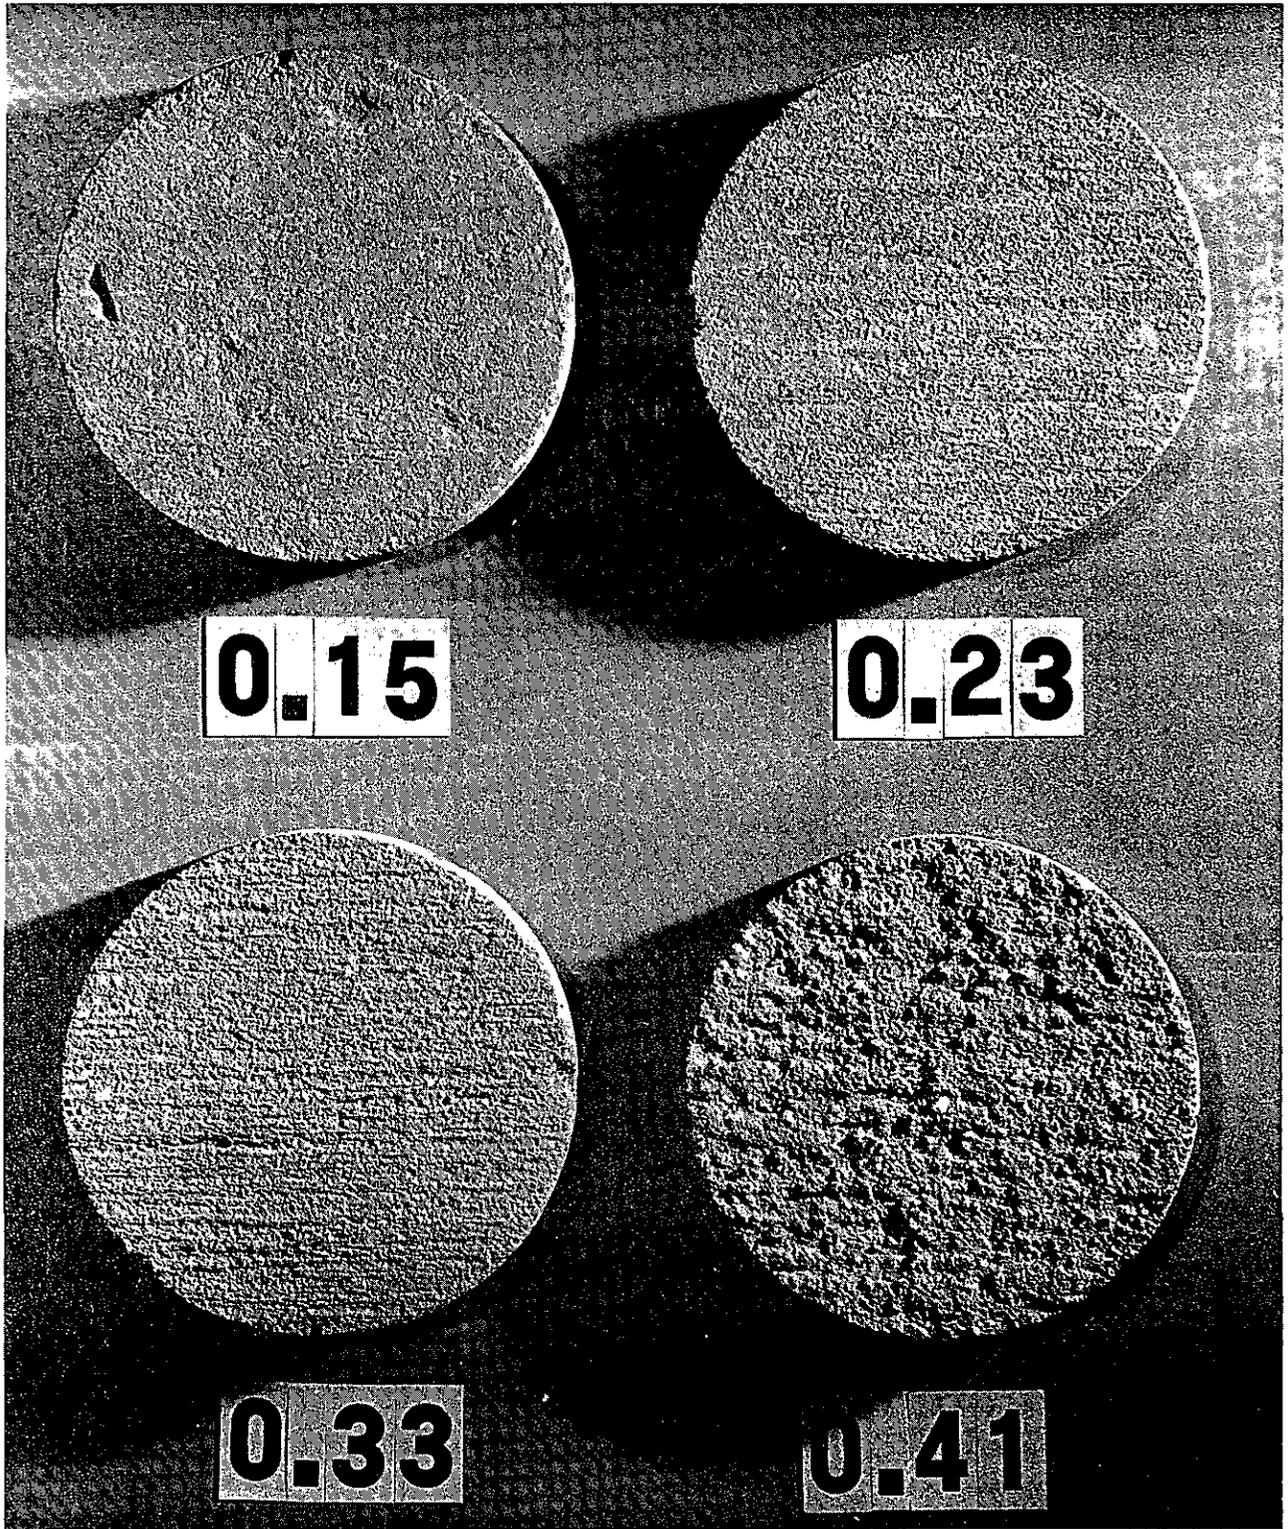
FIGURE VIII  
PHOTOS OF SURFACE TEXTURES

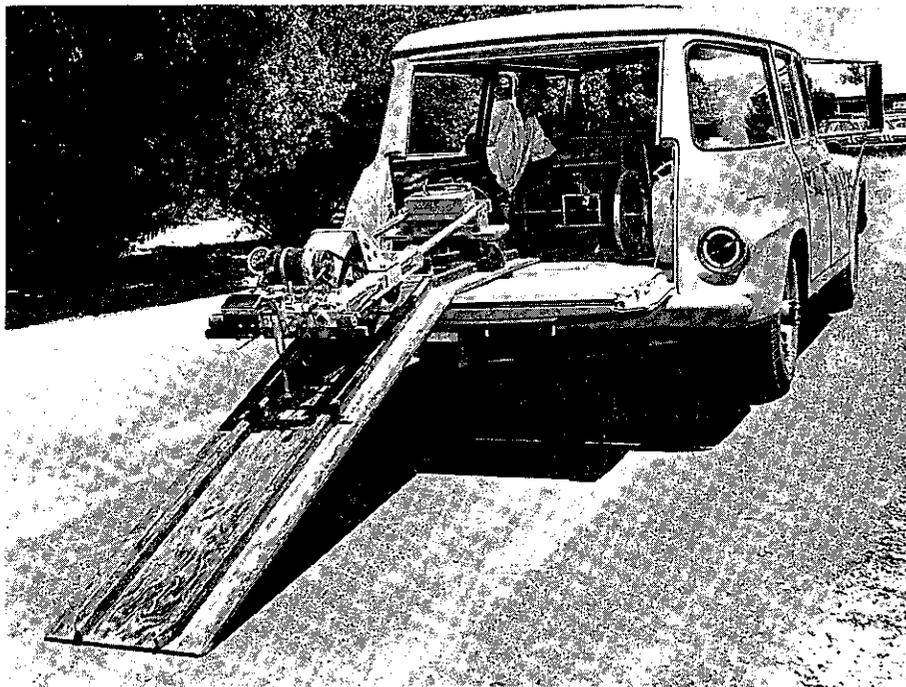
FIGURE IX  
APPARATUS BEING PLACED IN VEHICLE  
NOTE CABLE AND WINCH FOR MOVING SKID TESTER

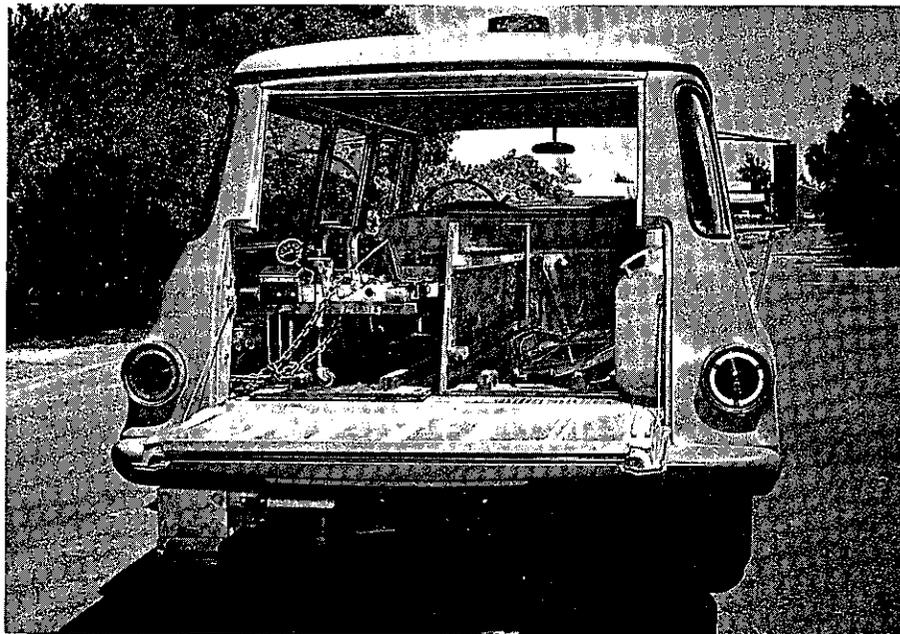
FIGURE X  
APPARATUS IN POSITION FOR TRANSPORTATION
