Coefficient Of Friction Of Various Grooving Patterns On PCC Pavement

State of California
Department of Public Works
Division of Highways
Materials and Research Department

Interim Report

NO. M & R 633126

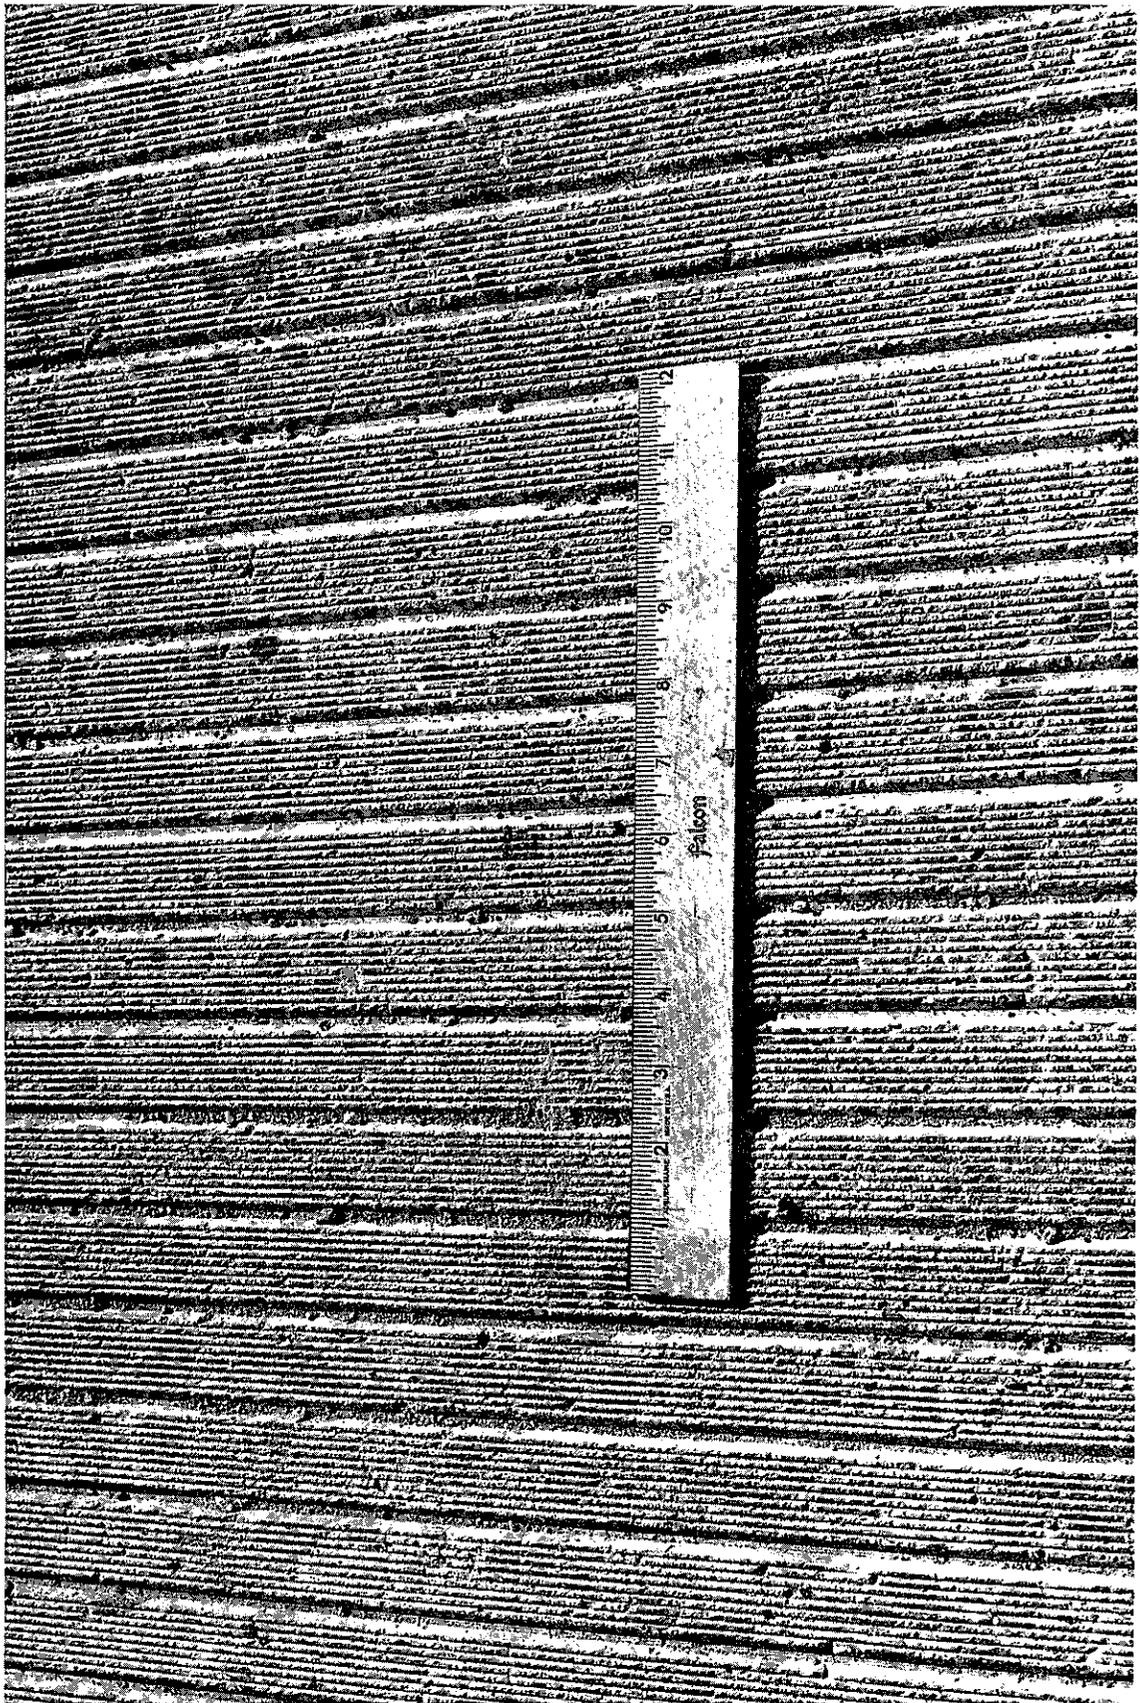
Figure 1

CHRISTENSEN STYLE 15 GROOVES

Six different grooving patterns were cut in each test slab on March 5, 1968, with a Christensen concrete planer. Rectangular grooves 1/8 inch wide by 1/8 inch deep at 1/2 inch, 3/4 inch and one inch center to center spacings and the number 6, 7 and 15 grooving patterns of the Christensen Diamond Services Company were used (Figures 1 and 2). The location of each of the grooving patterns on the slabs is shown in Figure 3. Due to the fact that the center of the south end of the trowelled slab was low, two passes with the number 15 pattern were necessary before the center of the slab could be grooved. For the same reason, an extra deep cut was used with the number six pattern on the trowelled slab. All the remaining grooves were cut at normal depth. The number 7 pattern was not cut for as long a distance as the other patterns because the machine started slipping sideways due to the smoothness of the trowelled surface and the fact that the slab had about a four percent cross slope. Figure 4 shows a close-up photograph of Christensen's number 6 pattern. The number 7 pattern is quite similar since it has the same dimensions for the grooves but has 57 grooves per foot while the number 6 pattern has 47 grooves per foot. Figure 5 shows the concrete planer operating in the background while in the foreground the 1/8 inch by 1/8 inch rectangular grooves at one inch centers are shown.

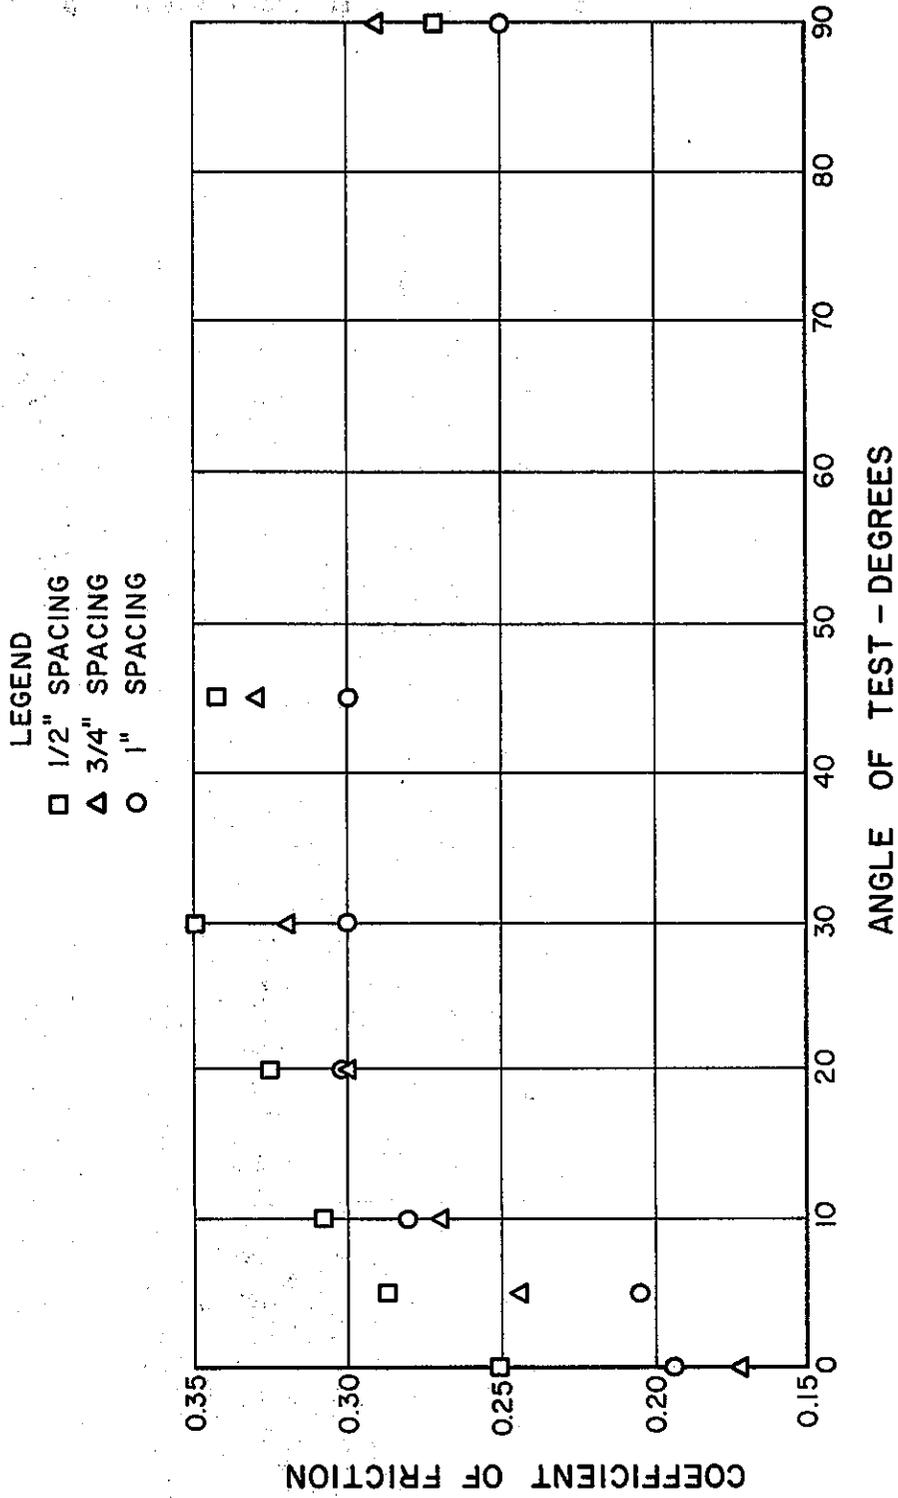
Figure 6

COEFFICIENT OF FRICTION VERSUS ANGLE OF TEST

increased more and more of the tire contact area encounters the grooves. Since the tire print is about four inches long, all of the contact area encounters grooves, which are spaced at one inch centers, at an angle of about 12 degrees or more. The test angle at which all of the tire print contacts the grooves decreases proportionally as the spacing between the grooves is decreased. The highest value of the coefficient of friction for grooved surfaces as measured with the California Skid Tester appears to be obtained when the test is performed at the smallest angle which insures complete contact of the tire print with the grooves since the smaller the angle the better the drainage for the test. This explains the reason for the higher values measured at 45 degrees shown in Table 2 for the trowelled PCC finish and the generally higher values for the tests measured at 15 degrees which are shown in Table 3.

On May 17, 1968, as a check on this conclusion, a series of measurements were made at angles of 5, 10 and 20 degrees on the 1/8 by 1/8 inch rectangular grooves in the trowelled surface. This data was combined with the measurements which were previously obtained and this information is presented as Figure 6. This figure shows the coefficients are nearly at their maximum values at an angle of 15 degrees and remain essentially at that level to an angle of 45 degrees and then gradually decrease to a lesser value at 90 degrees. This experiment tends to confirm our previous conclusion. Further evidence was visually noted during this testing. At the conclusion of a test at an angle which was too slight for the grooves to completely cover the contact area of the test tire, the portions of the tire that were in the grooves were relatively dry and the portions which were between the grooves were still quite wet.
