Seam Strength Of Asphalt Coated Structural Plate Pipe

State of California  
Department of Public Works  
Division of Highways  
Materials and Research Department

## SEAM STRENGTH OF ASPHALT COATED STRUCTURAL PLATE PIPE

**NO. M & R 636407**

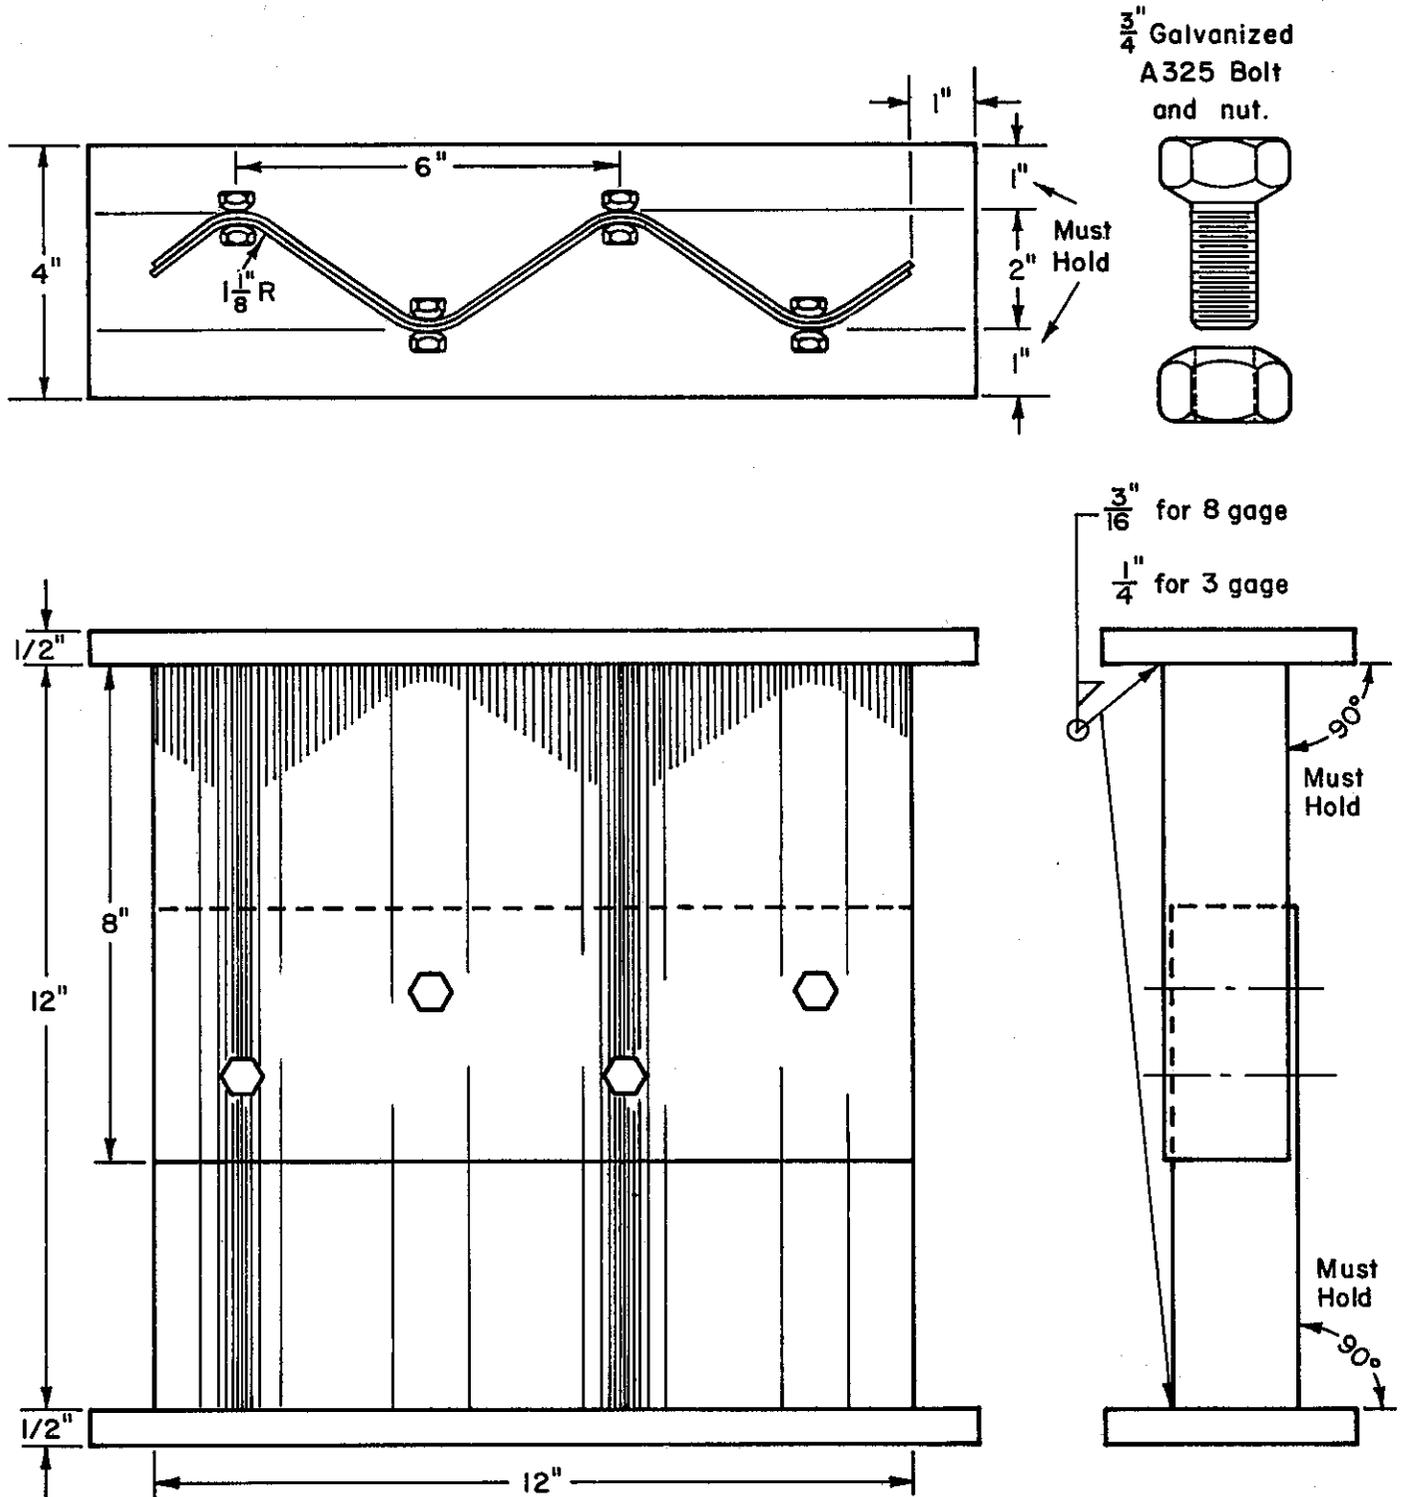
Figure 1

Twenty-four one-foot test specimens, including twelve eight-gage and twelve three-gage, were fabricated as shown in Figure 1. These gages represent the upper and lower range of gage sizes used by the California Division of Highways for galvanized structural steel plate pipe culvert. It was felt that data obtained from tests on these gage sizes would yield information that would be useful for all gage sizes within the presently used range.

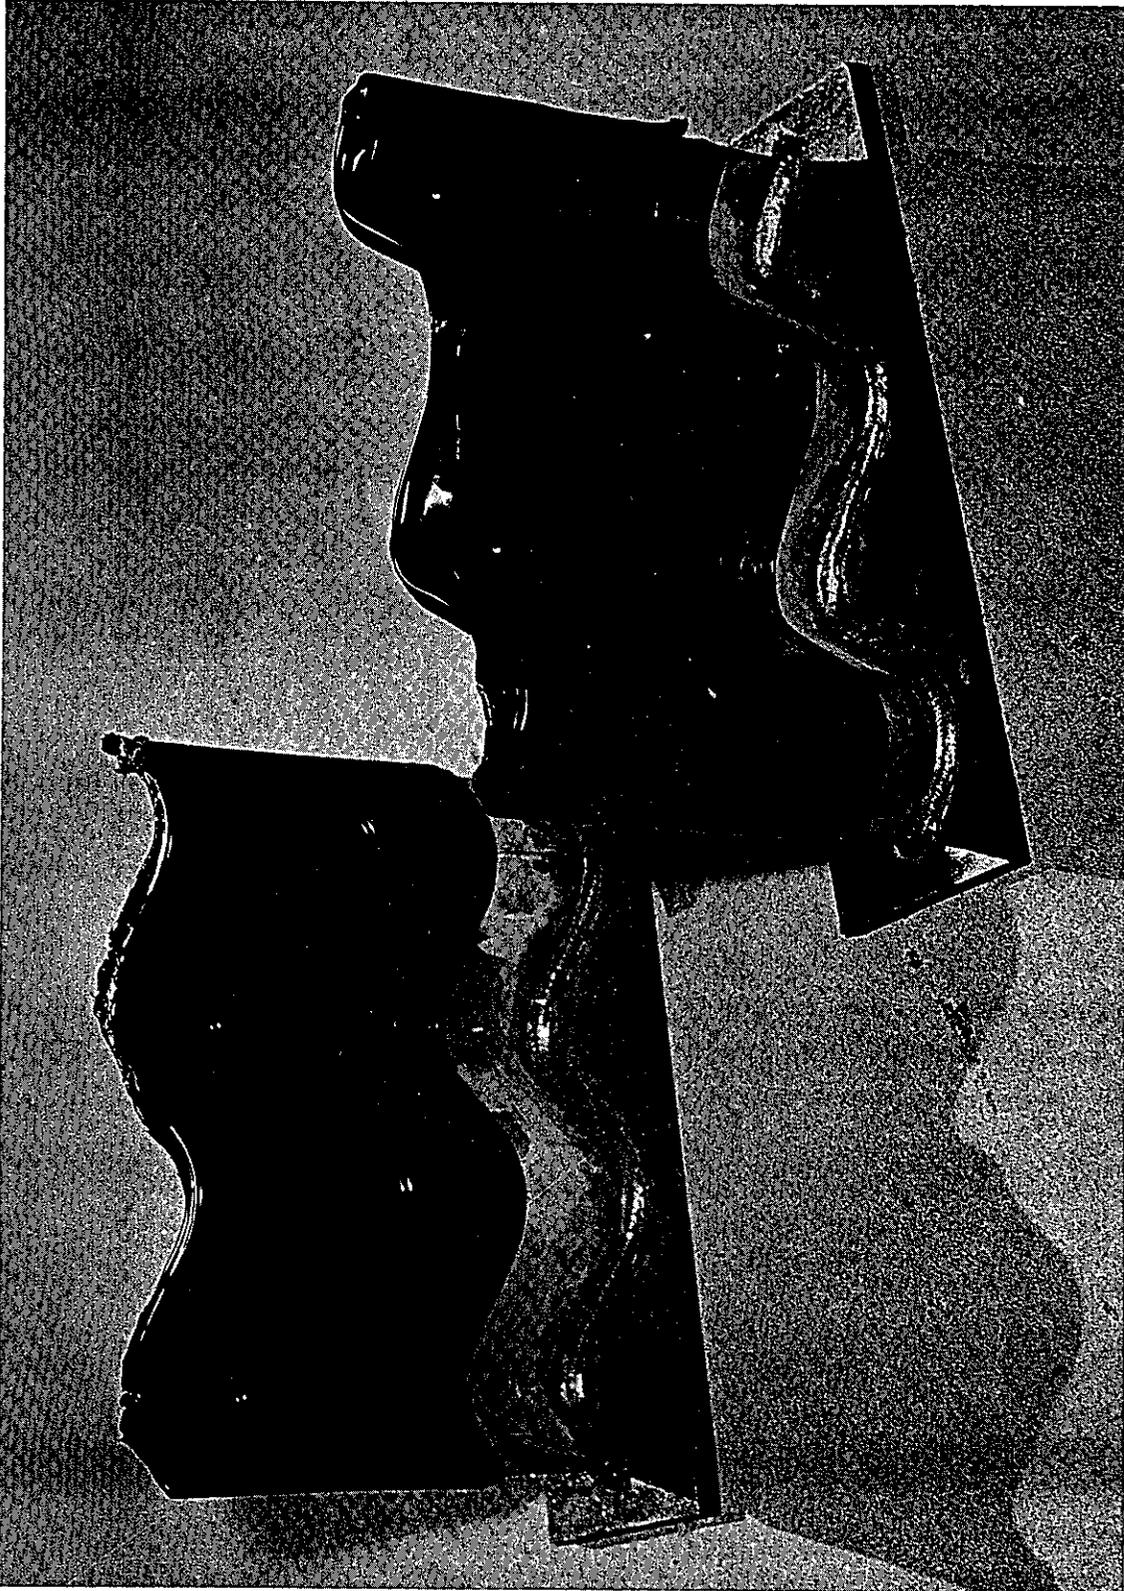
Figure 2

Six test specimens, from each gage, were coated with paving grade asphalt prior to assembly (Figure 2). The remaining six, from each gage, had a standard hot-dip galvanized surface, only.

A typical coated specimen is shown here before assembly

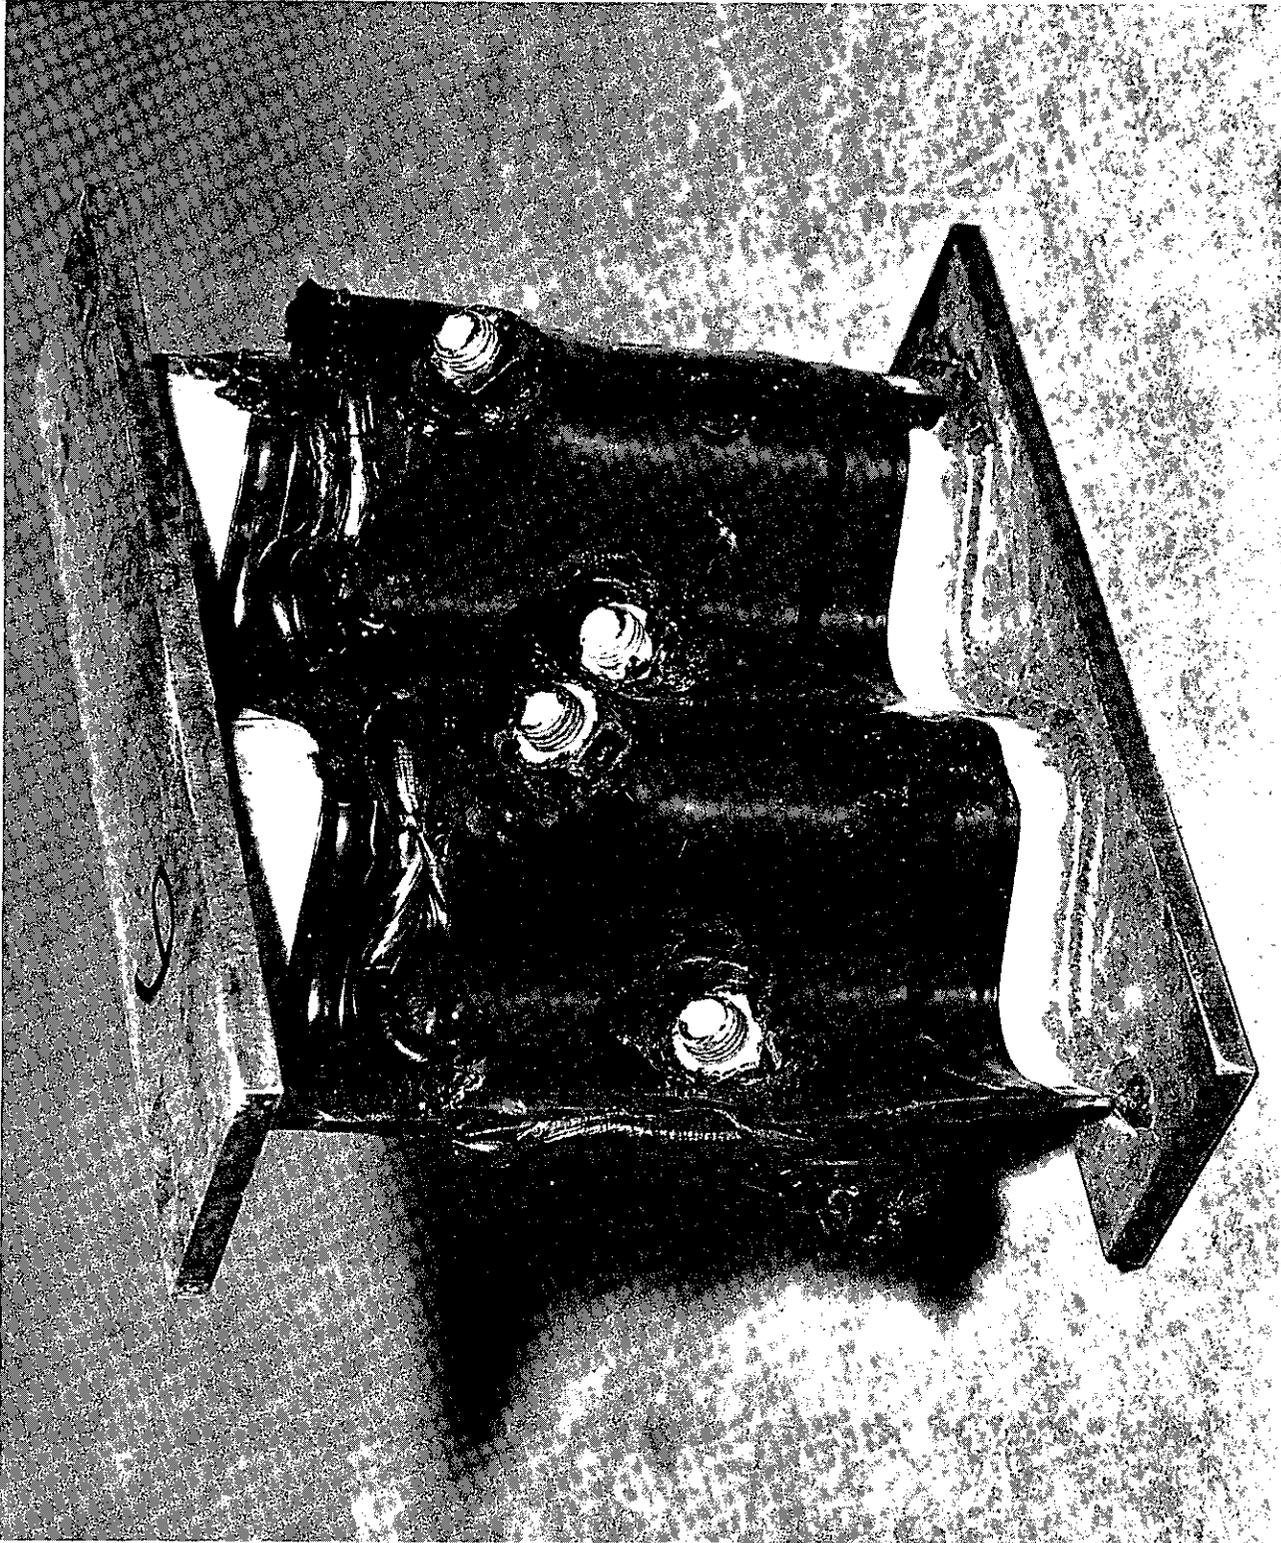
Figure 4

The mode of failure in most cases was a combination of plate bearing (at the bolt holes) and buckling (Figures 4, 5, and 6). The rotation of the bolt axis, as seen in Figure 5, indicates plate bearing failure. In two cases, some bolt shearing failure was also observed.

Coated specimen after being tested to ultimate load. Note bolt tipping.

Load deformation curves are shown in Figures 9 through 16. These curves indicate the joint's capacity for considerable movement before ultimate load is reached. This movement is shown by the bolt tipping seen in Figures 3, 4, 5, and 6. This indicates that the specimens retained their structural integrity while the deformations took place. It appears, therefore, that under field conditions the pipe would have the capacity to relieve itself of load by bolt tipping and subsequent sliding of the plates.

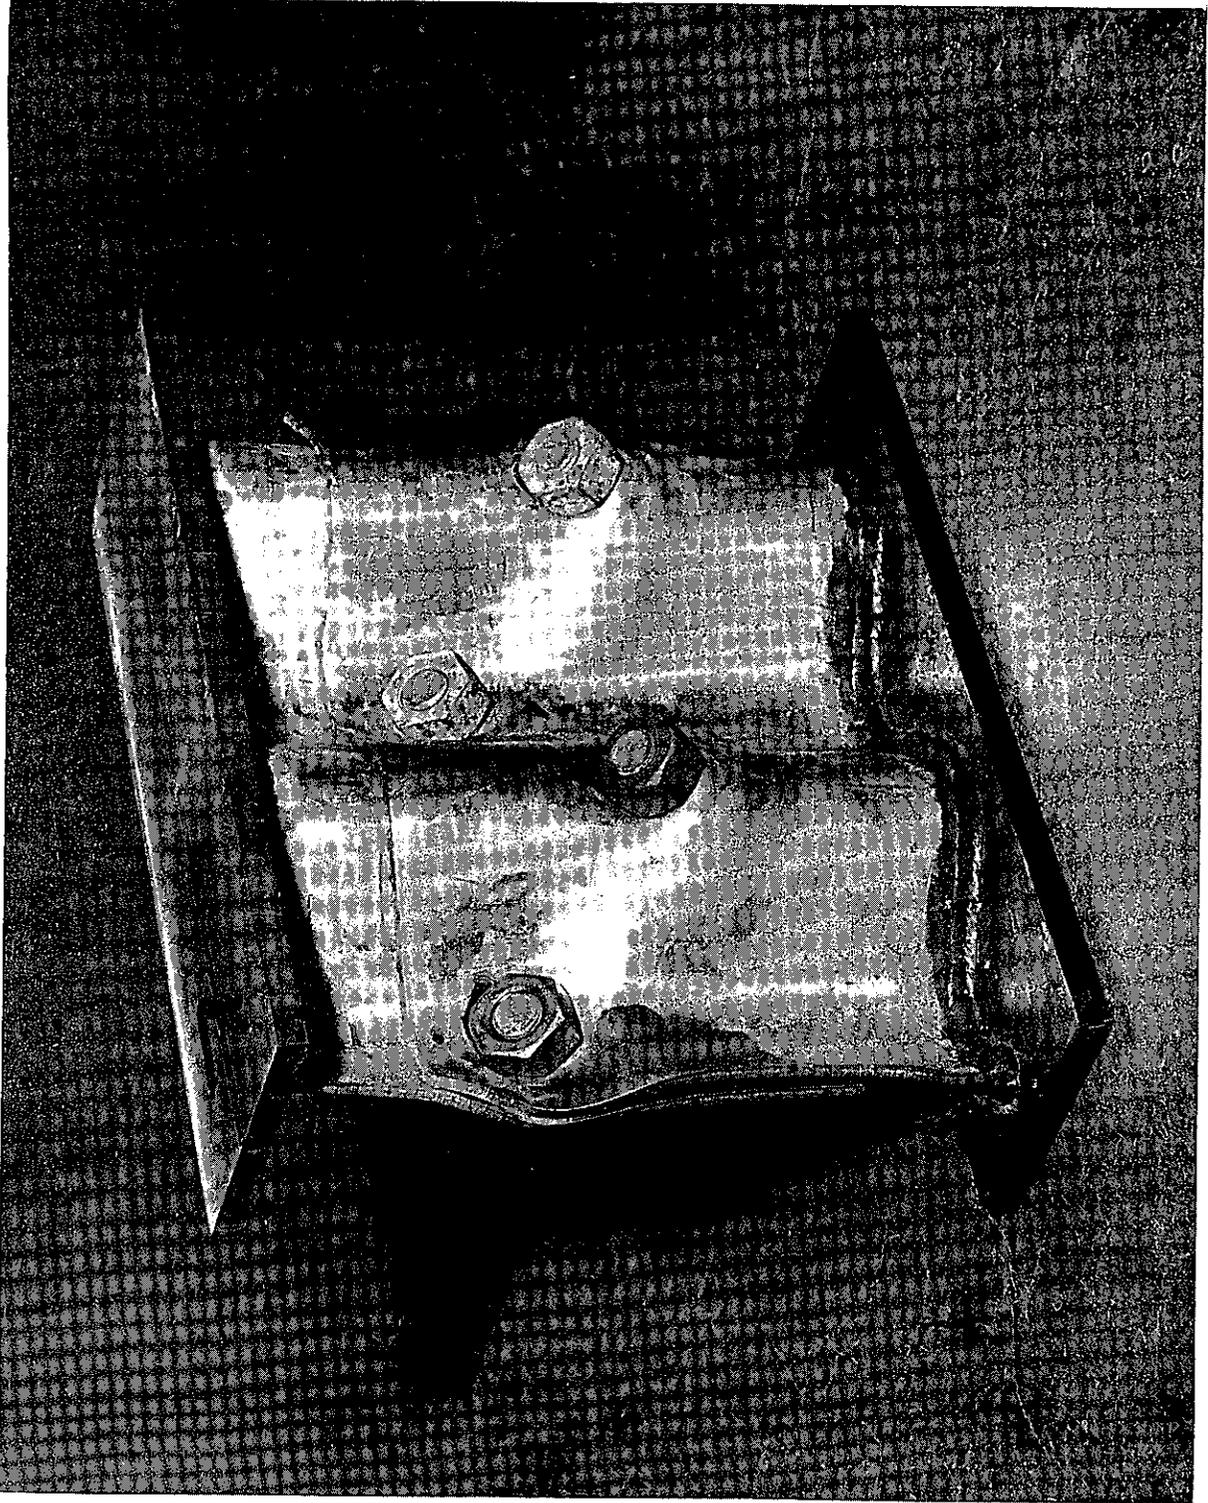
Figure 5

Uncoated specimen after being tested to ultimate load. Buckling of plates can be seen.

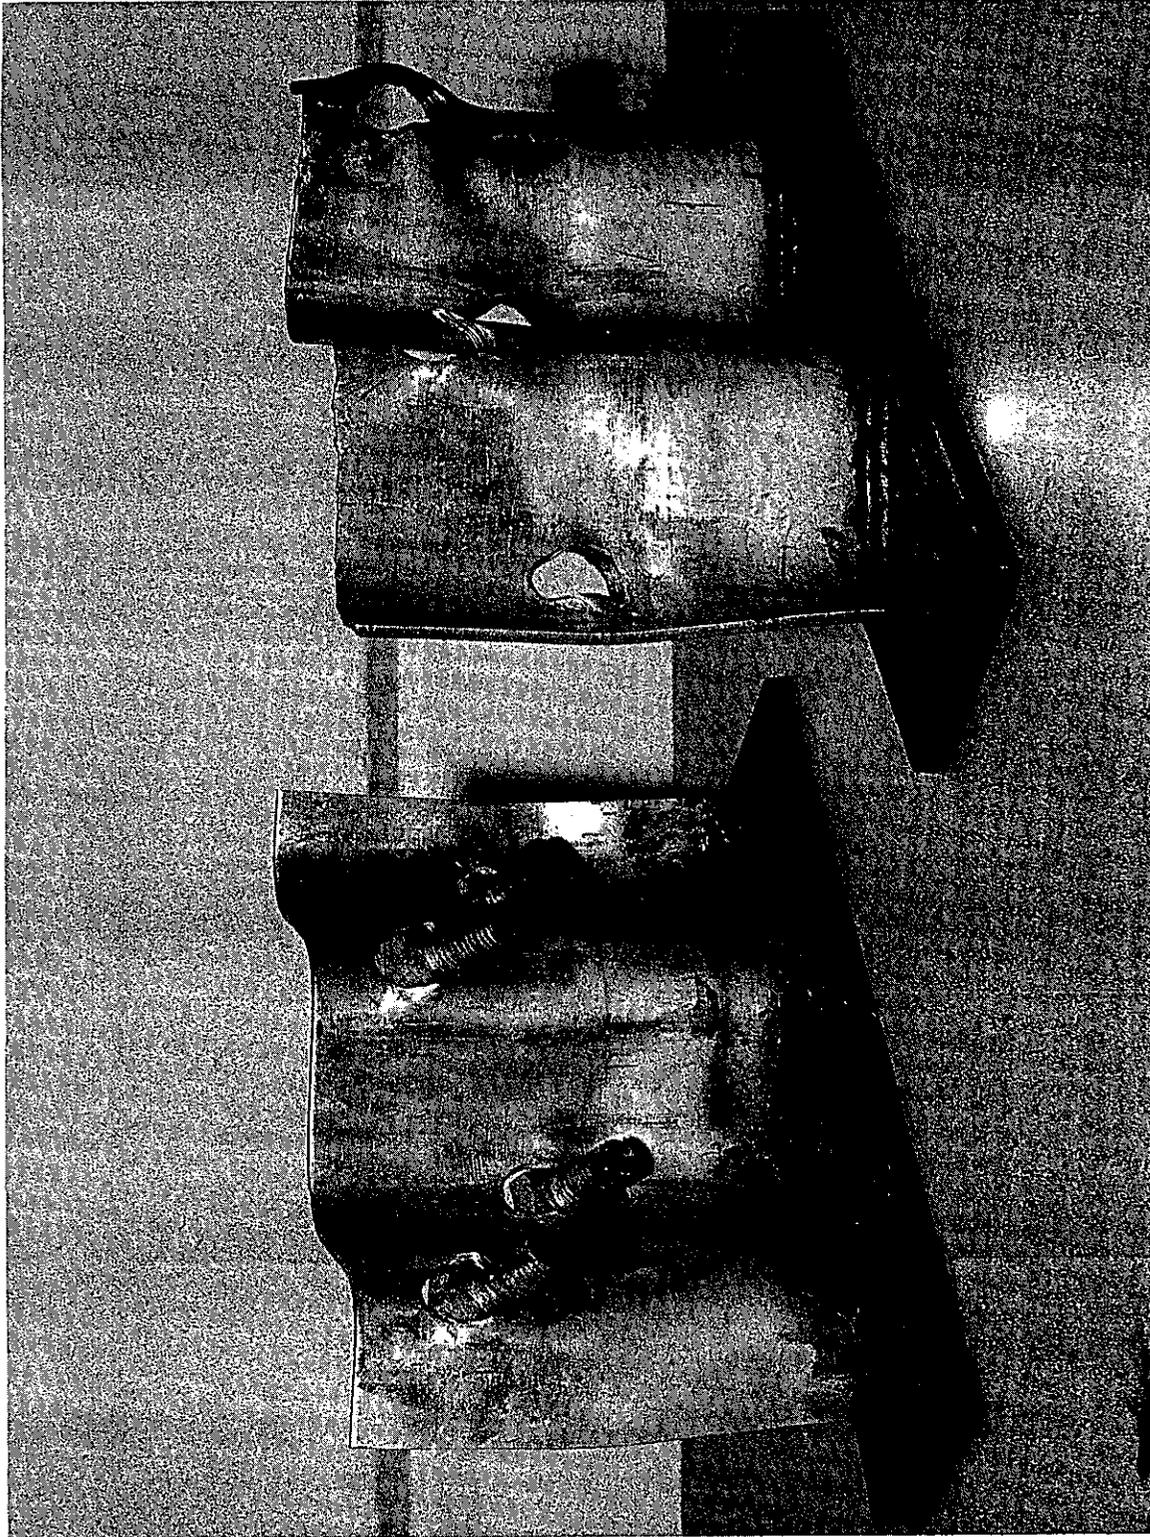
Figure 6

Disassembled specimen after being tested to ultimate load.  
Note bearing failures as well as slight buckling.

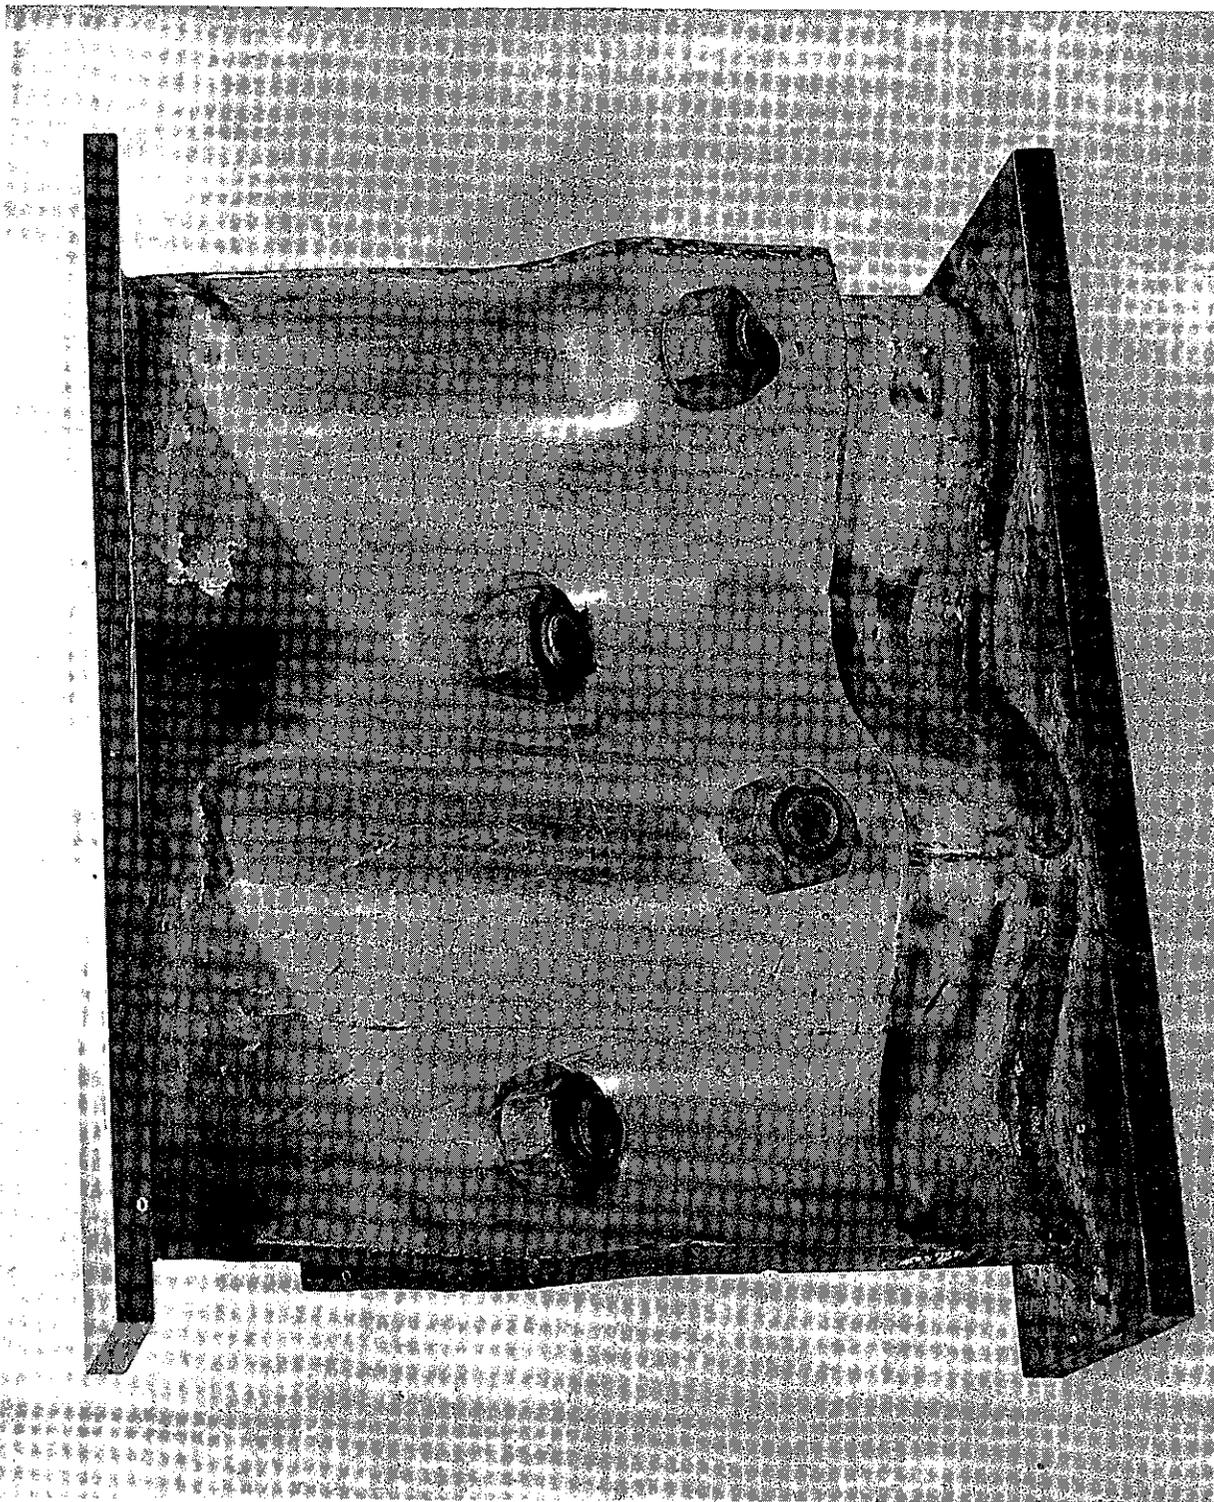
Figure 7

A comparison of individual ultimate seam strengths within some test cells indicated that some values were considerably lower than others. Subsequent visual observations of the test specimens, exhibiting low seam strengths, revealed that the angle of bolt tip varied among the four connecting bolts (Figure 7). This indicates that proper alignment of the bolt holes, in order to assure a uniform distribution of bearing forces along the seam, is critical to ultimate seam strength. The effect of minor misalignment of bolt holes in field installations would probably be less significant due to the much wider plate widths used. The phenomenon of improper hole alignment is a random variable and is included in the error term of the model equation.

Specimen showing differential bolt tipping. This is caused by poor hole alignment and results in unequal bearing forces along the seam, which results in low ultimate seam strength.

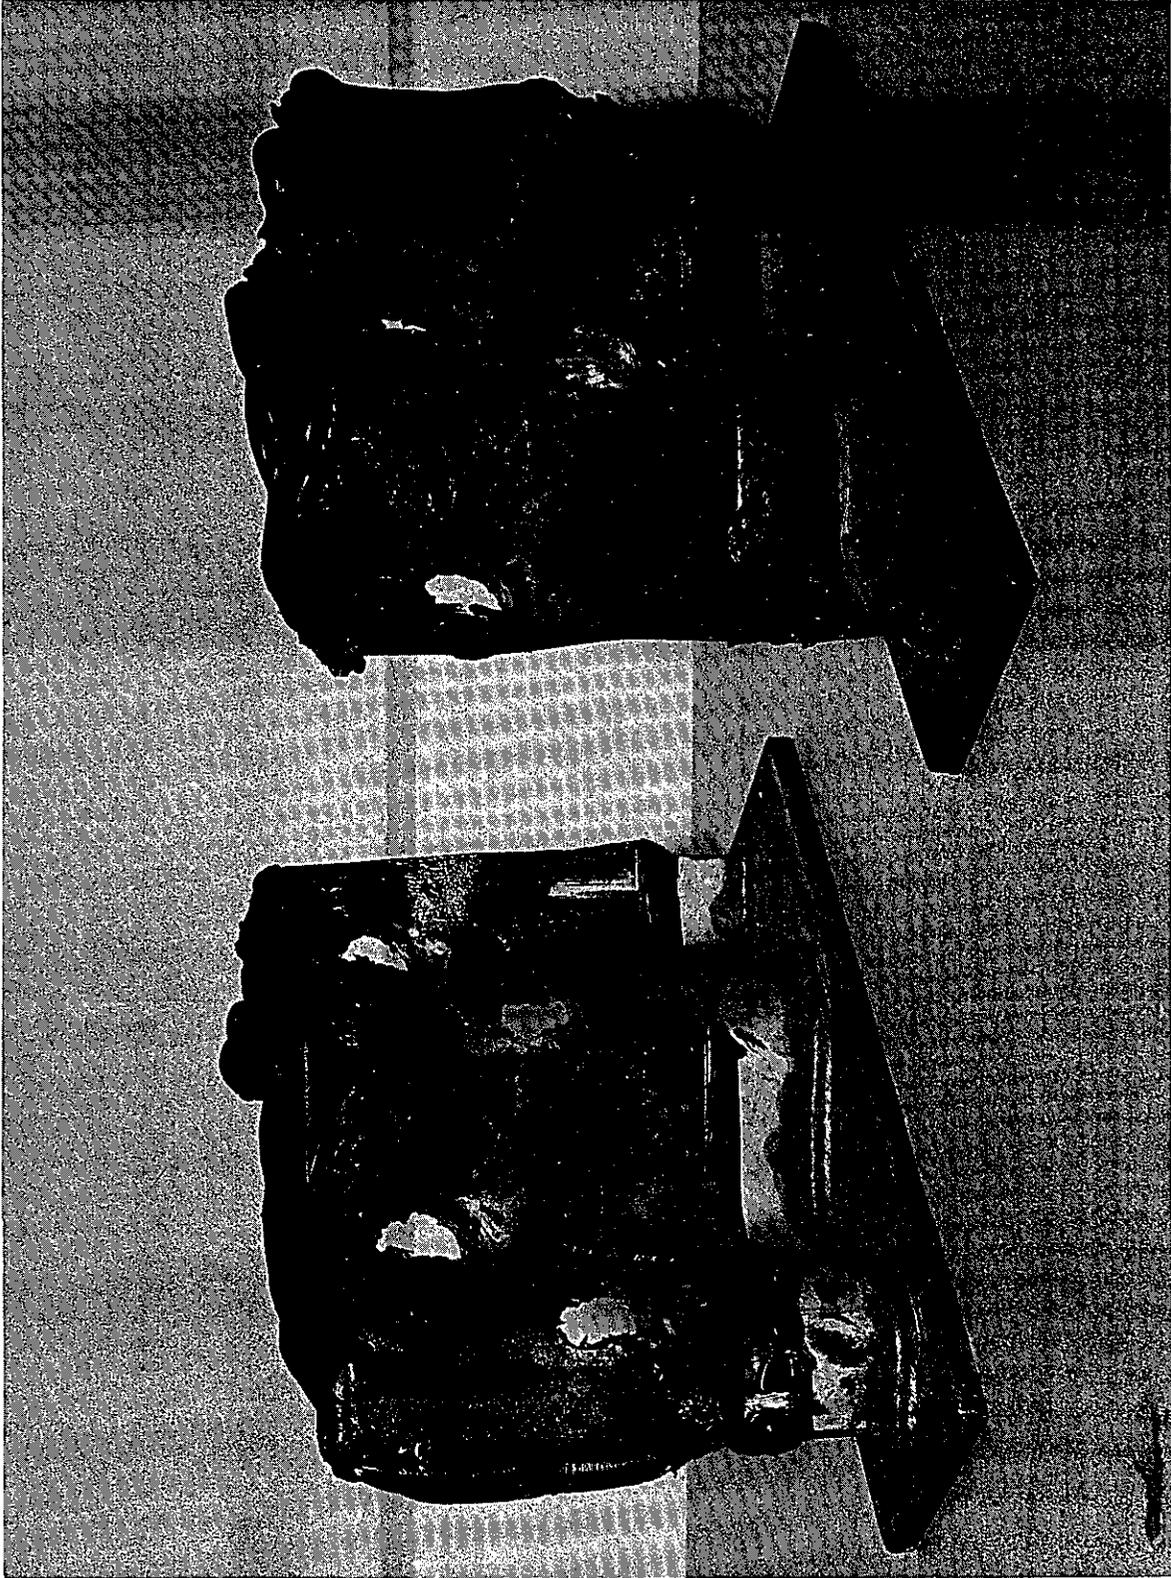
Figure 8

An attempt was made to separate two of the failed specimens to determine the thickness of the bituminous coating after torquing. Two were successfully separated and both showed an average of 0.03" of coating between the bolted surfaces. Within an area of approximately one inch around the bolt hole, the coating thickness was nil (Figure 8).

Disassembled coated specimen after testing. Sparsity of coating in the vicinity of the bolt holes can be noted.

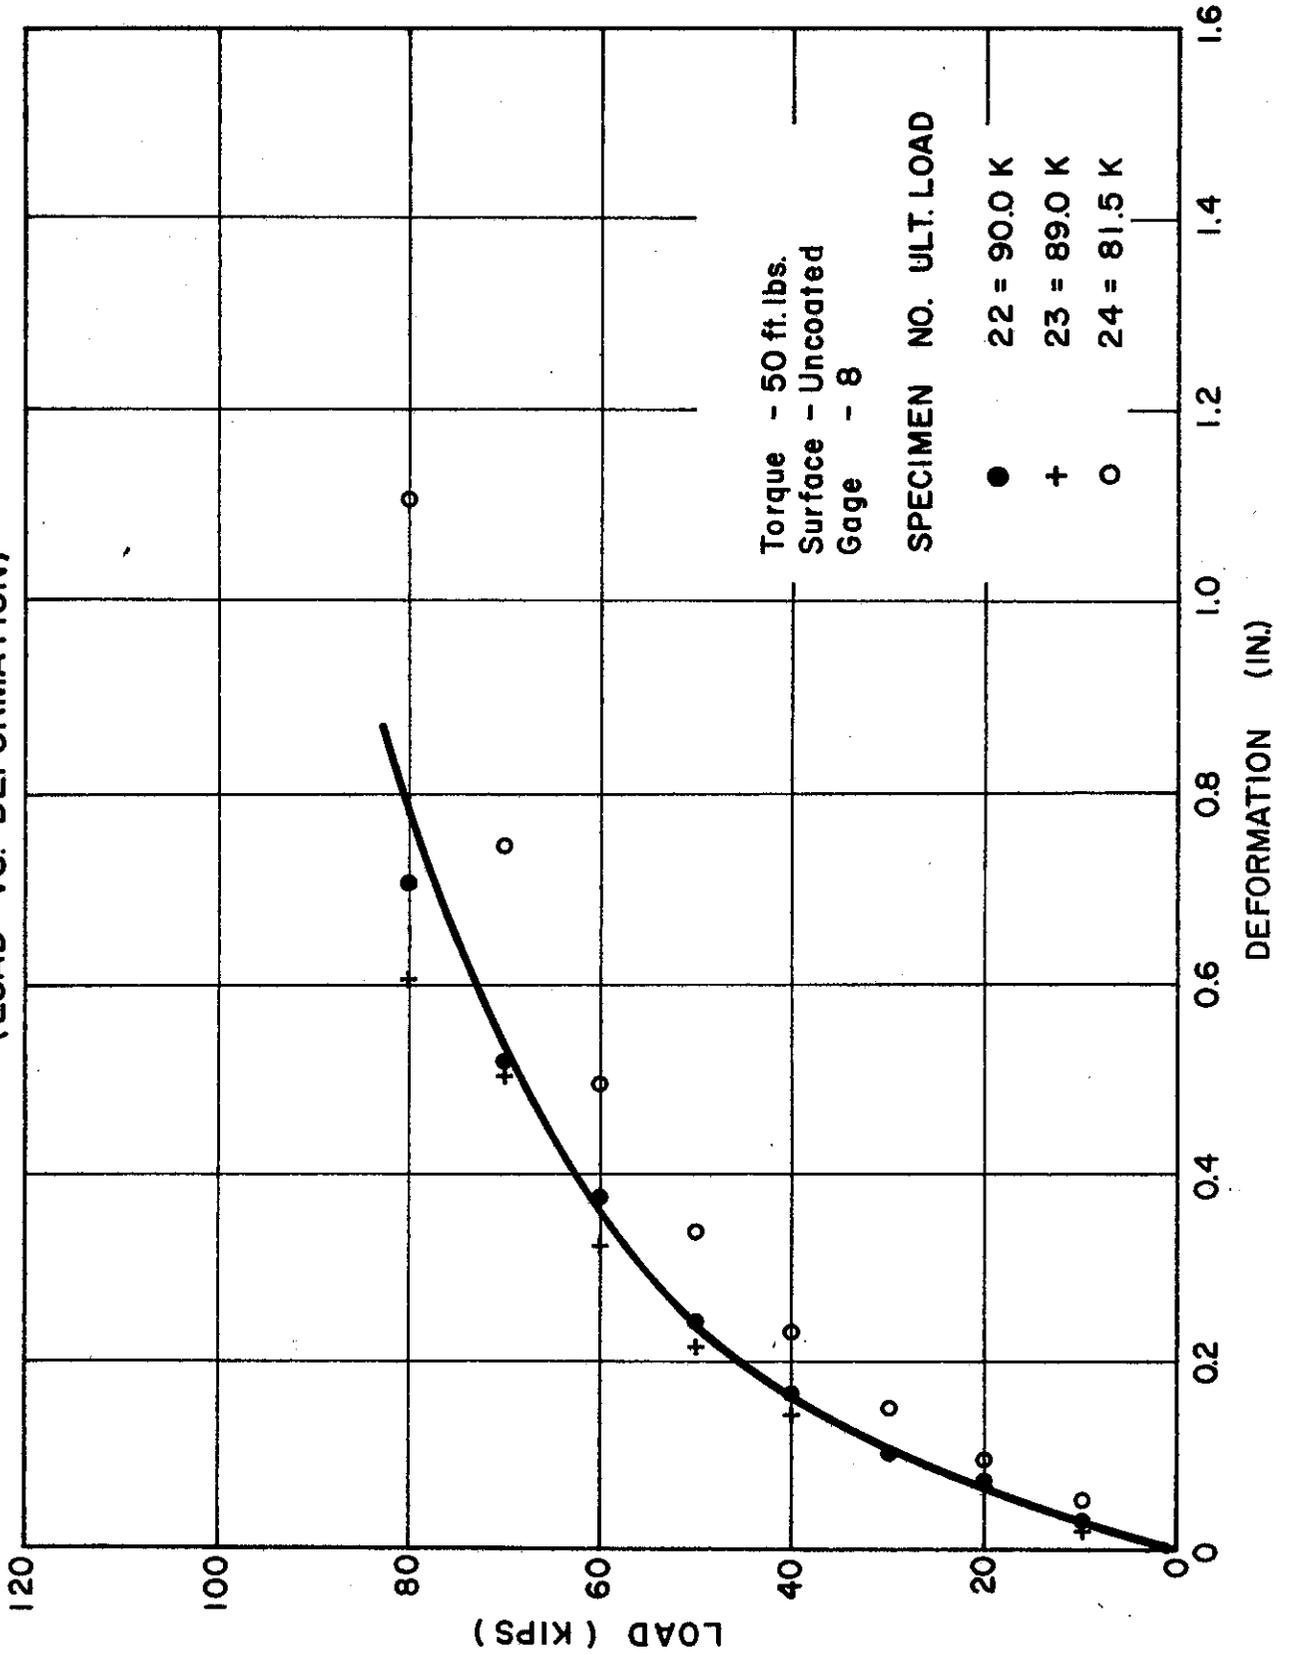
Figure 9

# MULTI-PLATE SEAM STRENGTH (LOAD VS. DEFORMATION)

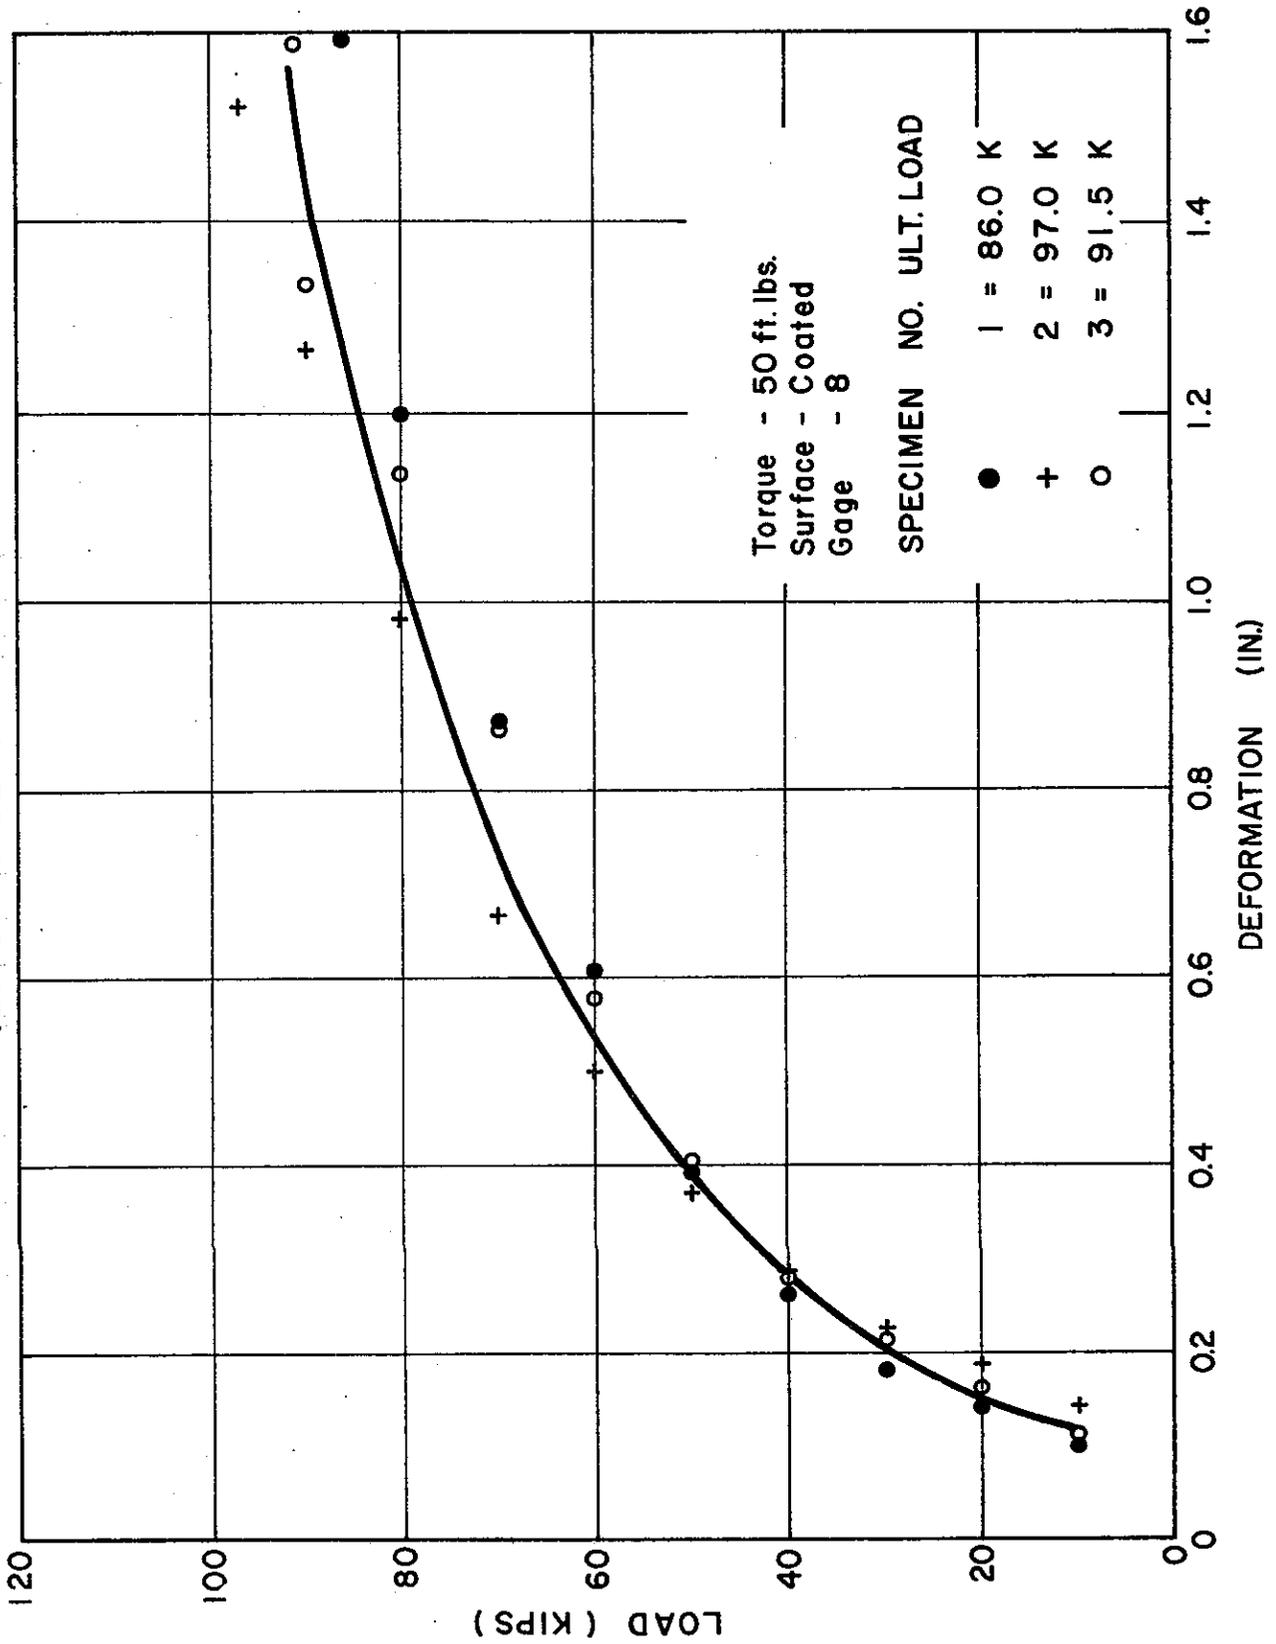
Figure 10

# MULTI-PLATE SEAM STRENGTH (LOAD VS. DEFORMATION)

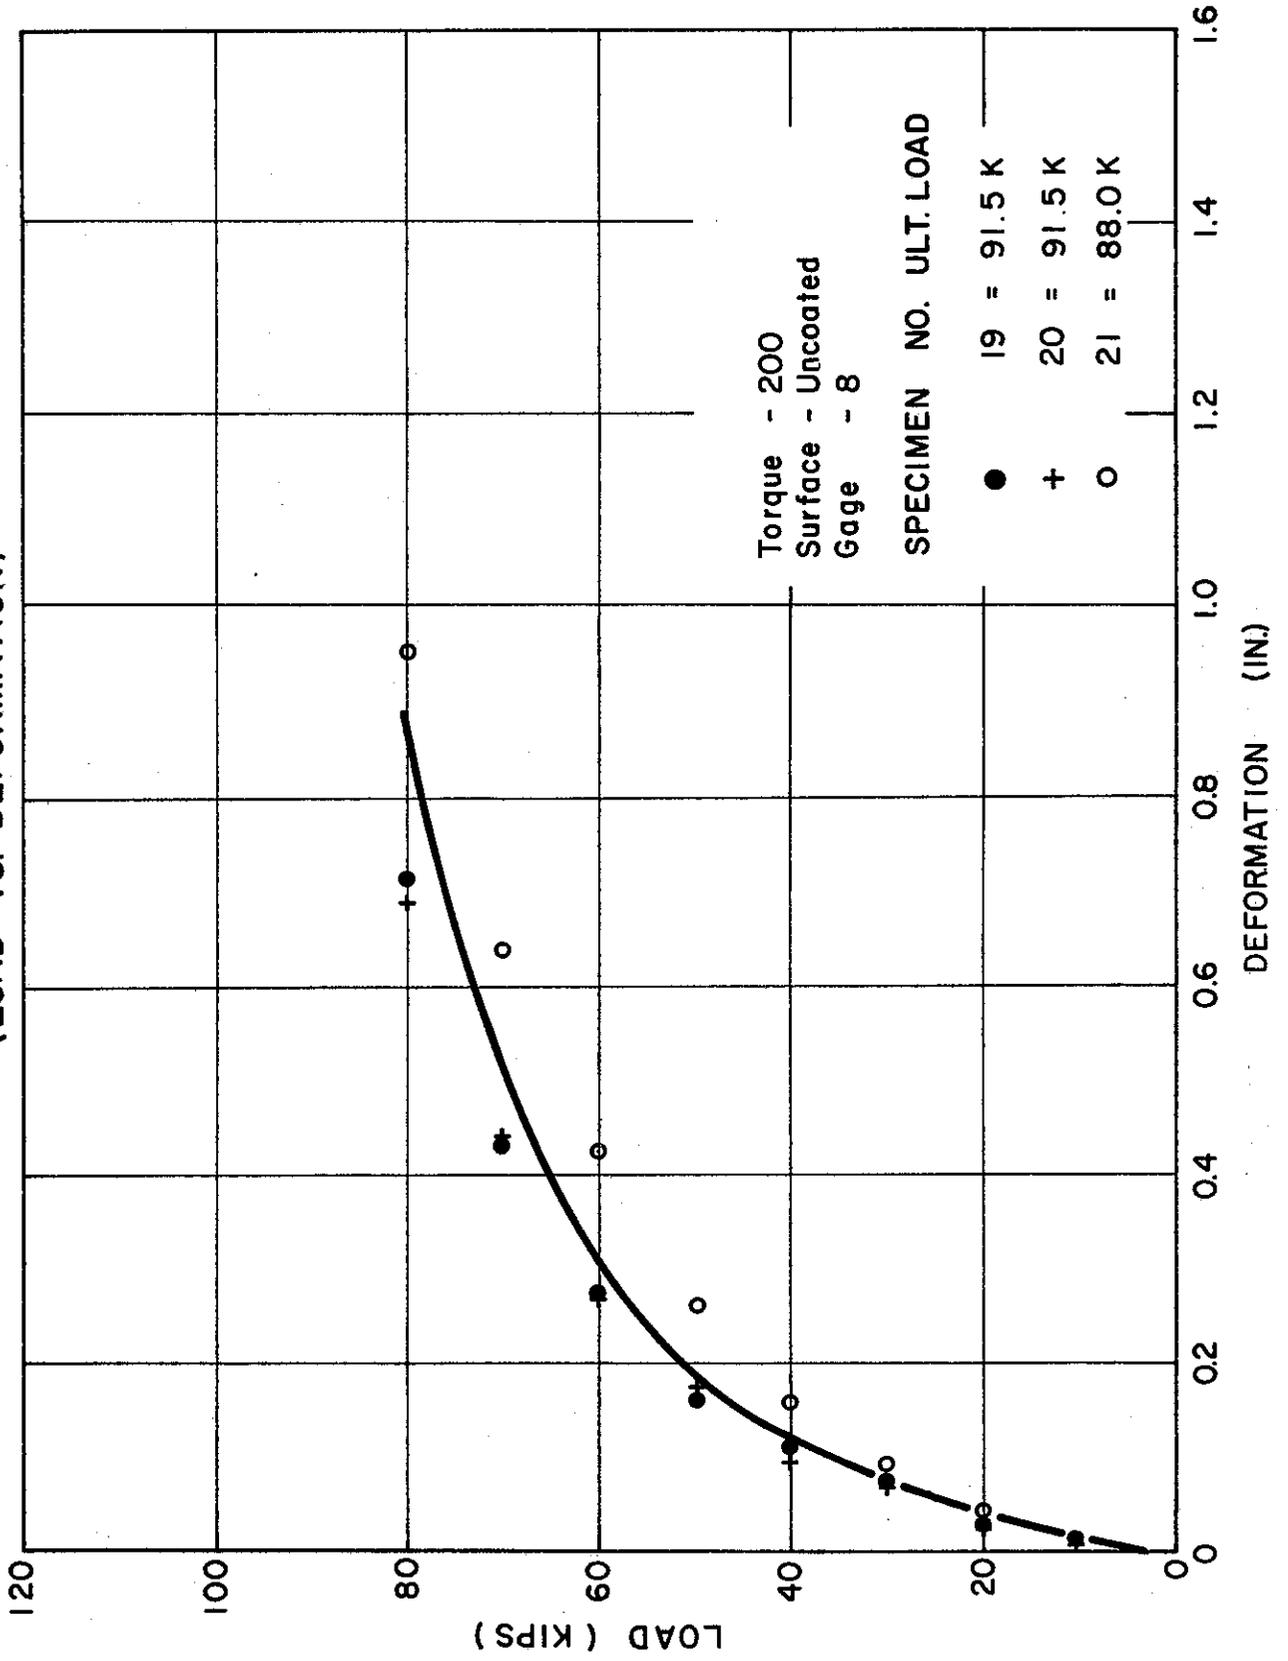
Figure 11

# MULTI-PLATE SEAM STRENGTH (LOAD VS. DEFORMATION)

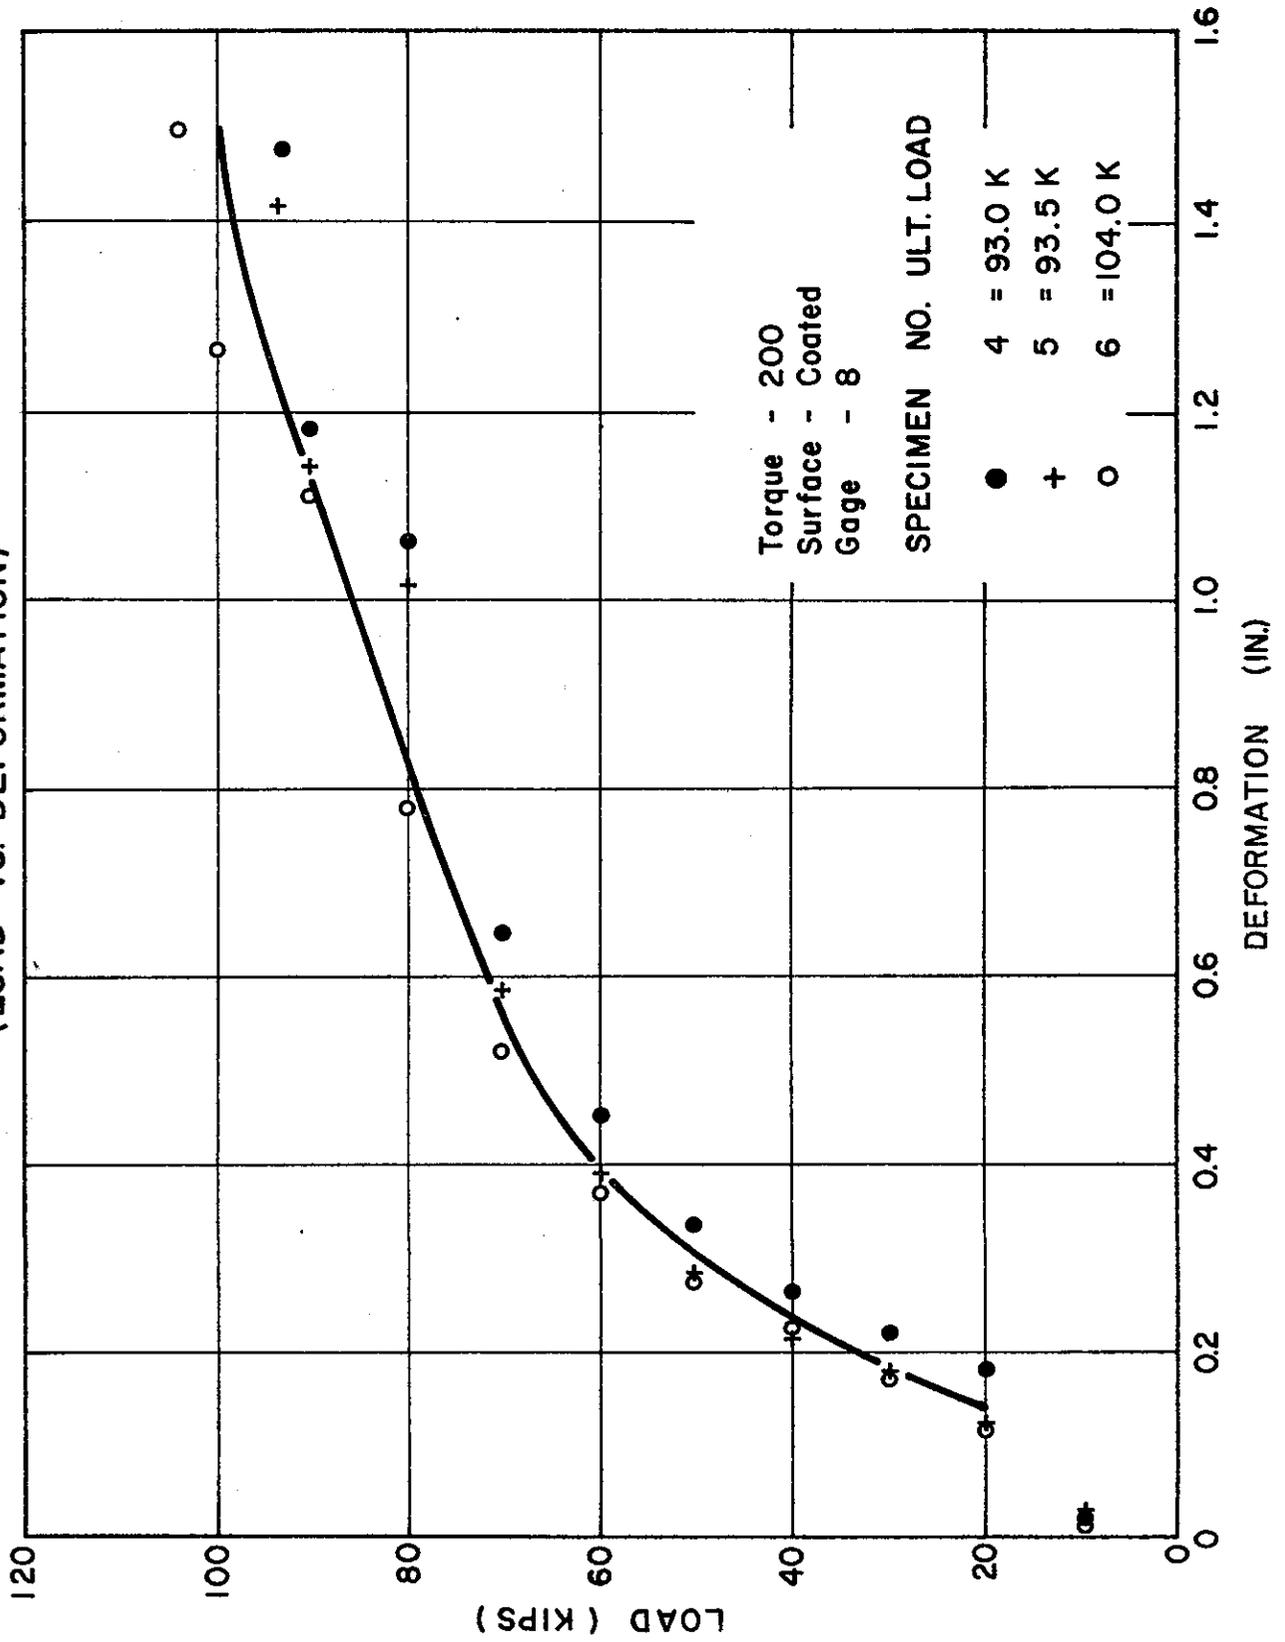
Figure 12

# MULTI-PLATE SEAM STRENGTH (LOAD VS. DEFORMATION)
