Seam Strength Of Asphalt Coated Structural Plate Pipe

State of California  
Department of Public Works  
Division of Highways  
Materials and Research Department

## SEAM STRENGTH OF ASPHALT COATED STRUCTURAL PLATE PIPE

**NO. M & R 636407**

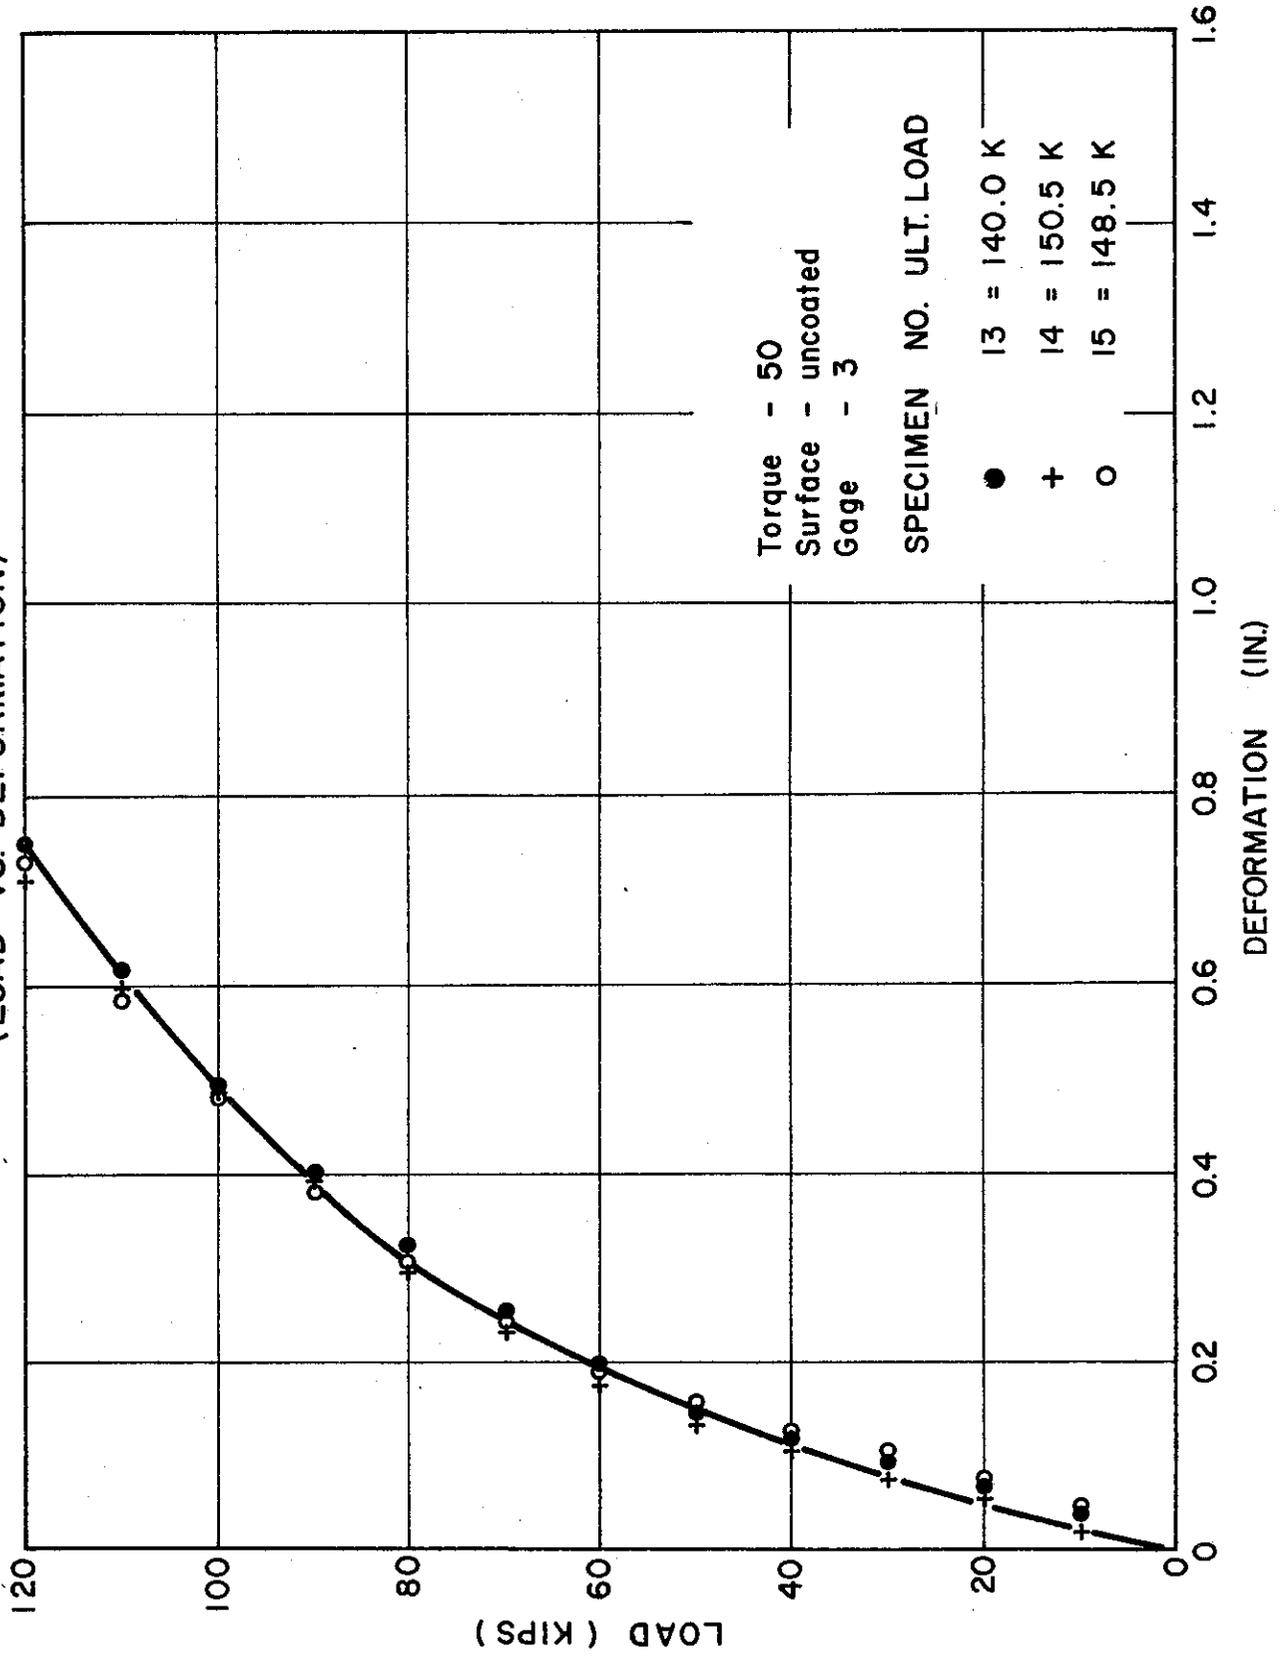
Figure 13

Load deformation curves are shown in Figures 9 through 16. These curves indicate the joint's capacity for considerable movement before ultimate load is reached. This movement is shown by the bolt tipping seen in Figures 3, 4, 5, and 6. This indicates that the specimens retained their structural integrity while the deformations took place. It appears, therefore, that under field conditions the pipe would have the capacity to relieve itself of load by bolt tipping and subsequent sliding of the plates.

# MULTI-PLATE SEAM STRENGTH (LOAD VS. DEFORMATION)

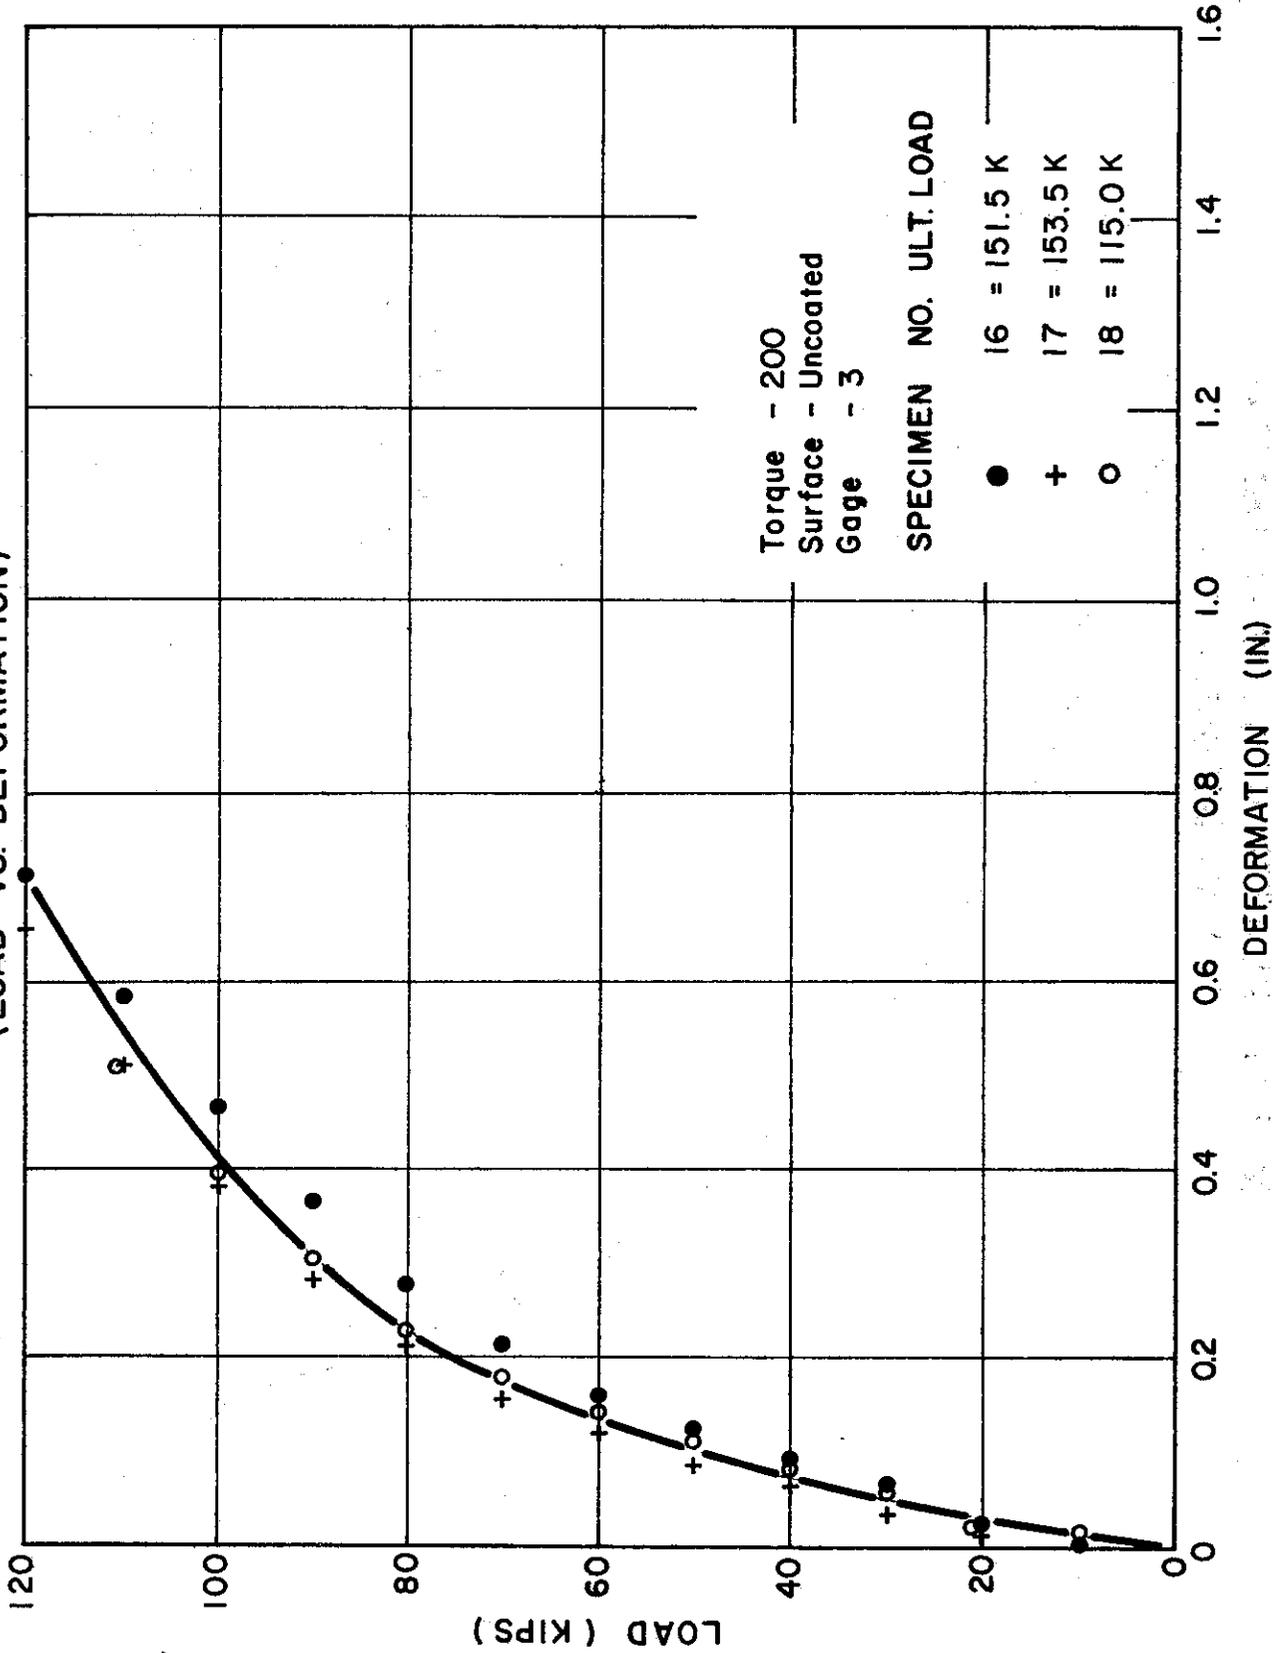
Figure 15

# MULTI-PLATE SEAM STRENGTH (LOAD VS. DEFORMATION)

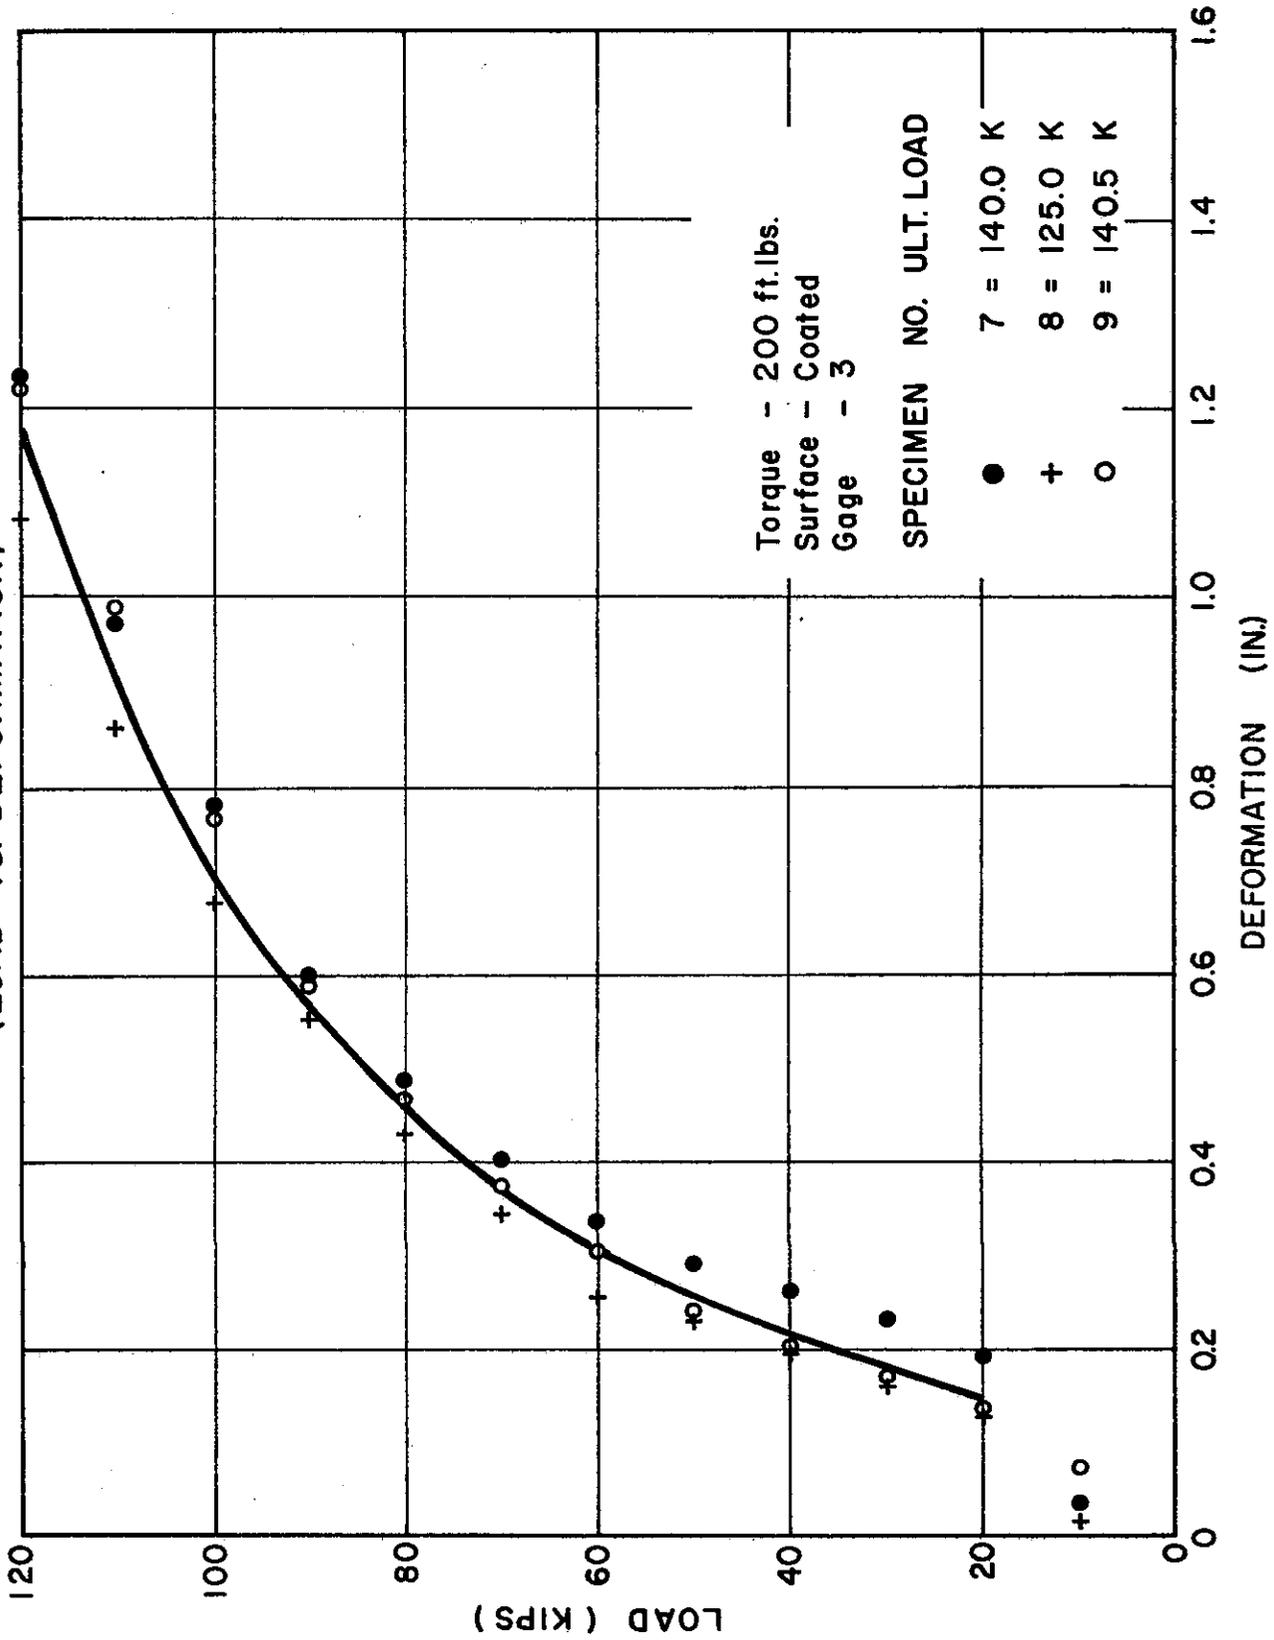
Figure 16

# MULTI-PLATE SEAM STRENGTH (LOAD VS. DEFORMATION)
