Crushed Glass For Use In Asphalt Concrete Or Cement
Treated Base

Final Report

FINAL REPORT

Crushed Glass for Use in Asphalt
Concrete or Cement Treated Base

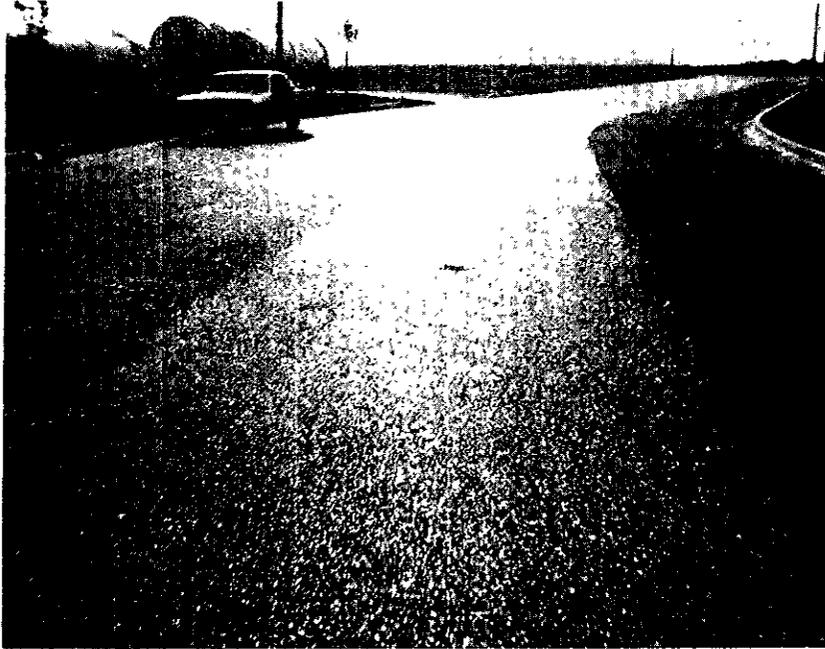
Photos Showing Glare on Glasphalt

The glasphalt pavement was visually inspected in January 1971, three months after construction. At this time, there was evidence of some raveling of glass from the mix by the presence of loose glass particles on the shoulders and in the gutters.

The glasphalt pavement was again visually inspected in April 1971. Prior to this inspection, the street had been hosed down and swept off. At the time of this inspection (about 5 P.M.) the street exhibited a definite glare (see attached photos). Close inspection showed that the asphalt had been removed from the top surface of the coarse glass asphalt. This removal apparently occurred during the aforementioned cleaning operation. A close inspection of the pavement also revealed that the coarse glass aggregate was fracturing and raveling in areas where vehicles were turning onto or off of the glasphalt. This would indicate that the glasphalt has low resistance to forces associated with turning and braking actions. This particular glasphalt street has had very little traffic and it is felt that considerable raveling might have occurred under even moderate traffic conditions. The portion of the street where glasphalt was only used in the base course is performing in a satisfactory manner and no distress is evident.
