Development and Crash Testing of a Bridge Rail Transition Barrier

RESULTS: Three bridge rail transition designs were developed and crash tested in an effort to meet National Highway Safety Research Program (NCHRP) Report 350 test level 4. Designs 1 and 2 failed due to excessive floorboard deformation to test vehicle and excessive deflection, respectively. Design 3 is recommended for operational use as a test level 4 transition for concrete bridge rails.

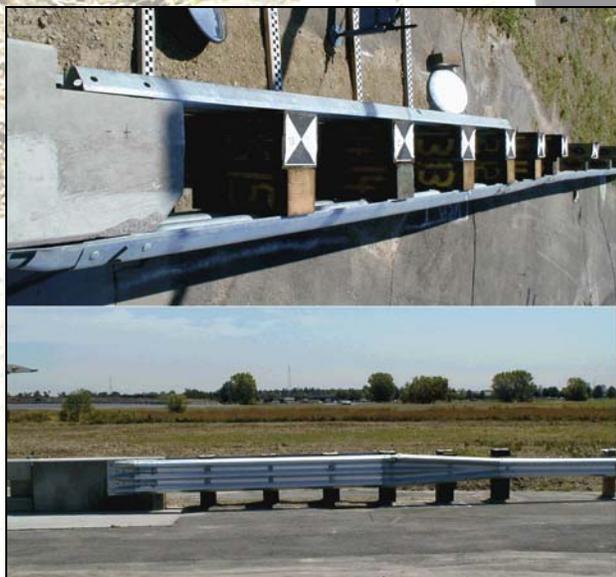
Figure 1 – Transition Design 3

The design of the transition underwent three iterations. The primary objectives for the design of each transition were: 1) Gradually increase the stiffness of the transition between the upstream W-beam guardrail and the concrete bridge rail, 2) Minimize pocketing potential for

NCHRP Report 350 stipulates that crash test performance is assessed according to three evaluation factors: 1) Structural Adequacy, 2) Occupant Risk, and 3) Vehicle Trajectory. Transition Design 3 rated acceptable in all these categories. For Structural Adequacy, there was some movement of the rail, and minor amounts of scraping and spalling of the barrier. For Occupant Risk, there were no signs of snagging or pocketing of the rail, as well as no sign of spalled concrete penetrating the occupant compartment of the vehicles. Finally Vehicle Trajectory, the test vehicle remained relatively straight after impact. Therefore, Transition Design 3 is recommended as an NCHRP Report 350 Test Level 4 transition for concrete bridge rails.

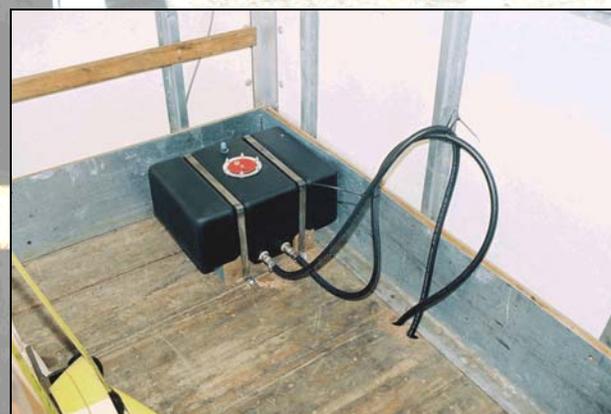
Figure 2 – Safety Fuel Tank in Cargo Area of Truck

In order to improve control and safety of test vehicles, additional modifications were implemented. The first modification was substituting a safety fuel tank for the stock fuel tank. Also, gaseous carbon dioxide was added to the stock fuel tank in order to purge the gas vapors and eliminate oxygen.

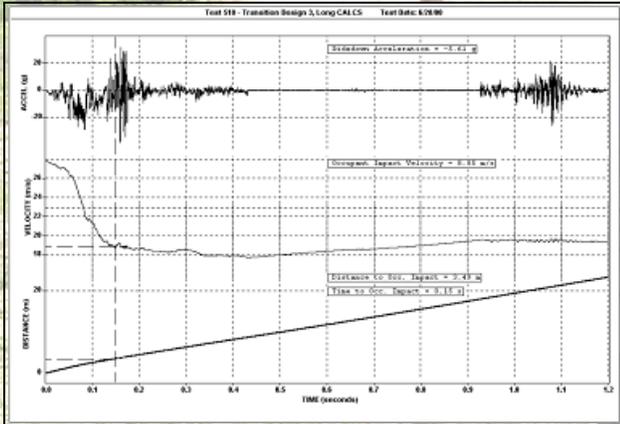
Figure 3 – Longitudinal Acceleration, Velocity, and Distance vs. Time for Test 518

With the use of accelerometers and integration, we were able to determine the acceleration, velocity, and distance vs. time of the test vehicles.

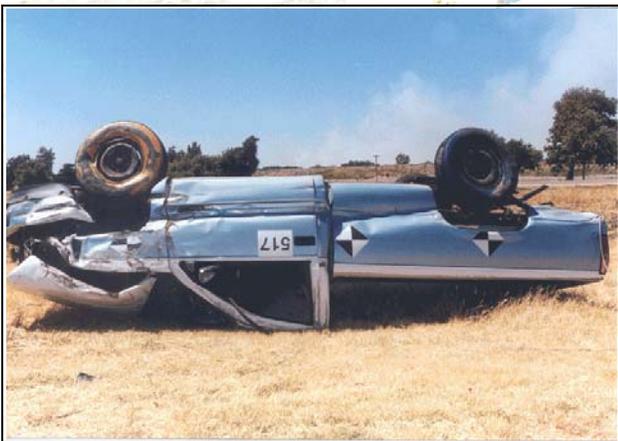
Figure 4 – Transition Design 2 Test Vehicle Post-Impact

The reactions during the testing of Transition Design 1 and 2 helped the designers to understand the design flaws. Transition 1 was a good starting point, but failed due to rail pocketing. Transition Design 2 solved the pocketing problem of the first design, but failed due to excessive rail deflection causing the test vehicle to roll over. Transition Design 3 was a success. The vehicle was smoothly redirected with no tendency toward pocketing of the rail, and vehicle damage was in the acceptable range for NCHRP Report 350 criteria.

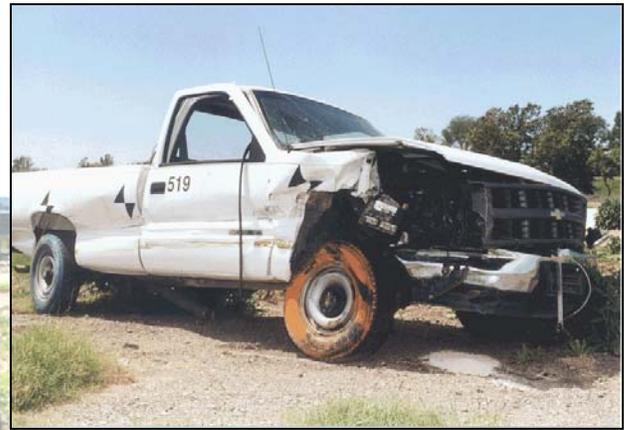
Figure 5 – Transition Design 3 Test Vehicle Post-Impact
