4. TITLE AND SUBTITLE
Evaluation Of Flexible Plastic Guide Marker And Clearance Marker Posts

RESEARCH REPORT

EVALUATION OF FLEXIBLE PLASTIC GUIDE MARKER AND CLEARANCE MARKER POSTS

INTERIM REPORT

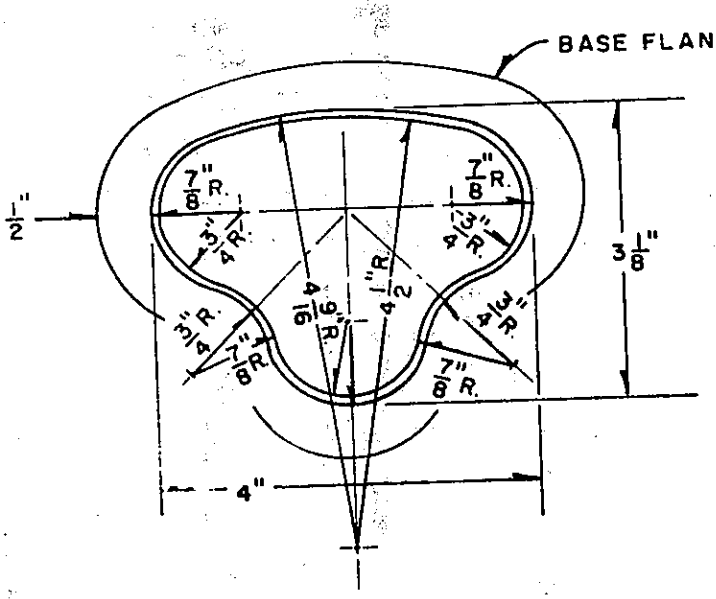
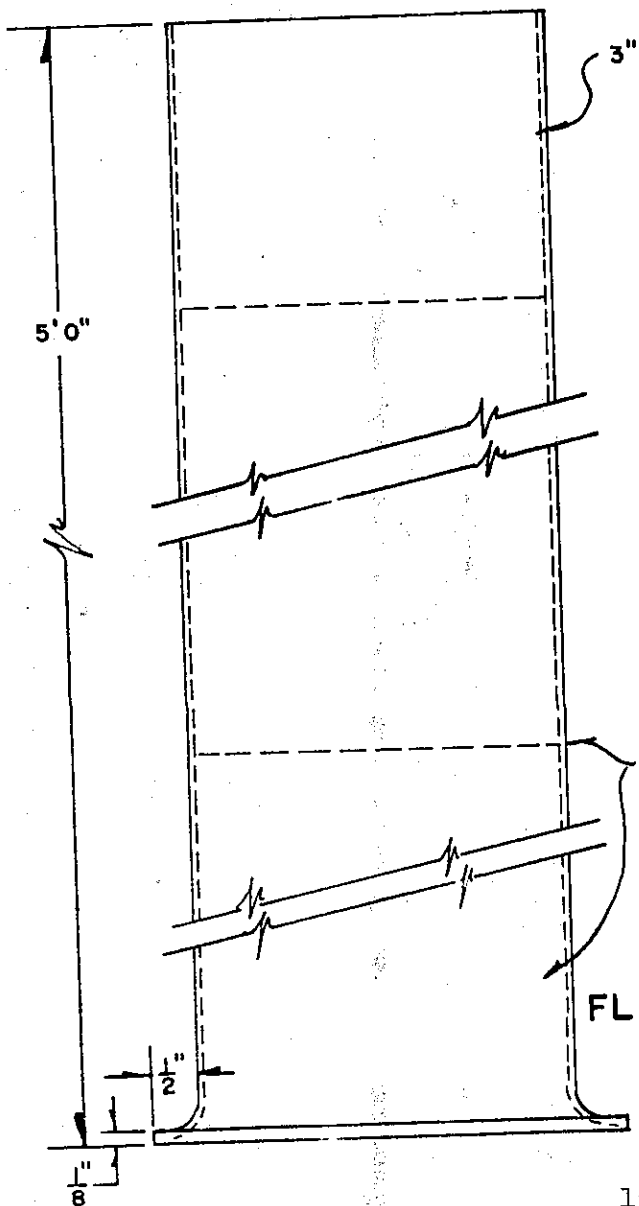
Figure 1

Both shapes of these guide marker posts were pulled out of the ground 1 to 3 inches after the 10 vehicular impacts. It is considered, however, that the anchoring system is adequate in restricting the pullout to the degree observed. The photos in Figures 1 and 2 show the amount of pullout as the distance the black line has been raised above the ground level.

The photo in the upper left corner of each figure shows one post before the first impact and the other three photos on the page show all three posts after 10 vehicular impacts. The reflective sheeting (Reflexite) on the post is damaged from the vehicular impacts and allowances must be made for replacement after a few impacts, even though in some cases the reflective sheeting lasted for the entire ten vehicular impacts.

It is recommended that the Autopost be considered acceptable on an interim basis. They are capable of complying to the requirements of the present specification for non-drivable flexible plastic guide markers. Even though our test series showed that the circular section guide marker would perform adequately with the omission of the bottom foam plug or other interior backfill, the manufacturer has not recommended installation without the backfill or foam. Therefore, this change is not recommended at this time.

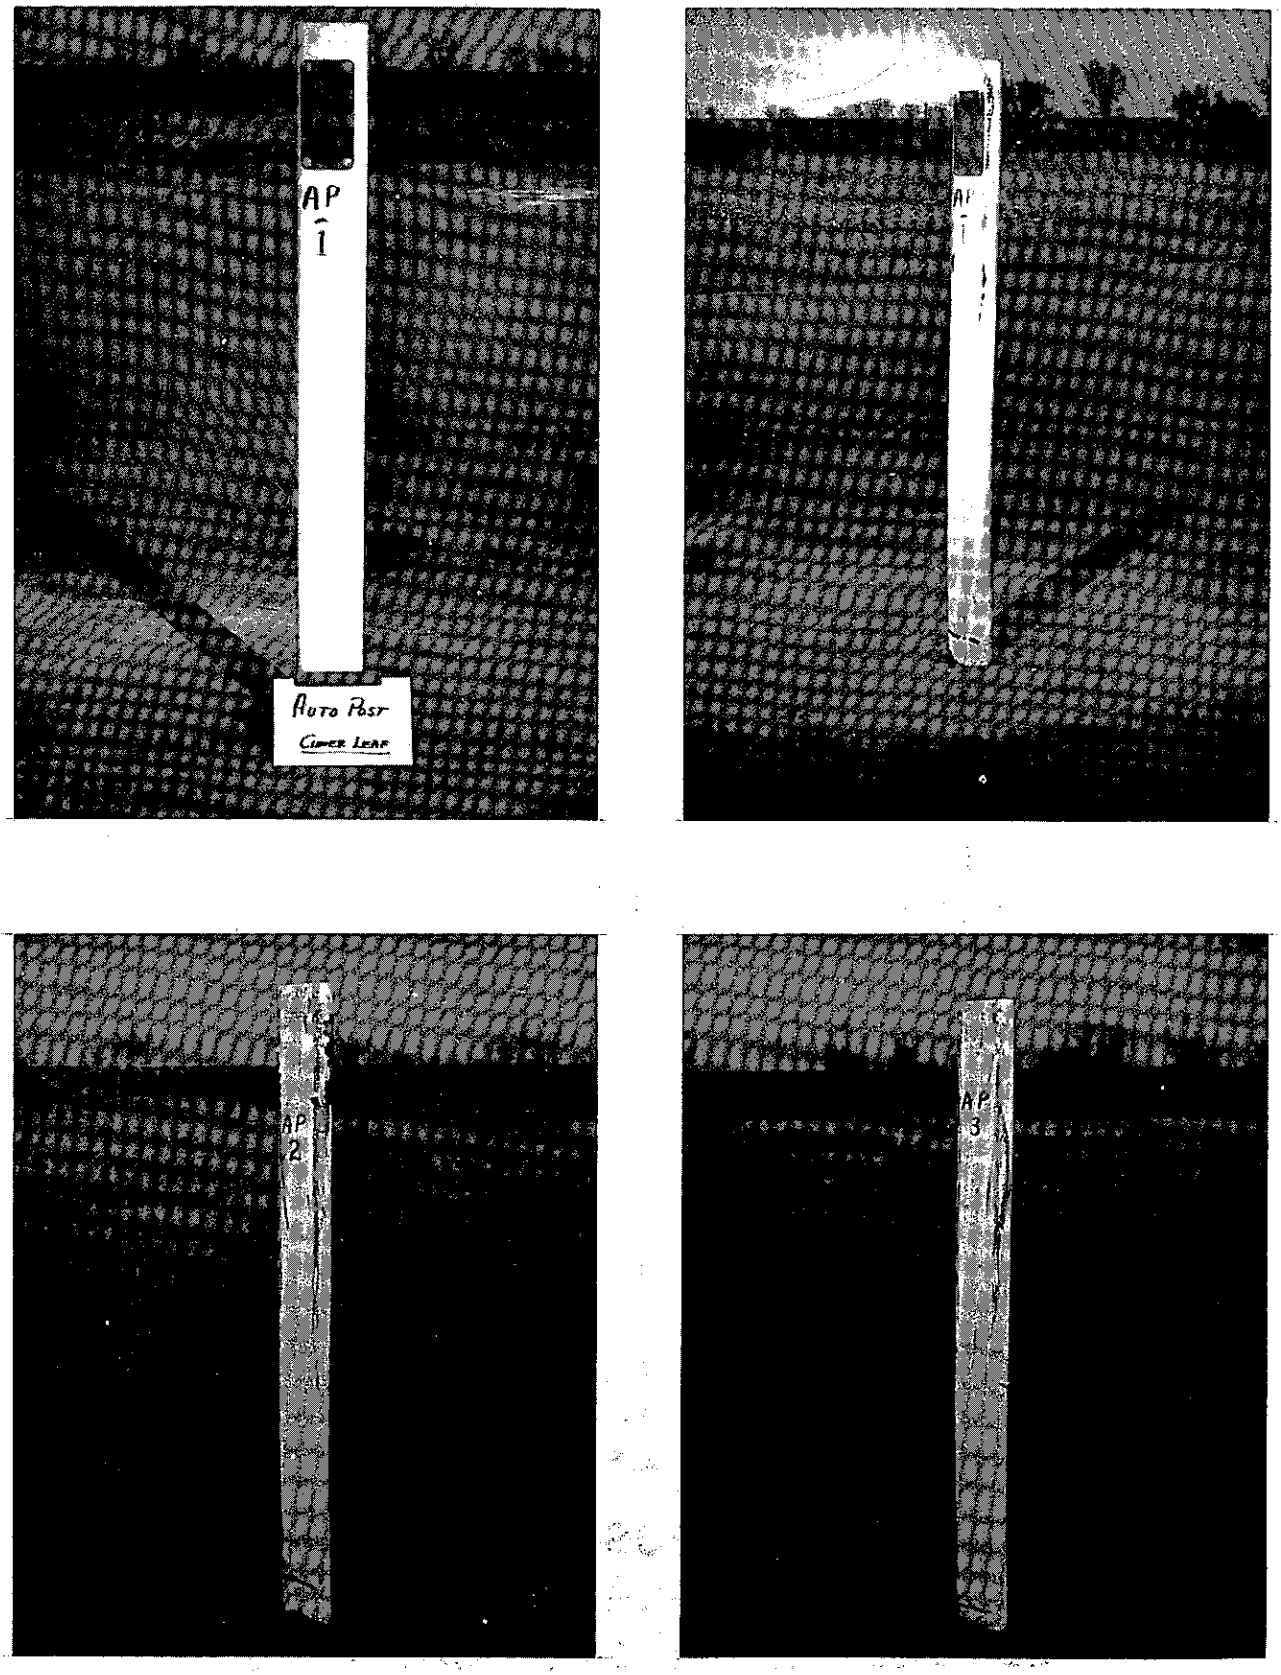
AUTOPOST - CLOVERLEAF POST Figure 2

AUTO POST
"CLOVERLEAF"
FLEXIBLE PLASTIC GUIDE MARKER &
CLEARANCE MARKER POST

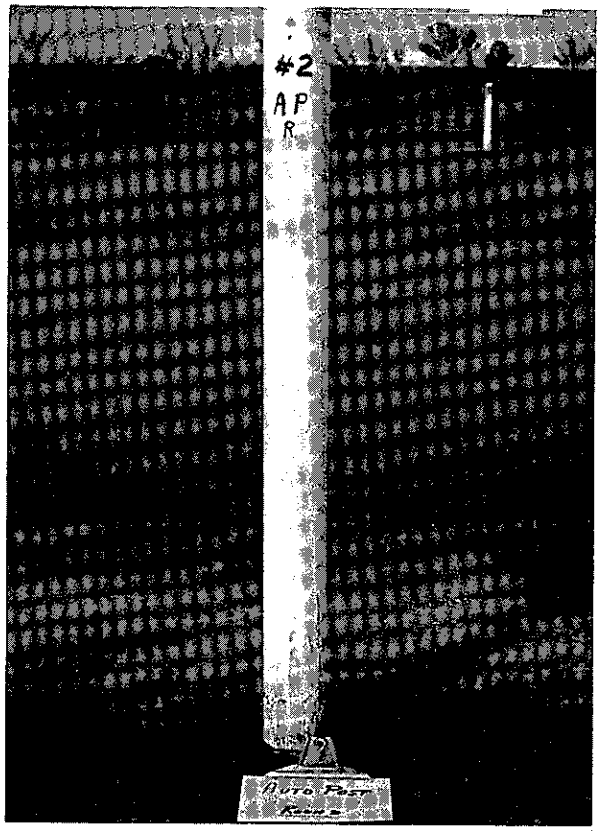
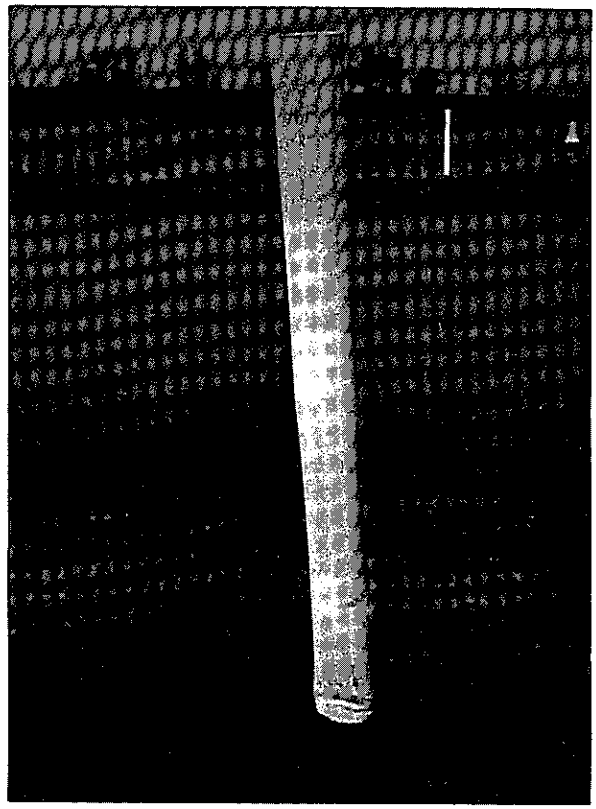
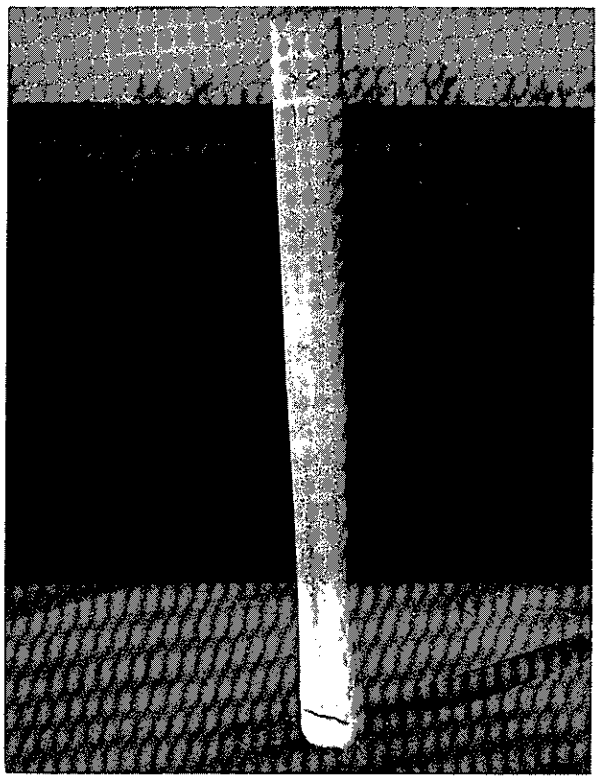
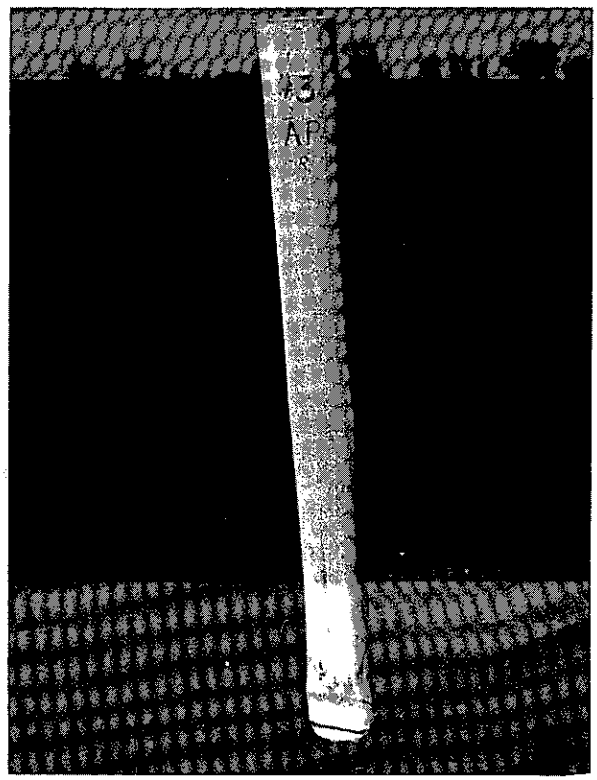
The foam plastic plug placed in the top of these guide marker posts dislodged and was knocked out on the first vehicular impact. However, the guide markers performed very adequately without the top foam plug for the remaining impacts.

The amount of vehicular damage when striking these guide markers at 55 mph is considered very minimal. No apparent damage was detected on the vehicle from any of these encounters. The damage to the three posts tested in each shape was also considered minimal.

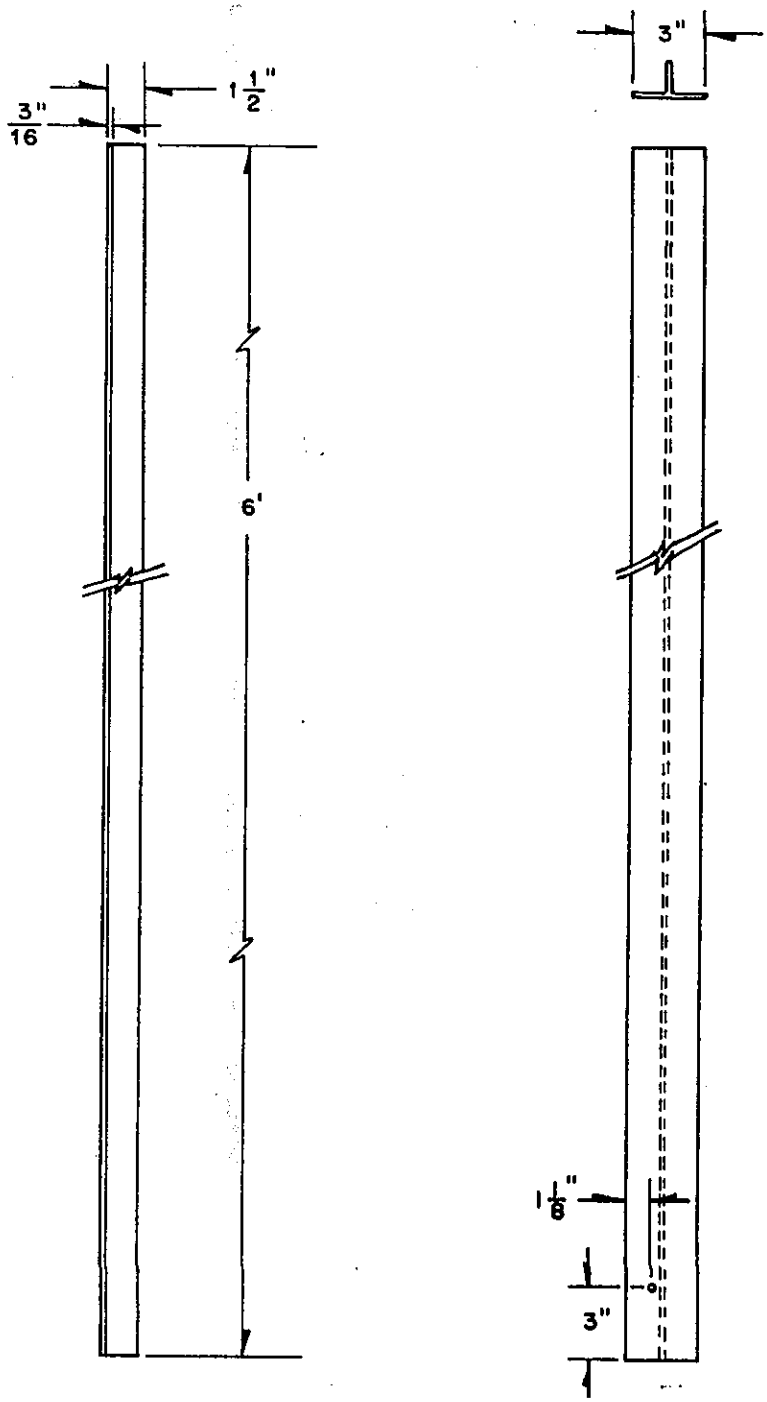
LANCO "TEE"
FLEXIBLE PLASTIC GUIDE MARKER &
CLEARANCE MARKER POST

There was little or no damage to the vehicle from any of the 55 mph impact tests. The guide marker post tended to return to an approximate vertical position after each impact with a pullout of 0 to 1/2" from the ground. After the first vehicular impact the marker canted 5 to 20° from the vertical. After 10 impacts the post approached a canted position of 30° from the vertical. During the vehicular impacts the post developed an S-shaped curve as can be seen in one of the photos. It is considered that this shape and appearance would not be acceptable even though the marker returned to a semi-upright position. Due to this deformed shape, this marker is not considered acceptable.

It is recommended that no further testing be performed with this specific Lanco T-post design as a flexible guide marker post. Its performance does not compare with the other flexible guide marker posts being evaluated.

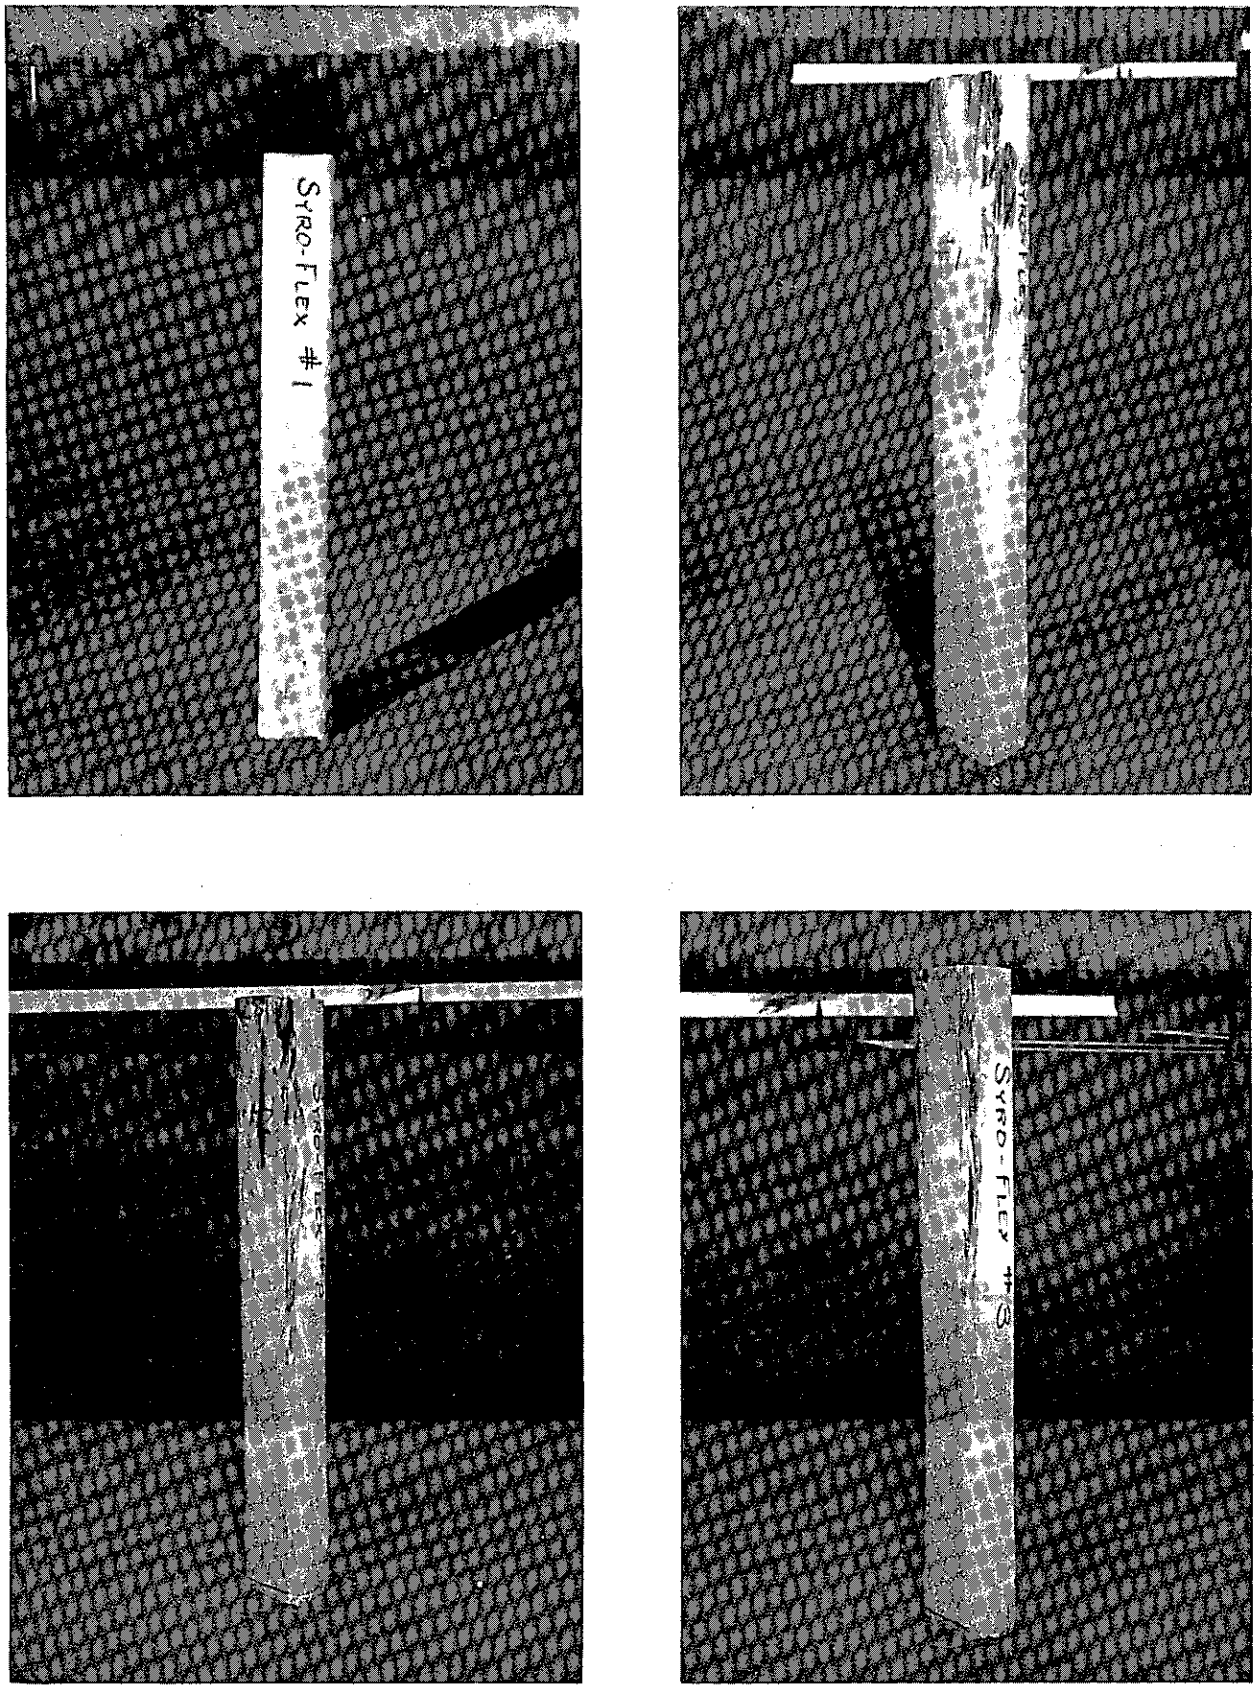
On February 14, 1977, the Syroflex guide marker post was tested with 10 vehicular impacts. This guide marker post had previously been tested and approved by Caltrans and there are many installations throughout the state. It is fabricated from a flexible white plastic and has an isosceles triangle cross section. The long sides of the isosceles triangle are approximately 4 3/4" and the short sides approximately 4" wide. The side facing the traffic consists of one of the long legs of the triangle. See Figure 7 for details of the Syroflex post. This guide marker post is a non-driveable type; a hole has to be provided in the ground to install the guide marker, the interior of the marker requires backfilling. A black cap is provided by the manufacturer to cover the top and keep water and debris out of the interior of the post. This post is shown in the photos in Figure 8.

This guide marker post was able to withstand the 10 vehicular impacts at 55 mph and satisfactorily return to a vertical position, as was found in earlier tests and evaluations. The black cap cover on the top of the post was knocked off on the first vehicular impact. The upper left photo in Figure 8 shows one of the three posts tested before the first vehicular impact and the other three photos show all three posts after the 10 impacts. The damage to the vehicle from the impact was minimal. The damage to the posts was also considered minimal. The anchoring system for this guide marker was satisfactory with only 1/2" to 1" pullout from the ground after the 10 vehicular impacts.

It is recommended that further installations of this marker post be forestalled until suitable evidence is developed or obtained which would attest to its long term serviceability.

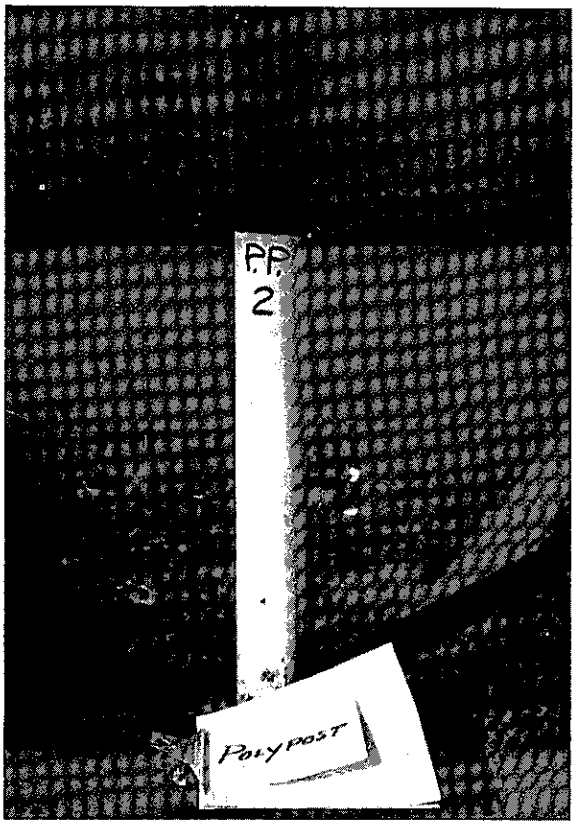
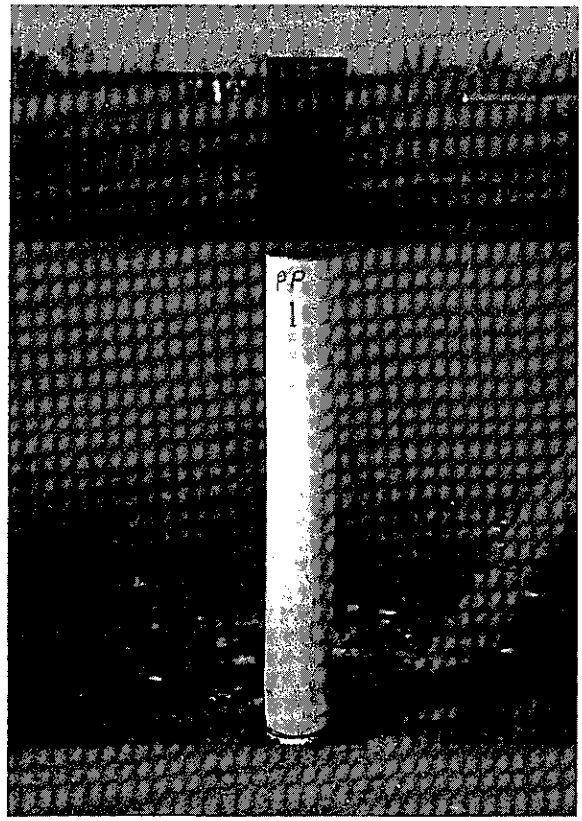
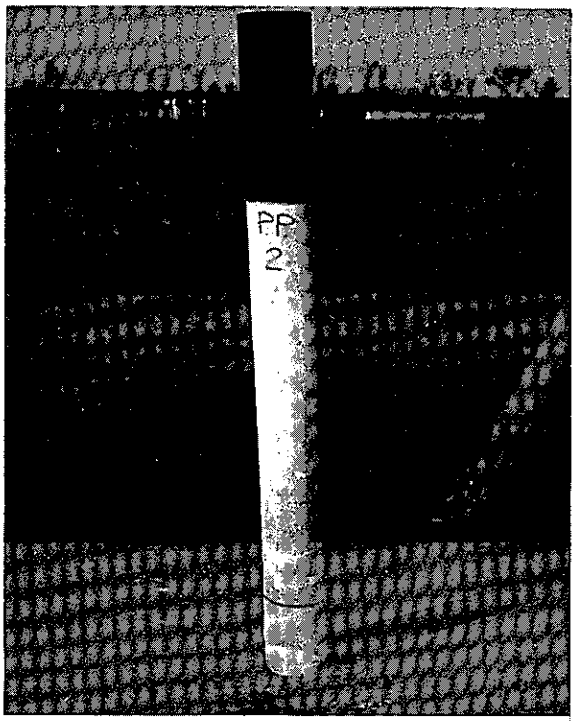
The second series of tests was conducted to verify the manufacturer's claim that the post would perform satisfactorily without interior backfilling. This installation was not successful. The guide marker post failed to return to vertical when the interior backfill was omitted.

There was slight or no damage to the vehicle from the 55 mph impact into this backfilled guide marker post. The post was able to withstand the 10 vehicular impacts and return to a vertical position with little or no apparent damage. Care must be taken to insure the backfill is tightly compacted for this post as anchorage depends entirely on the friction between the post and the soil. Two of the three posts pulled out of the ground 4" to 6" from the impacts. The third post pullout was very minimal. Approximately 1/2" or so. It was found during the second test series that the post would not

It is recommended that this post be considered acceptable at this time and further evaluated by trial field installations to be monitored for long term serviceability and general performance. Our present specification for non-driveable flexible guide markers is appropriate and should be used in specifying the Polypost guide marker post.

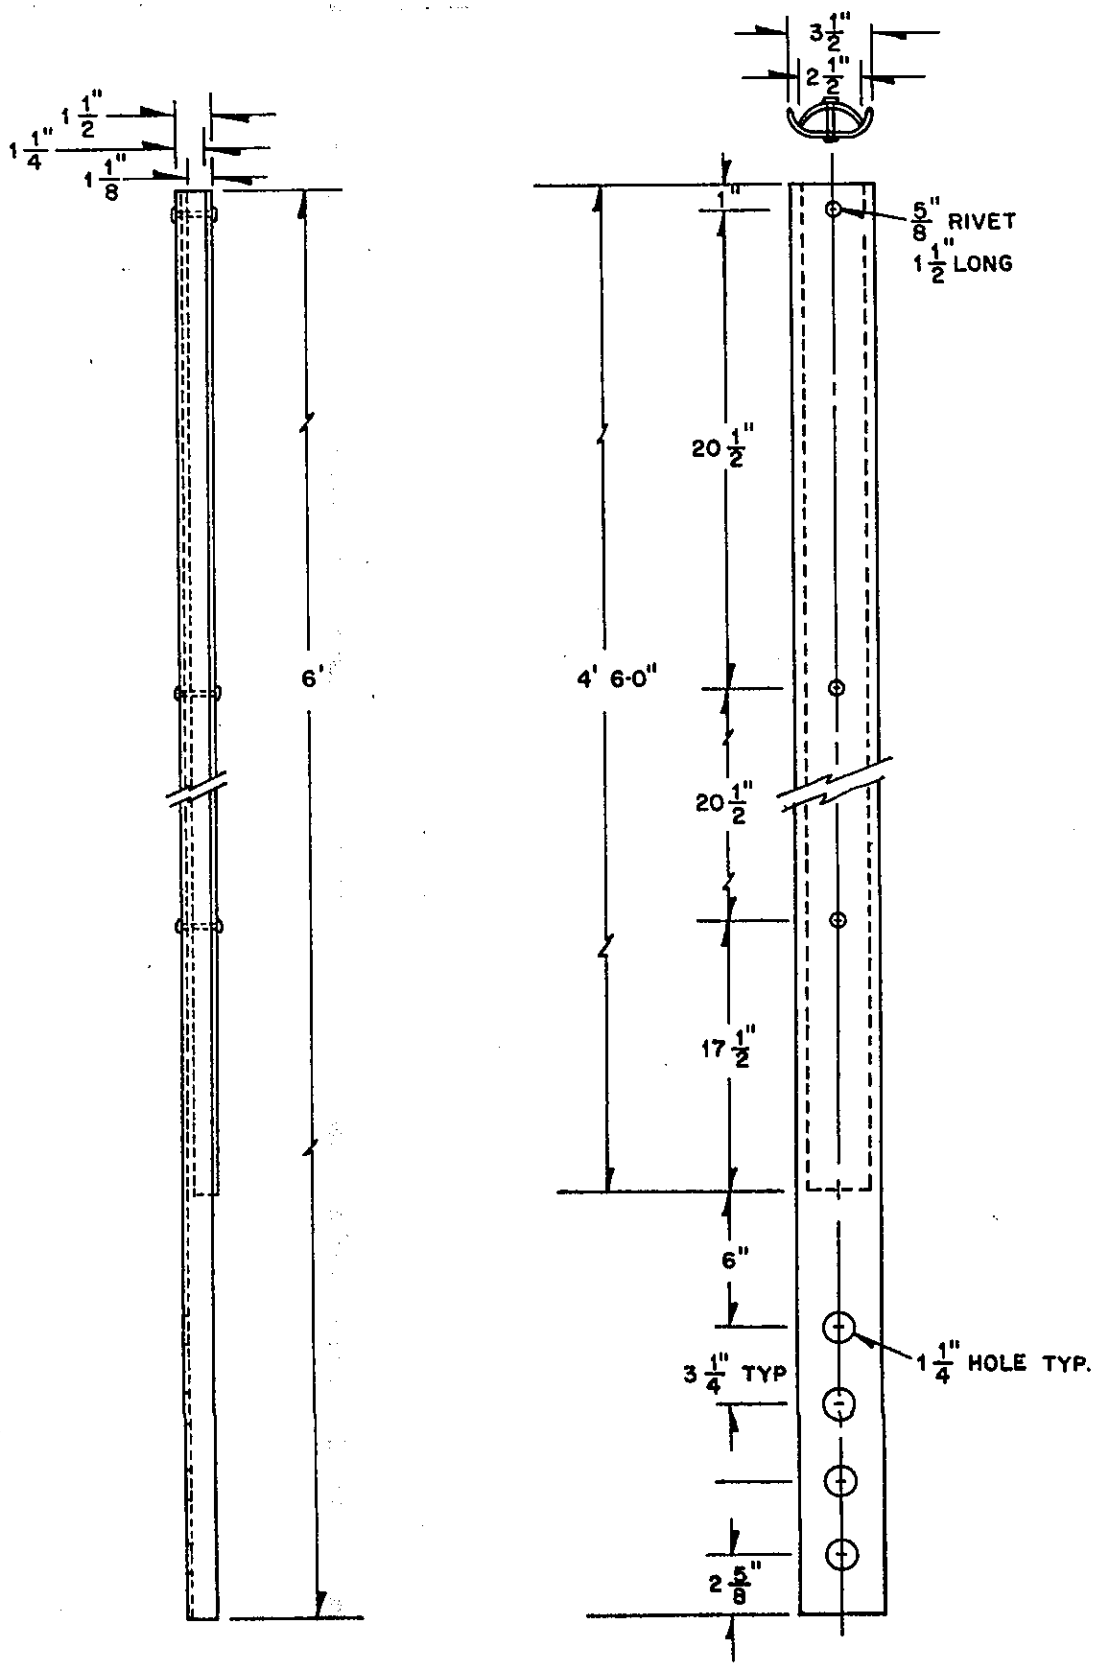
Figure 11

The Guardian flexible guide marker post was tested on April 29, 1977, for its ability to withstand repeated vehicular impacts at 55 mph. This post is fabricated of a relatively hard but flexible polycarbonate plastic. The manufacturer claims that ultraviolet light inhibitors have been incorporated into the plastic which assures little or no affect from ultraviolet light and claims it to be durable in weathering with a long predicted service life. The guide marker has a 3 1/2" face and is constructed by two pieces which are riveted together as shown in Figures 11 and 12. The two pieces work together in providing the required stiffness to maintain a stable vertical member. The manufacturer indicated that this is a semi-driveable flexible guide marker post which would require a special spade or tool to make a pilot hole in the ground first to drive it into the ground. We did not develop a means of driving this guide marker in place in this study and therefore classify it as a non-driveable type. This guide marker would not require interior backfilling.

"GUARDIAN"

It is recommended that no further evaluation than mentioned above be conducted on this post unless design changes are made.

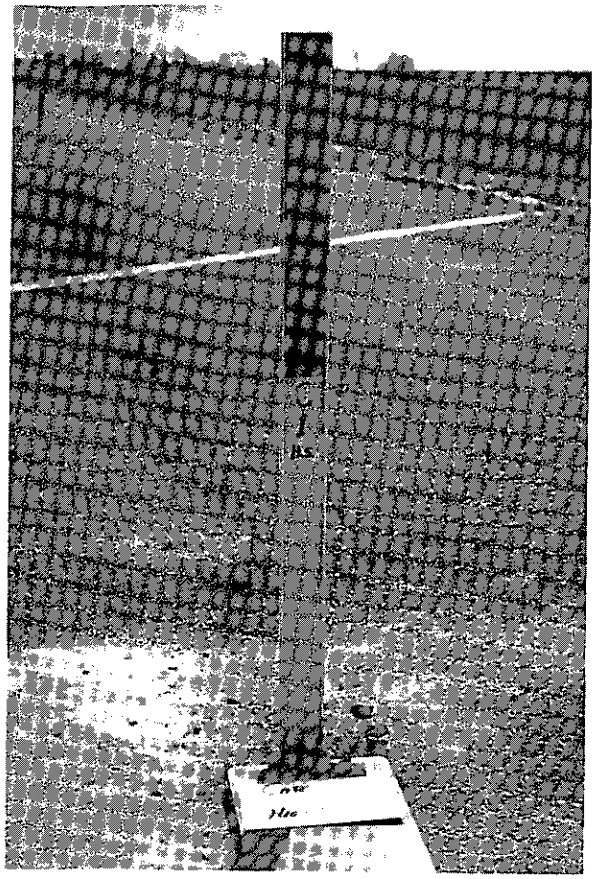
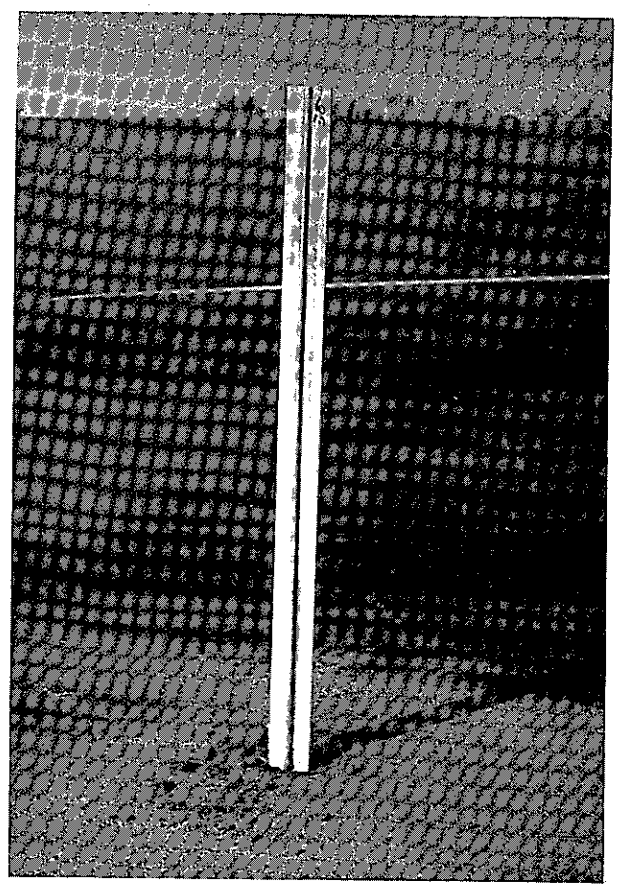
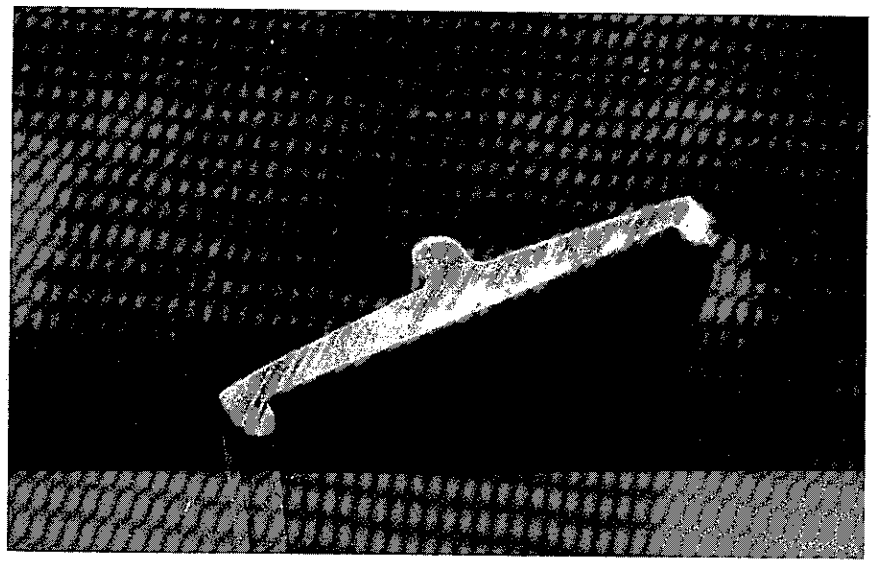
Figure 17

The initial test on the 2 1/2" wide ribbed flexible guide marker post, which the manufacturer claimed could withstand the higher impact speed of up to 55 mph resulted in a post failure at that speed. The impact sheared the post off at the ground level as shown in photos in Figure 17. However, when the

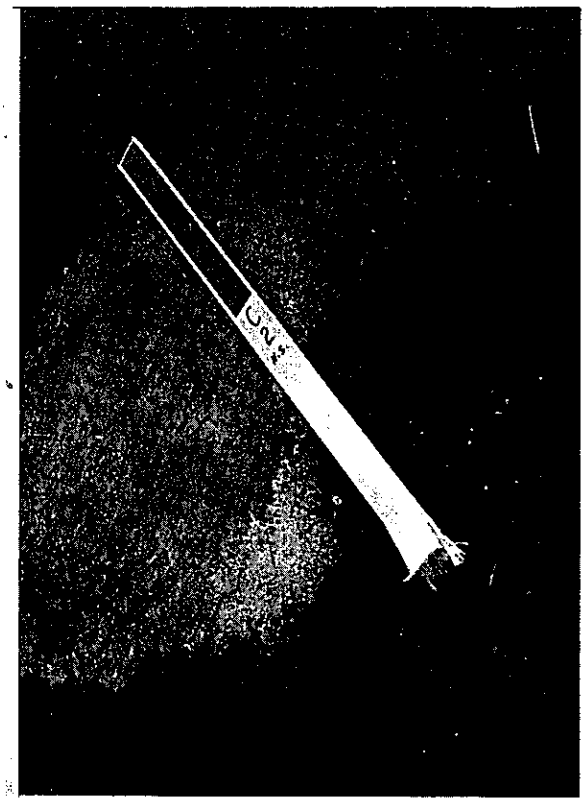
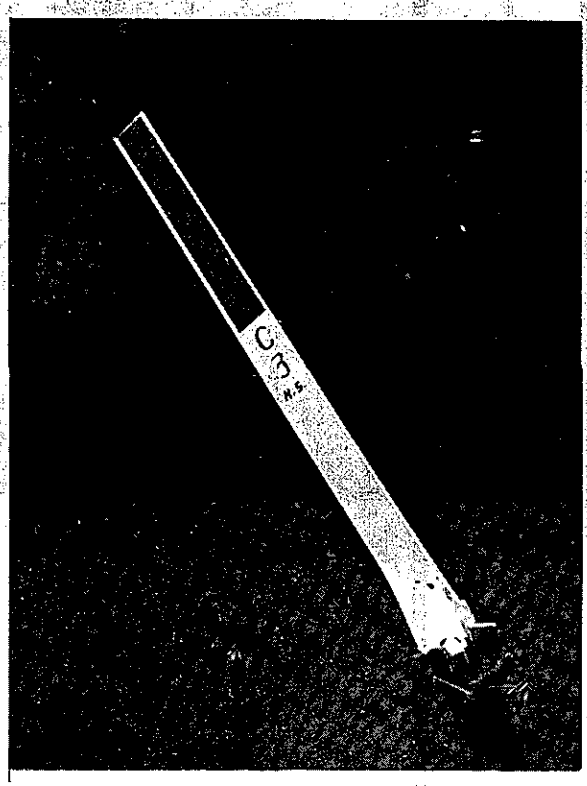
Figure 18

The upper right picture shows the appearance of the top of the ribbed post after 10 vehicular impacts. The first impact was at a speed of 35 mph. The subsequent 9 impacts, after the plastic hinge had been developed in the lower speed impact, were at 55 mph. Even though the post was still standing vertically, we would consider its frayed end condition unacceptable. However, in the first 5 impacts, there was no appreciable fraying or separation of the component parts of the post as developed in the next 5 impacts.

From the impact testing performed to date on the flexible delineator post, it appears that for the post to withstand 55 mph impacts without failure, a plastic hinge must be developed in the post at ground level. This can be accomplished by bending the post to the ground by a slow speed impact or other effective methods. Thus the installation instructions should include the requirement for a radius in the soil or other supporting material at the post-surface interface, and in addition the development of a plastic hinge in the post at the same location.

It is recommended that the latest design of the Carsonite post be considered acceptable for trial installations and further recommend that installation of the posts be monitored for a period of time to determine their performance and identify problems associated with them. A suggested specifications for driveable flexible plastic guide marker and clearance marker posts is attached.
