Evaluation Of A Shoreline Erosion Control Project

December 1973

Transportation Laboratory
California Division of Highways
Sacramento, California 95819

Interim 1971 thru 1973

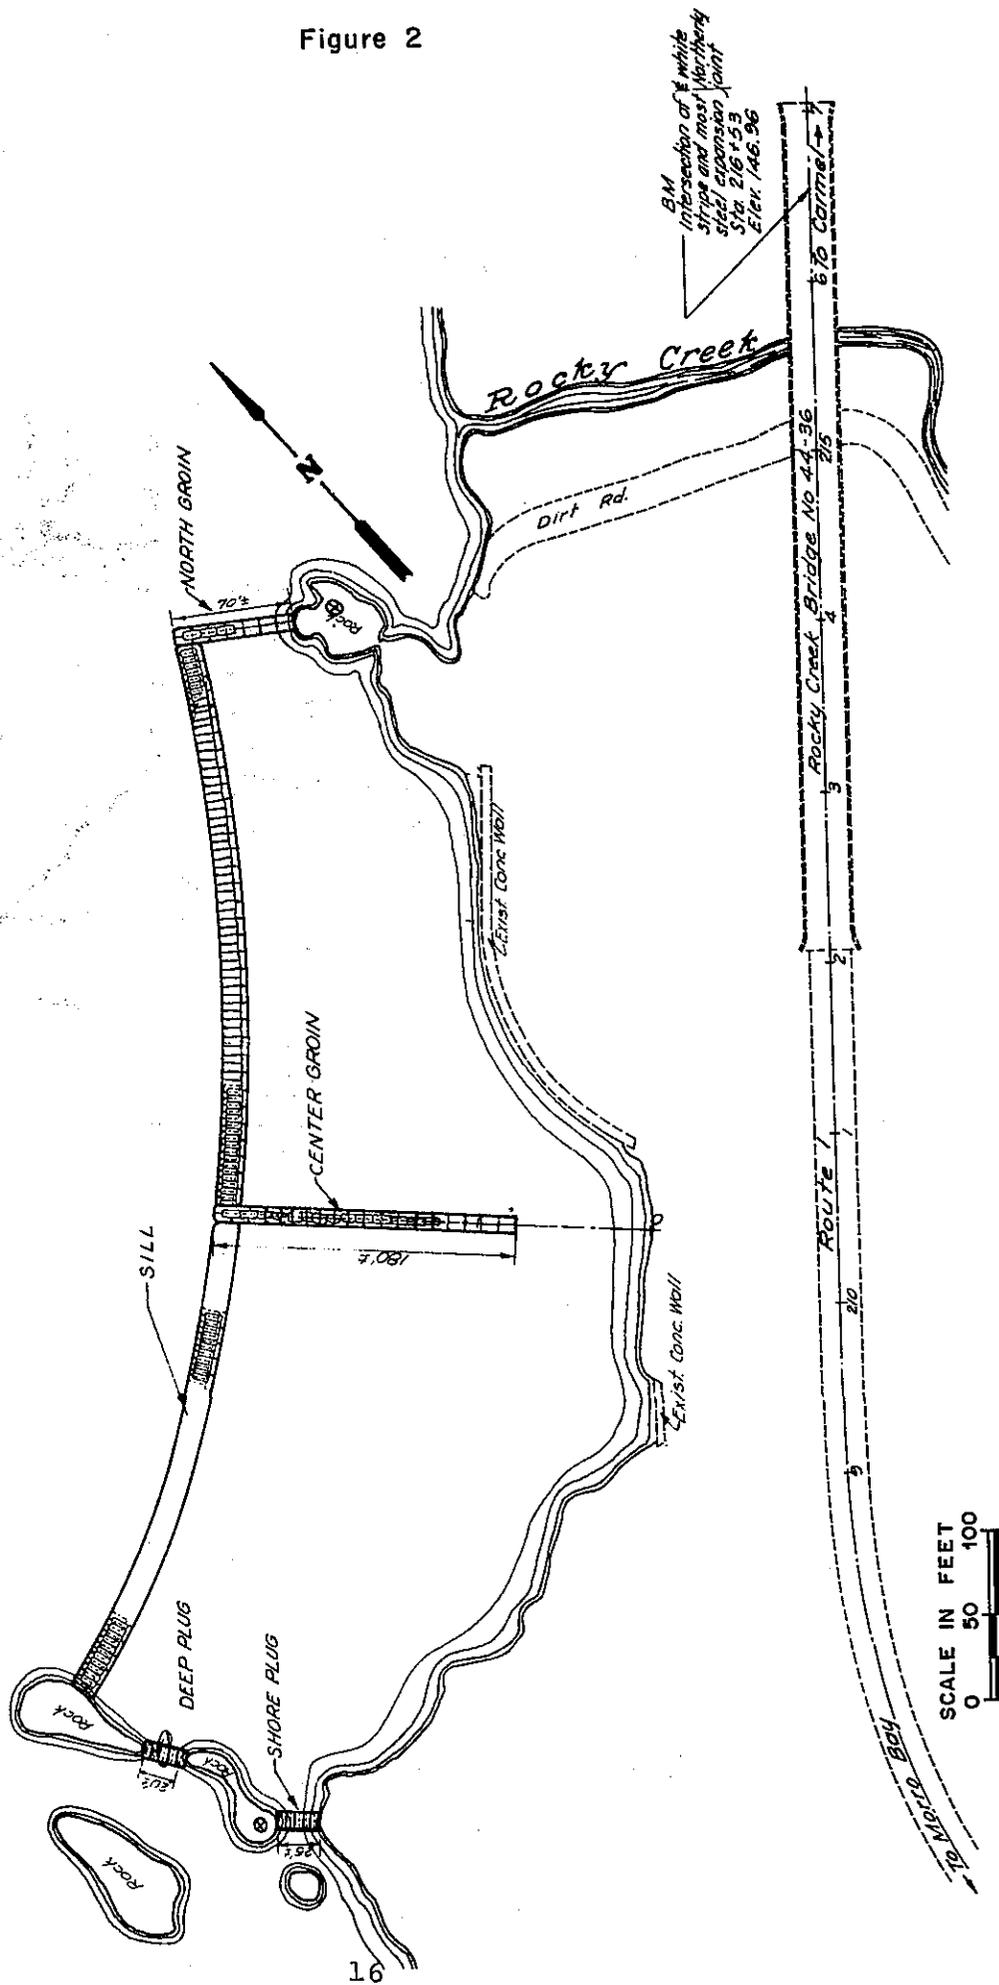
Figure 2

Because of their previous experience, Erosion Control West was invited to inspect the site and, if the proposed sill and groin sandtrap appeared feasible, submit a proposed design. Representatives of Erosion Control West and Erosion Control, along with a private coastal engineering consultant did conduct a field review. They concluded that the proposed project was feasible and submitted the design shown in Figures 2, 3 and 4.

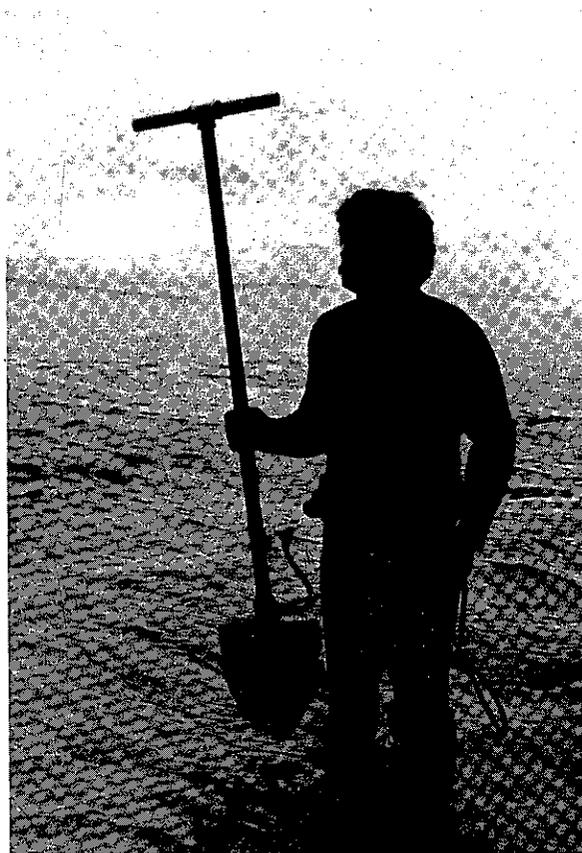
Plate 7 - Anchor Spade

Various anchoring systems were tried. The most successful was a specially constructed spade which would become more firmly planted the greater the force applied. Plate 7 shows one of these anchor spades. The bags must be held firmly in place in order to achieve a uniform and constant elevation for the top of the sill and groins. Because the bags draw in from the original five feet by ten feet size as they are filled it is necessary to place them carefully and hold them securely so that no gaps occur to permit a loss of sand.
