DESIGN INFORMATION BULLETIN No. 83 - 02
CALTRANS SUPPLEMENT TO FHWA CULVERT REPAIR
PRACTICES MANUAL

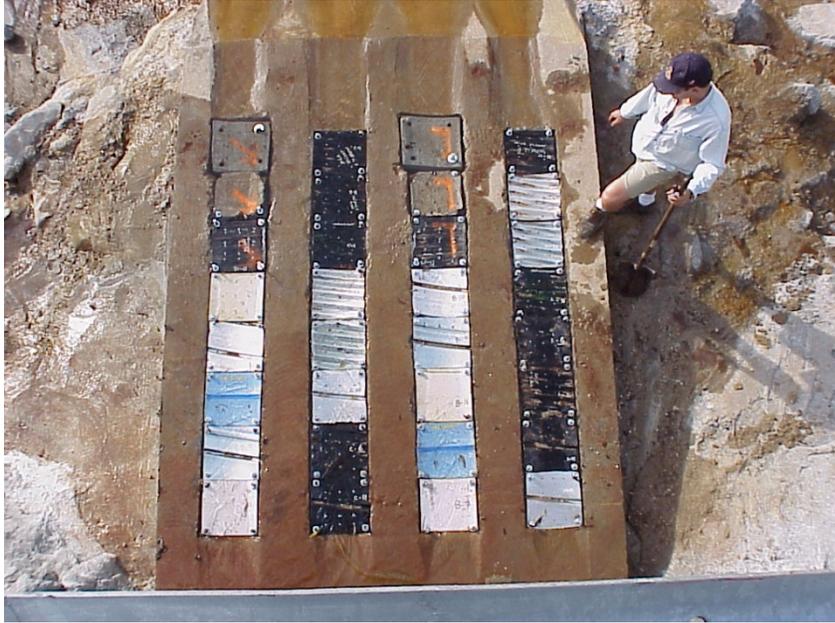
Caltrans abrasion test panel installation showing various culvert materials and coatings

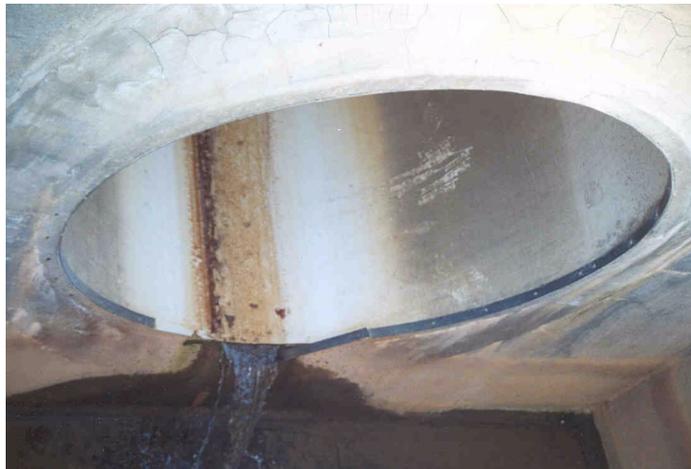
Example Polyvinyl Chloride (PVC) Lined RCP using T-Lock™
Polyvinyl Chloride (PVC) sheet liners manufactured by Ameron
Protective Linings Division

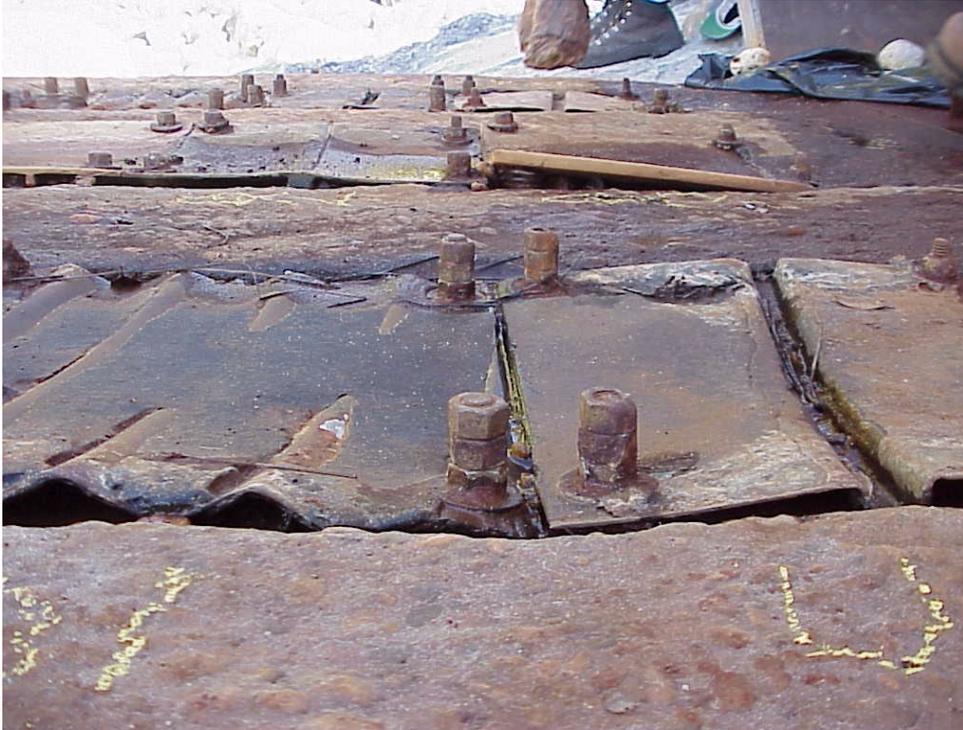
Various culvert material test panels shown above after 1 year of wear at site with moderate to severe abrasion (velocities generally exceed 10 ft/s, see table next page). Note the significant wear to abrasive resistant protective coatings, which, would typically not be recommended under these conditions (see table next page). The bed load material composed of 90% quartz sand. Also note the wear on the leading edges (right) of the steel nuts.

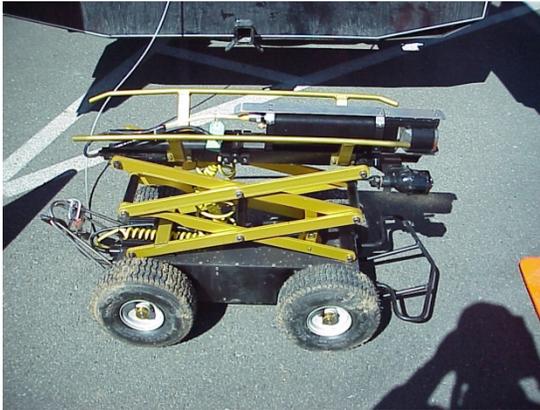
For long pipes 24 inches or smaller in diameter, it will probably be necessary to perform an inspection of the barrel with a remote controlled video camera. All Districts have a remote camera.

Remote controlled camera Vehicle

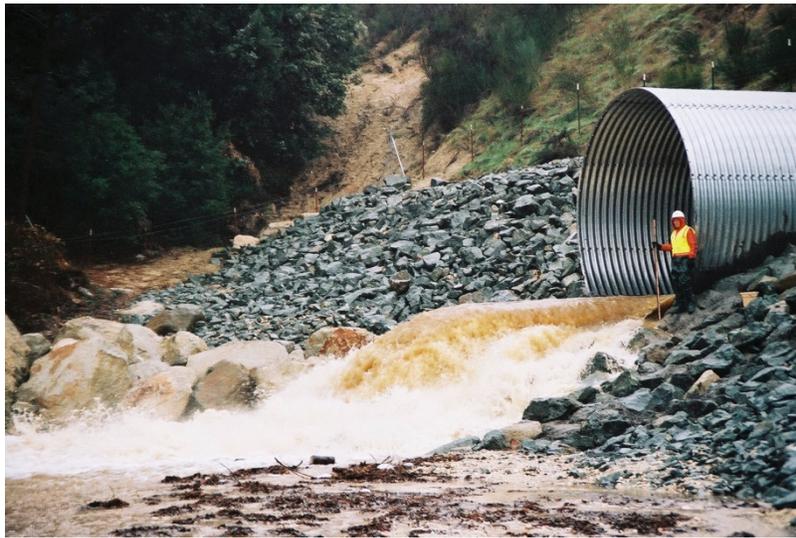
Energy dissipator plunge pool and bank protection at large diameter culvert outlet

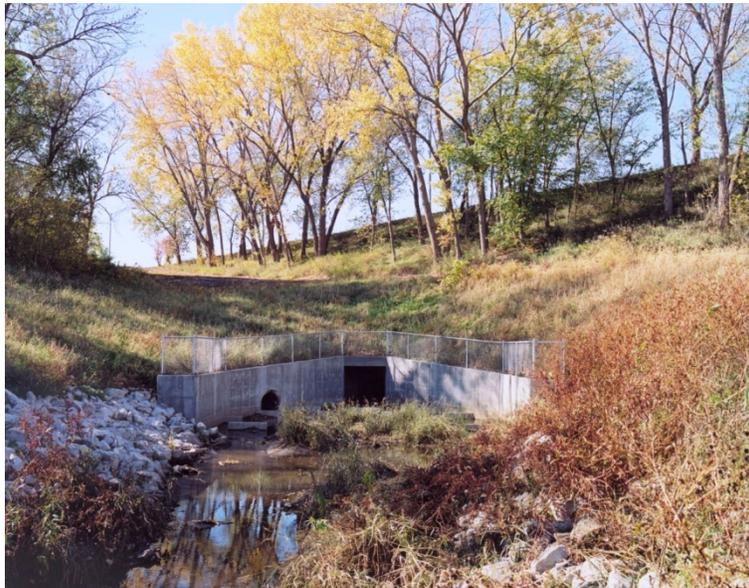
Energy dissipator with flared wingwalls and bank protection

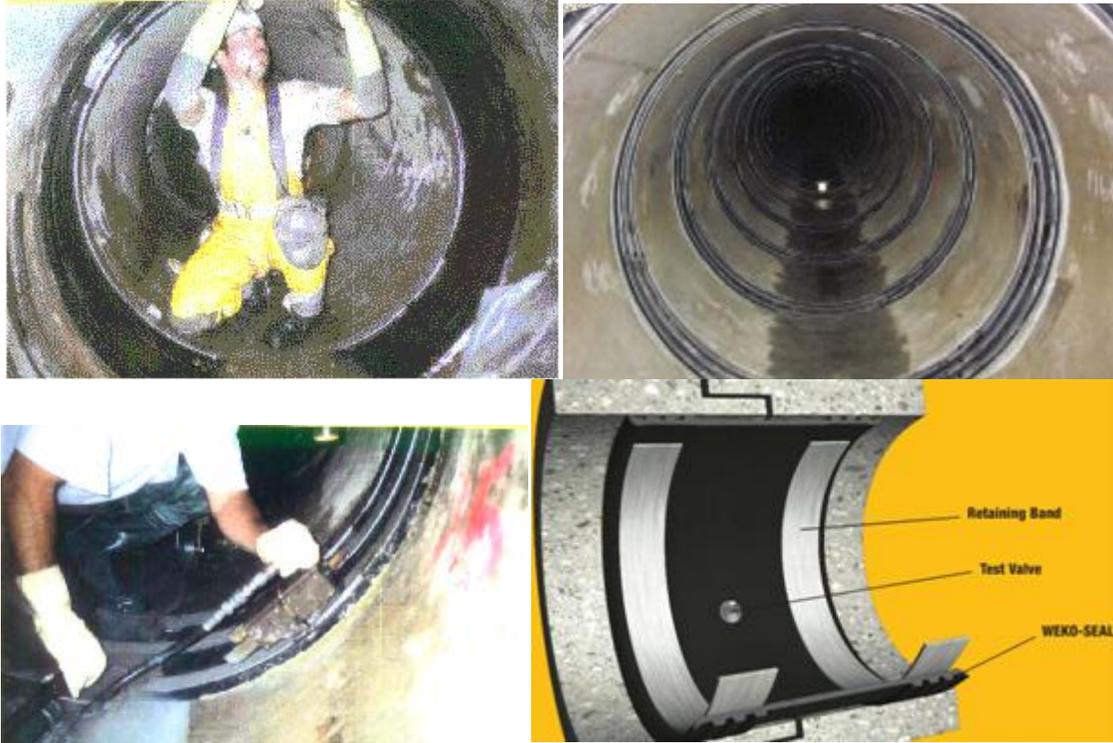
AMEX-10/WEKO-SEAL Internal Joint Sealing System examples above (Courtesy of Miller Pipeline).

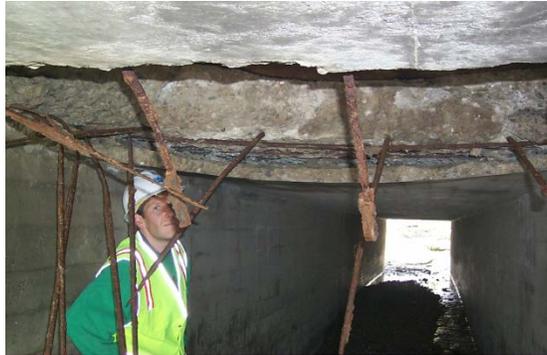
Failed crown in Reinforced Concrete Box Culvert

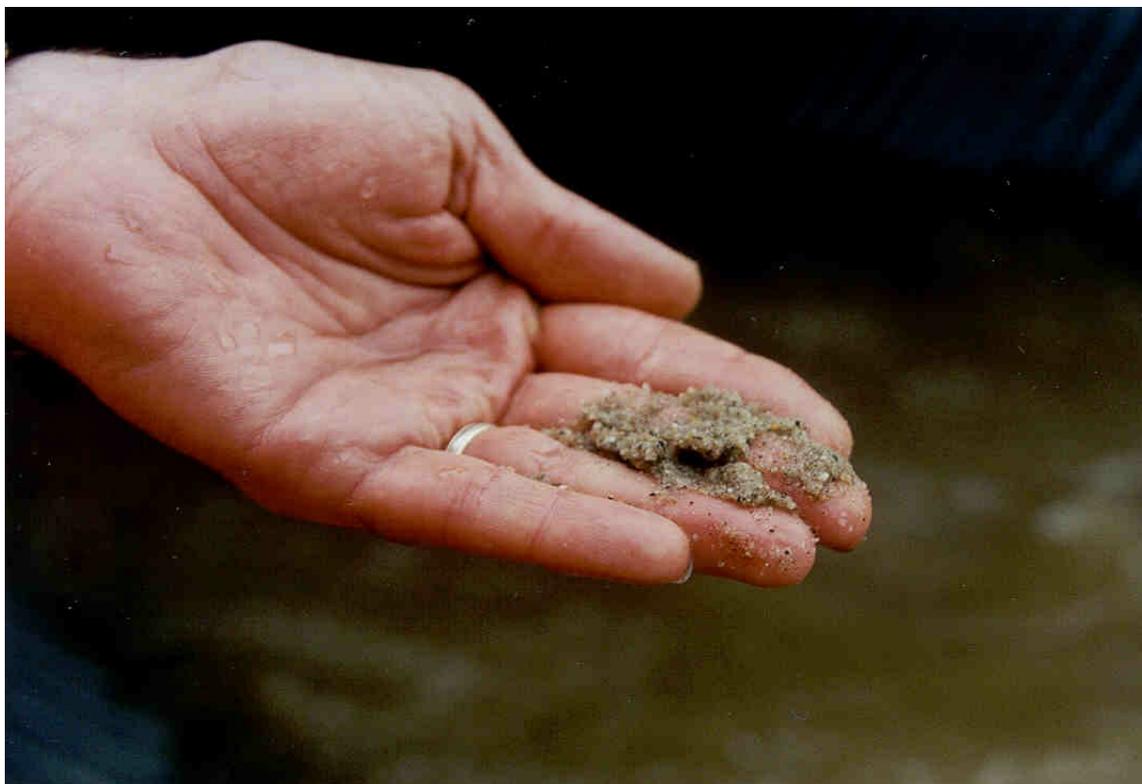
Example of abrasive, angular, quartz – sand bedload

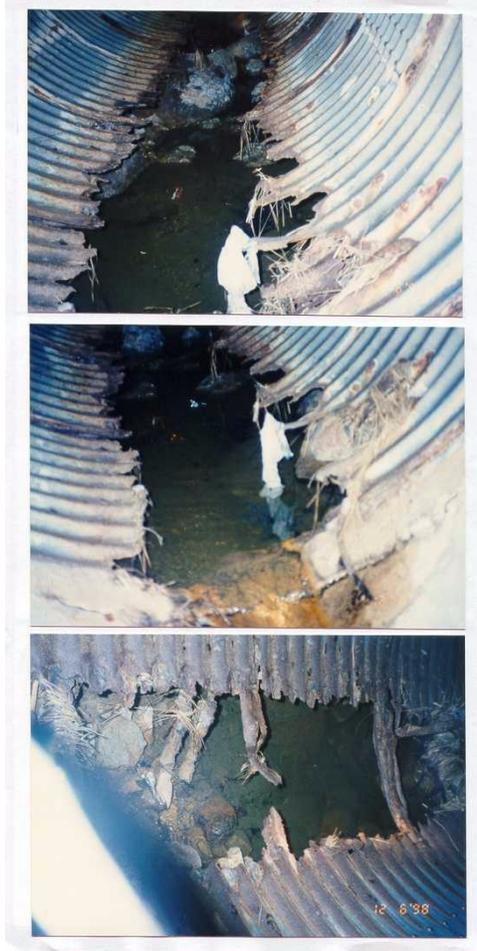
Corrosion that attacks the bare steel is accelerated by abrasion

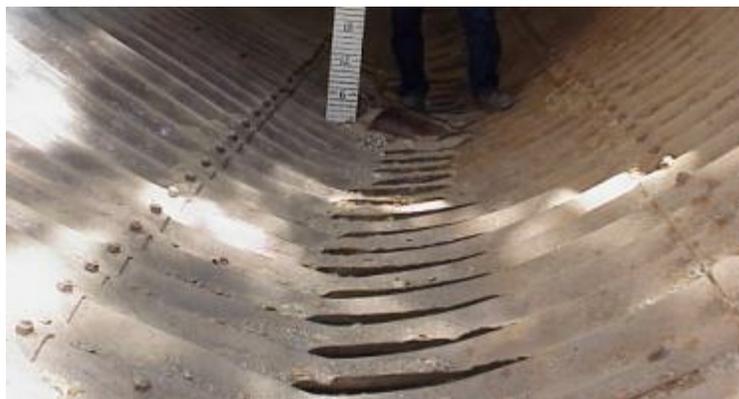
Worn invert on leading edge (to flow) of corrugations

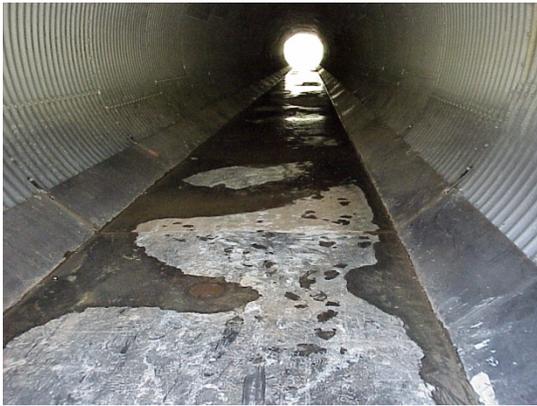
Finished 0.375-inch thick steel plate invert

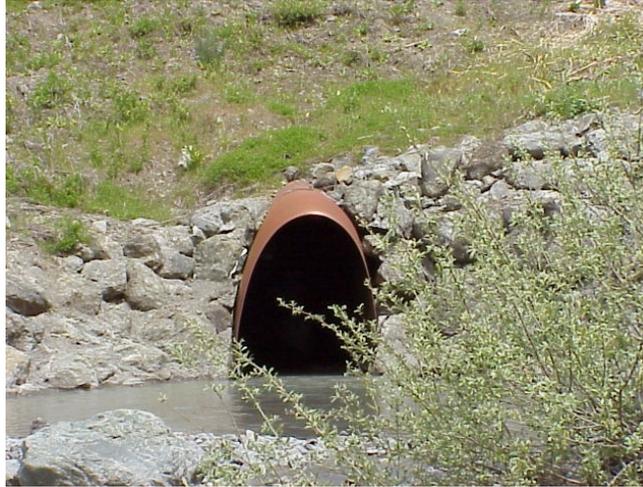
Example of shape distortion caused by soil movement

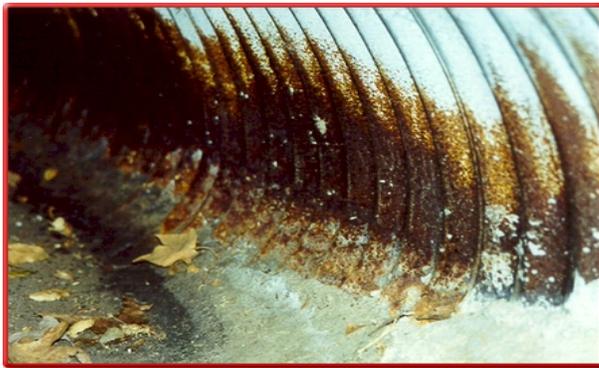
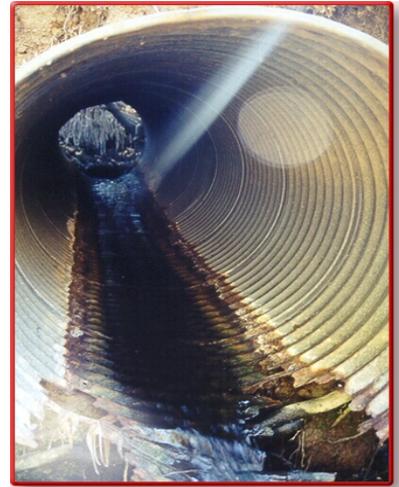
Corroded steel pipe examples.

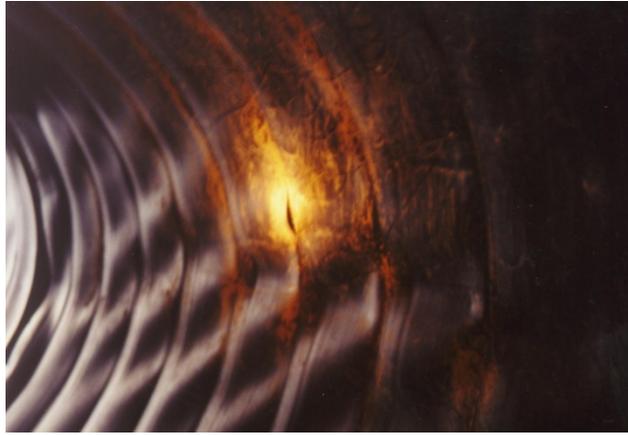
Small crack and wall rippling

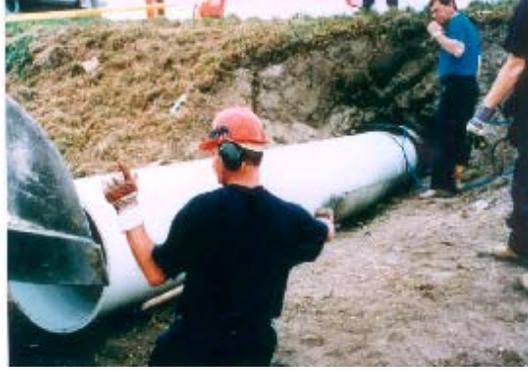
Inserting a PVC slipliner

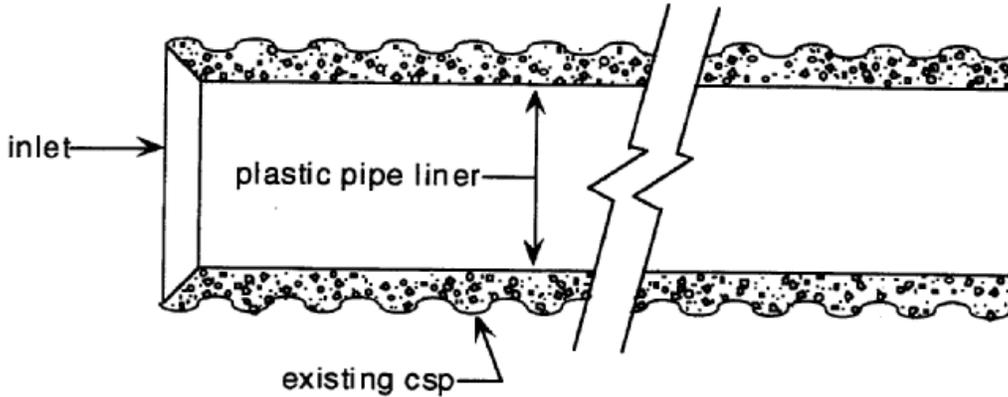
Grouting of annular space between inserted pipe and culvert.

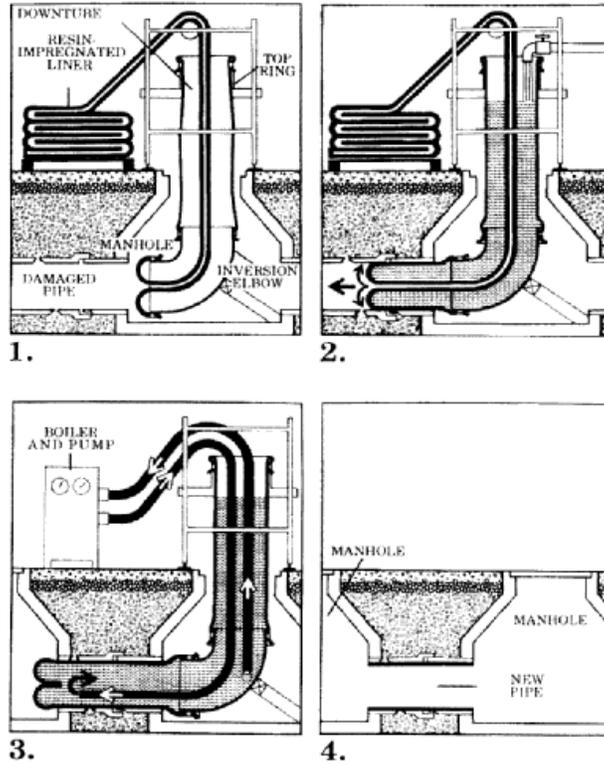
Typical inversion tube insertion process.

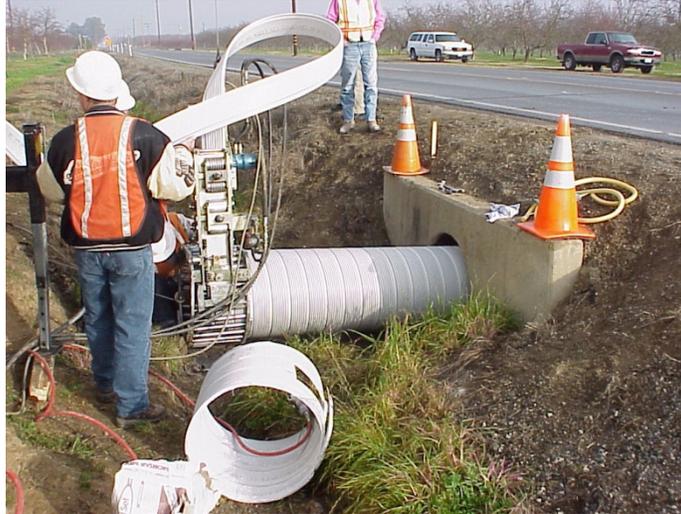
Rib Loc Expanda Pipe™ lining system example shown above

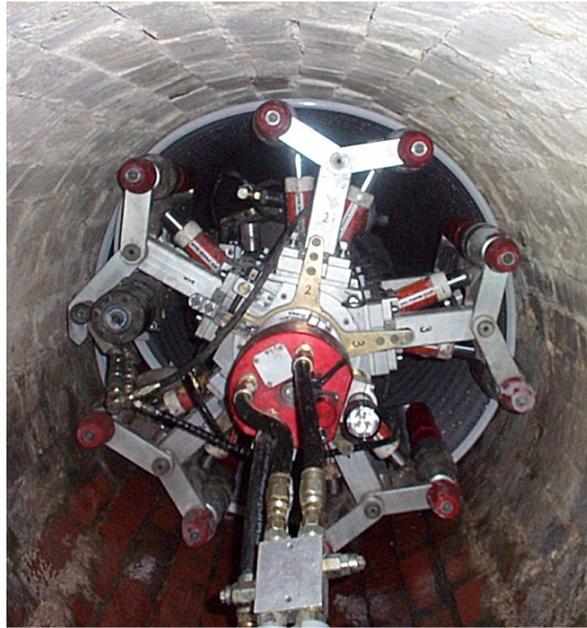
Full bore, traveling machine system: Rib Loc Rotaloc™ lining system shown above.

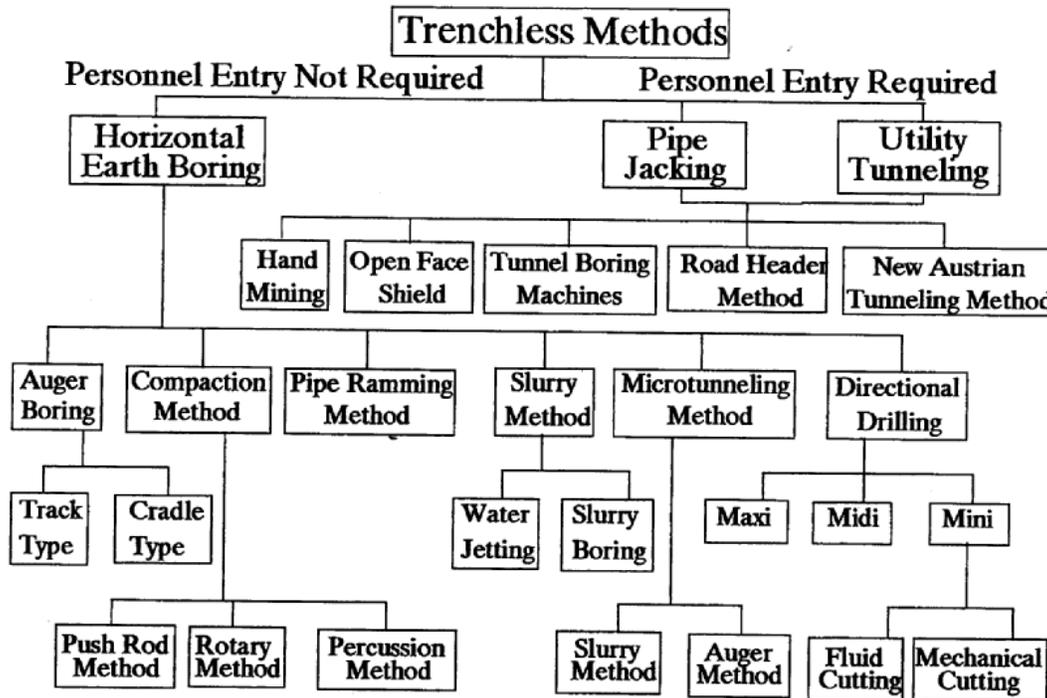
FIGURE 6 Classification systems for trenchless methods.

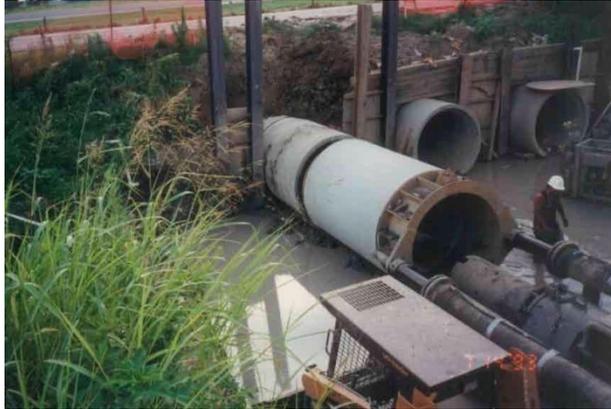
RCP Pipe Jacking example

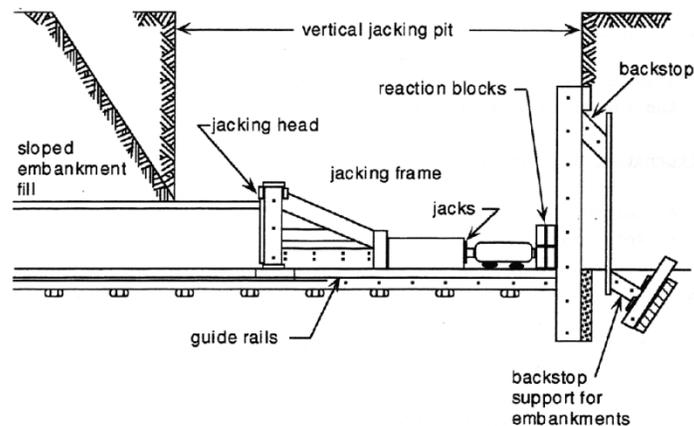
A typical equipment setup for jacking concrete pipe is as shown schematically above.

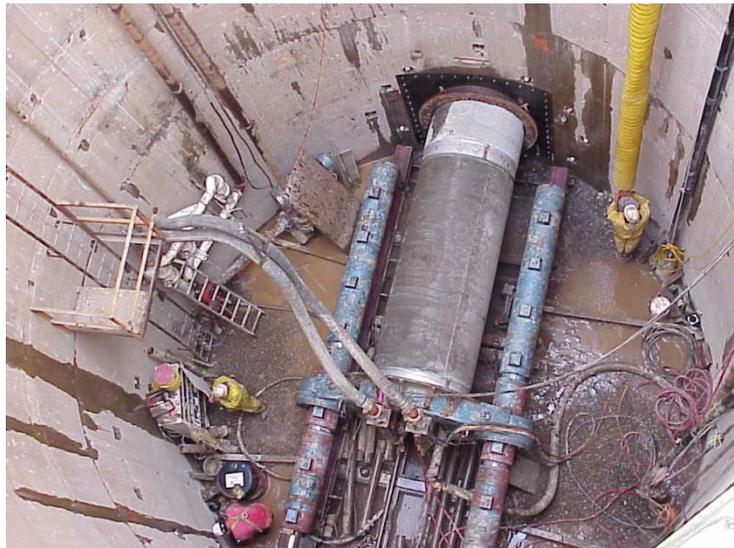
Jacking pit for 48 inches RCP Microtunneling project under American River, Sacramento

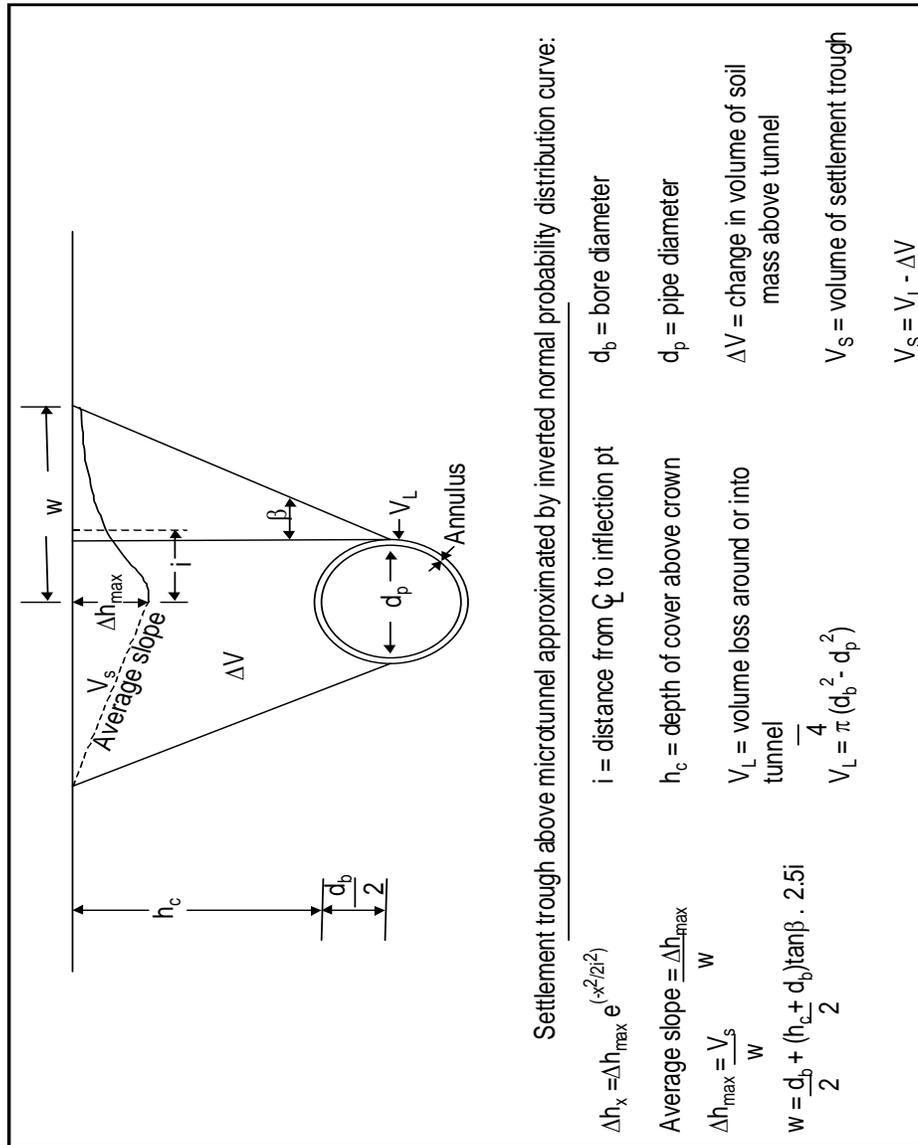
Figure 1 - Systematic Settlement Diagram (Modified from Cording & Hansmire, 1975)

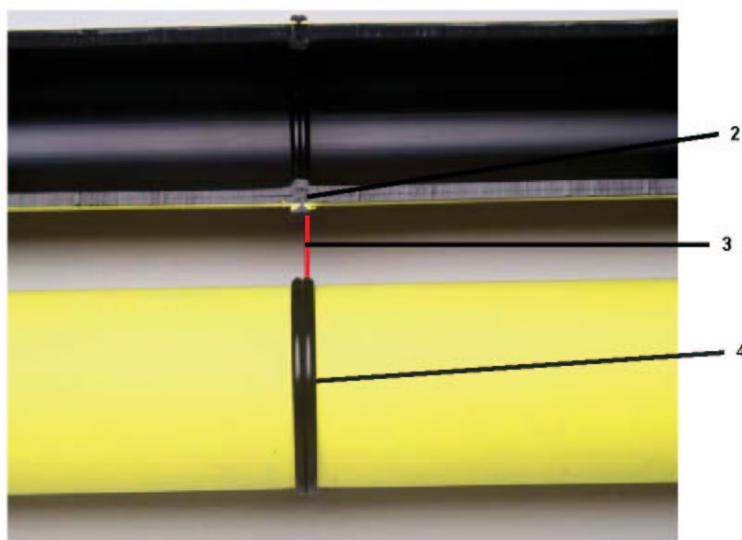
2. Proper alignment - no gaps or voids
3. Proper melt, pressure and alignment
4. Proper double roll-back bead

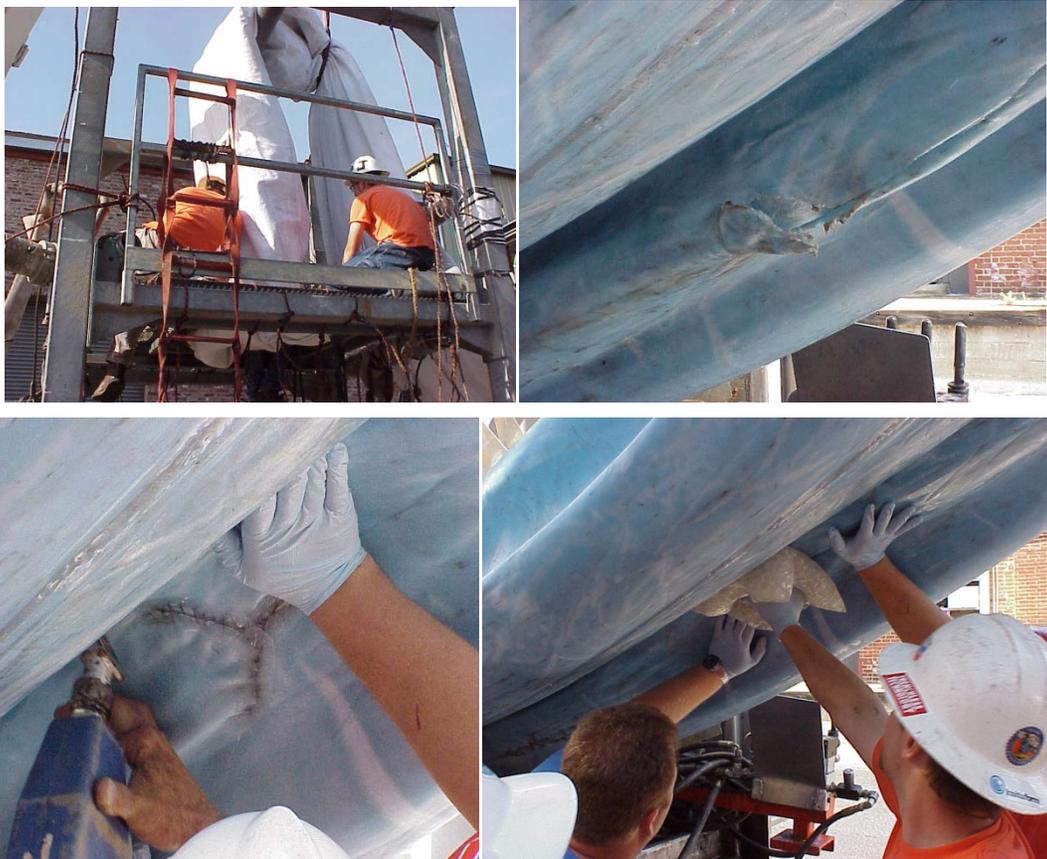
Example of liner tear during installation and subsequent repairs.

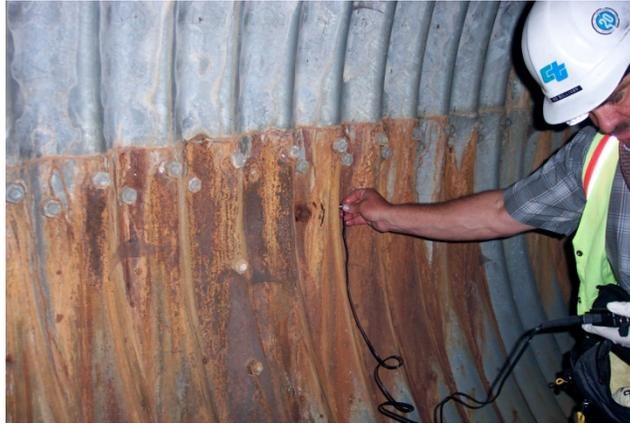
Taking thickness measurements. Note evidence of leaking horizontal seam at springline

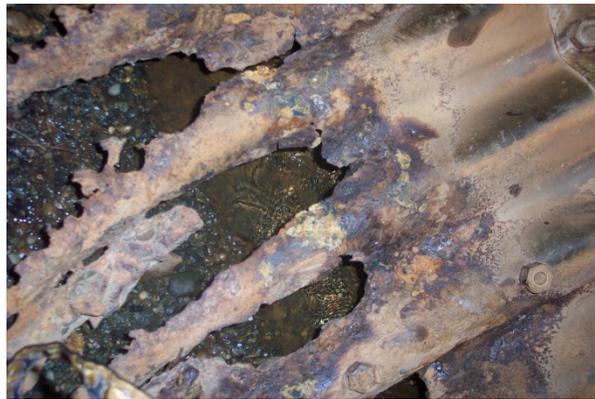
Total loss of invert and existing nuts showing minimal wear

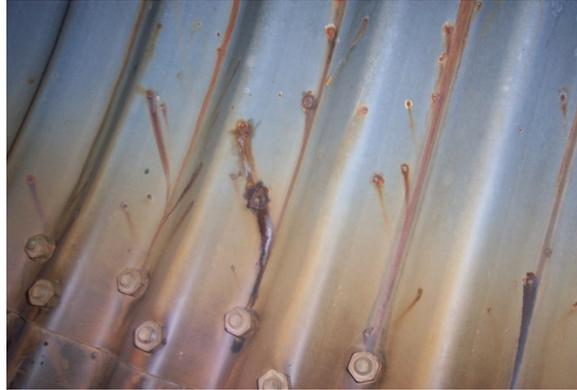
Typical local corrosion cells. Note that the corrosion is coming in from the backside, thus the pipe is in worse condition than it appears. See picture of void found from probing during construction.

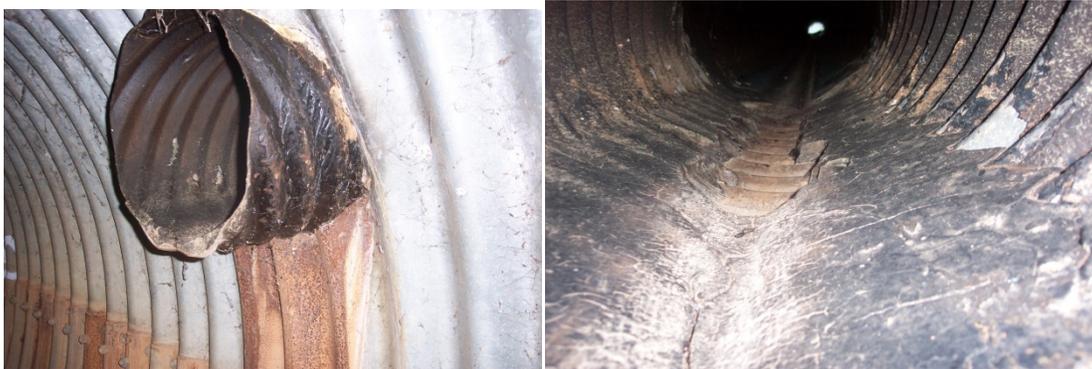
36 inch Bitumen coated CMP tie-in. Note rust stain below from perforated invert. Perforations in invert to 36 inch CMP allowed water to leak behind 96 inch culvert

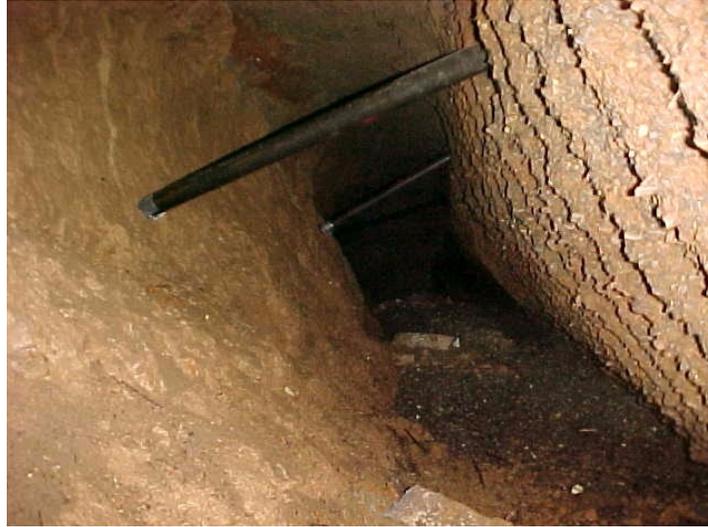
Large, long void that was located by probing. Note corroded back side of culvert on right side of picture.

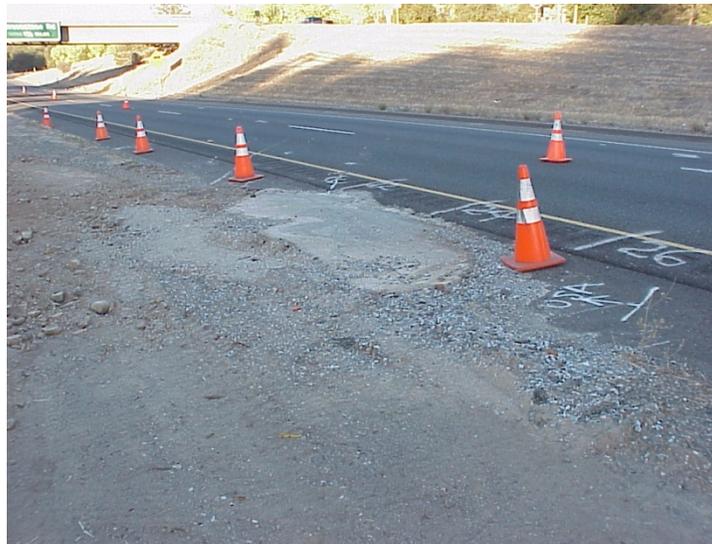
Freshly placed slurry where void migrated to surface.

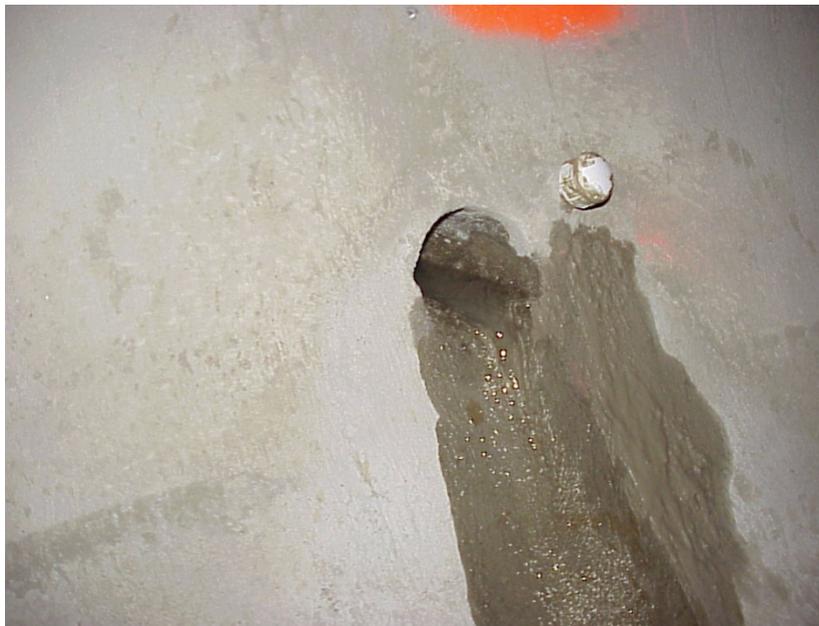
“Cored” grout hole in shotcrete used to fill large void with 3-sack sand slurry leaking groundwater during contact grouting. Note capped contact grout port.

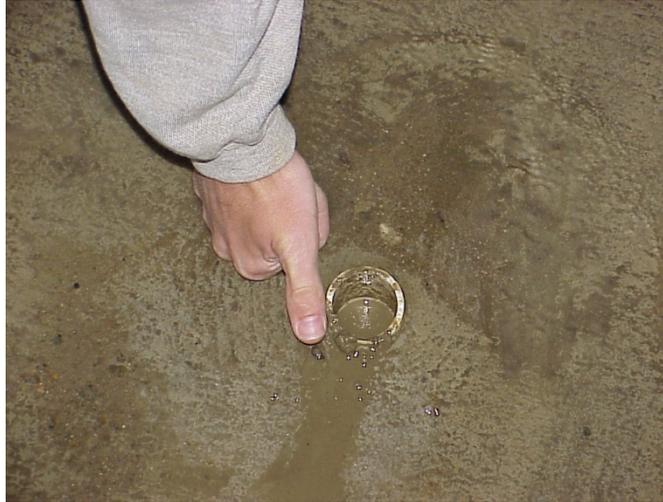
PVC pipe “weep” placed in rock below invert. Later, larger weeps were “cored” in addition in addition to these.

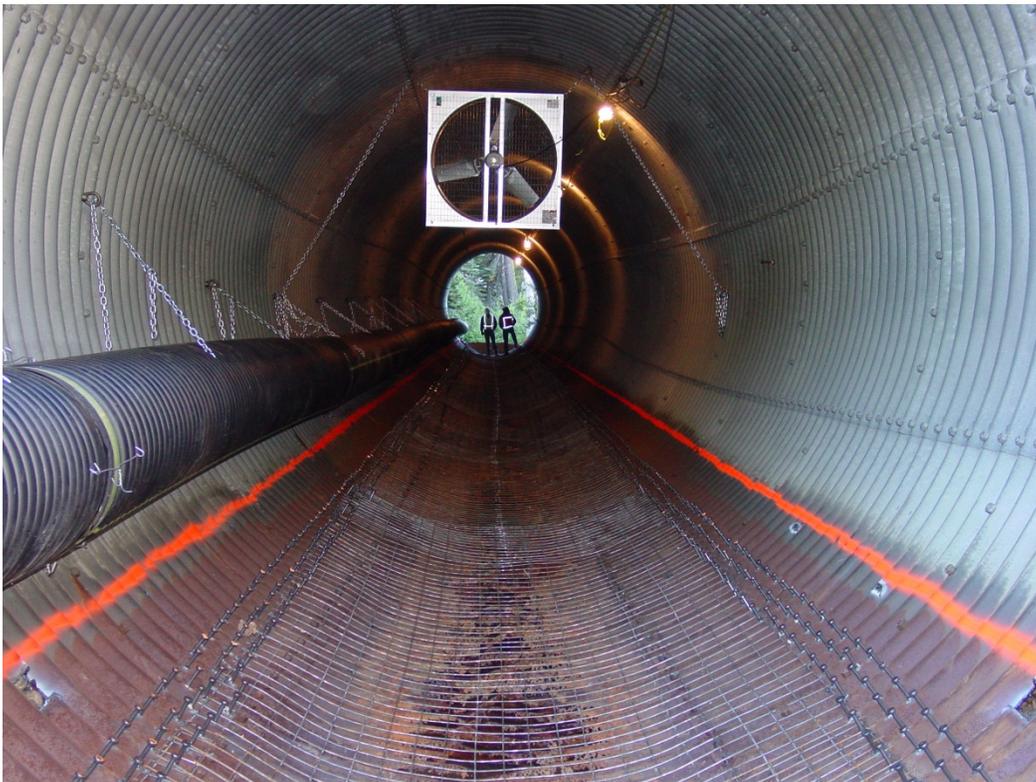
Eastbound pipe prior to Concrete placement with temporary HDPE by-pass, WWM and Nelson studs.

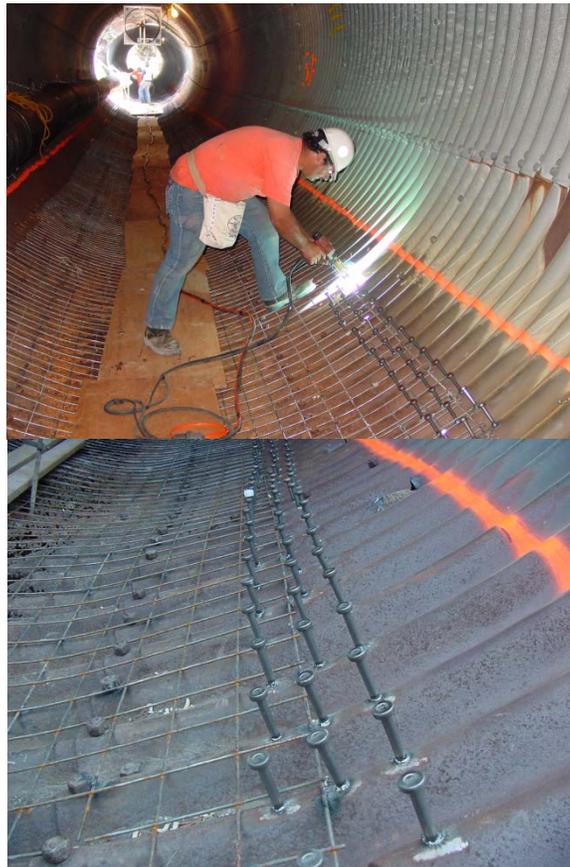
Shear connector welding studs (Trade name Nelson Headed Anchors and Nelson Threaded Studs are acceptable structural fasteners. Nelson studs are regularly used in bridge superstructure construction. They are relatively inexpensive (roughly 25 cents each) and depending upon the overfill height and culvert pipe thrust, Nelson Headed Anchors can function to anchor and transfer the culvert thrust load from the wall into the concrete invert lining through shear transfer. In addition, they are welded electrically which avoids the gaseous fumes resulting from normal structural welding. Six longitudinal rows of studs (3 running left of center and 3 running right of center) 6 inches apart on each corrugation were installed. Approximately, 4300 studs were installed in a few days at a cost of about \$7,000.

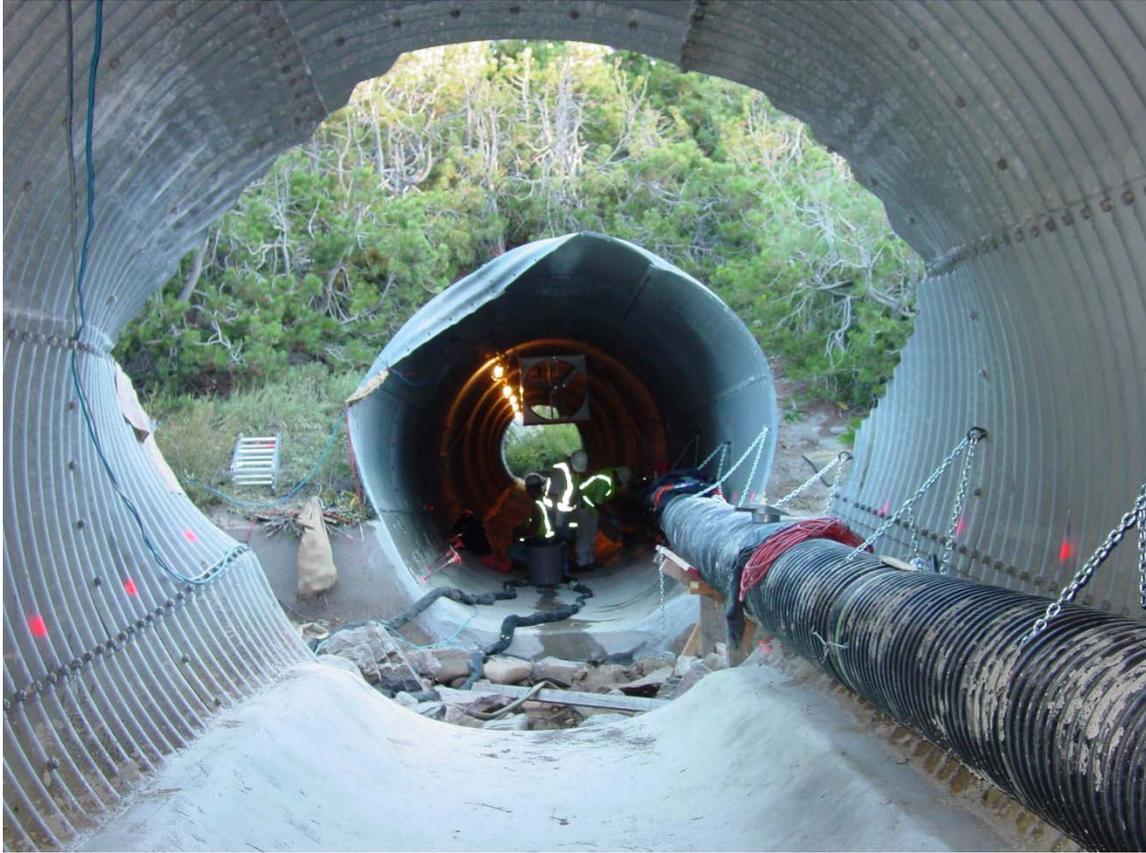
View of both pipes after concrete invert paving.

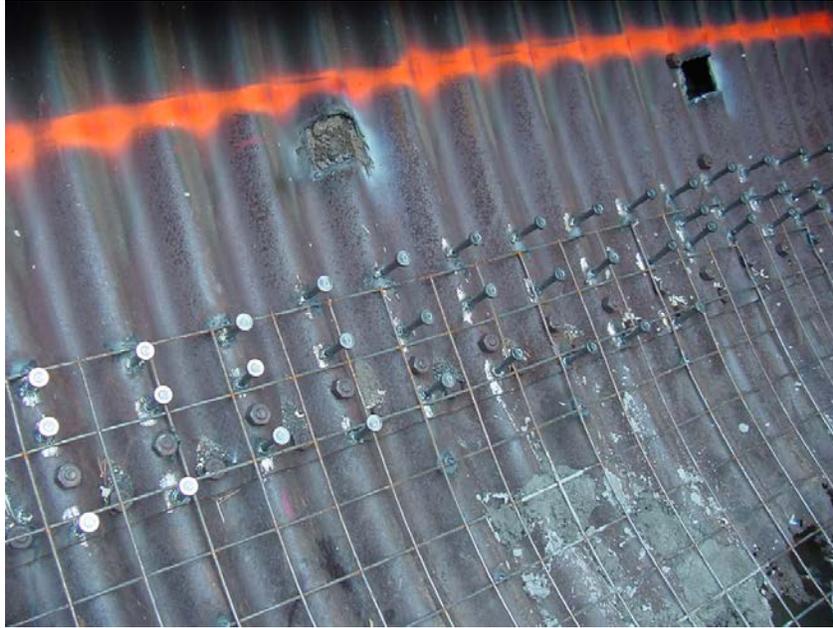
Coupons cut in sidewall of culvert for probing and grouting

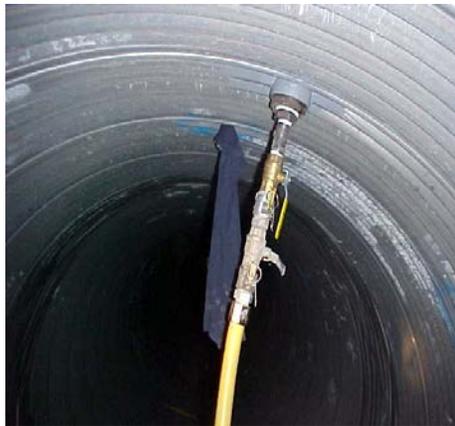
Grouting through grout port in soffit of liner
